## Appendix G: Conducted Spurious Emission

### Test Result

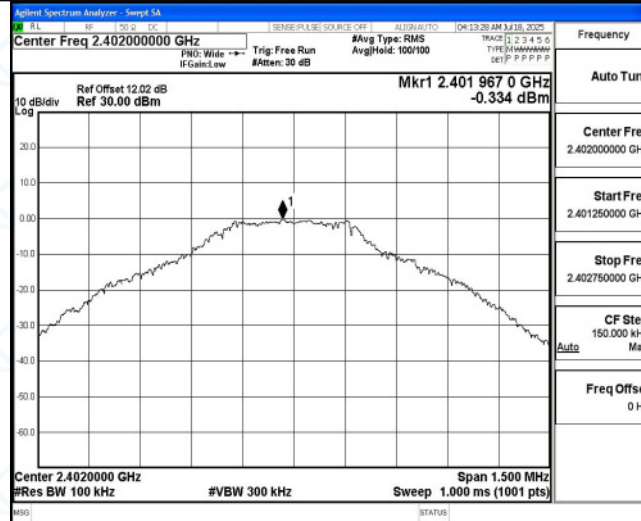
DH5\_Ant1\_2402\_0~Reference

| TestMode | Antenna | Freq(MHz) | FreqRange [MHz] | RefLevel [dBm] | Result [dBm] | Limit [dBm] | Verdict |
|---|---|---|---|---|---|---|---|
| DH5 | Ant1 | 2402 | Reference | -0.33 | -0.33 | --- | PASS |

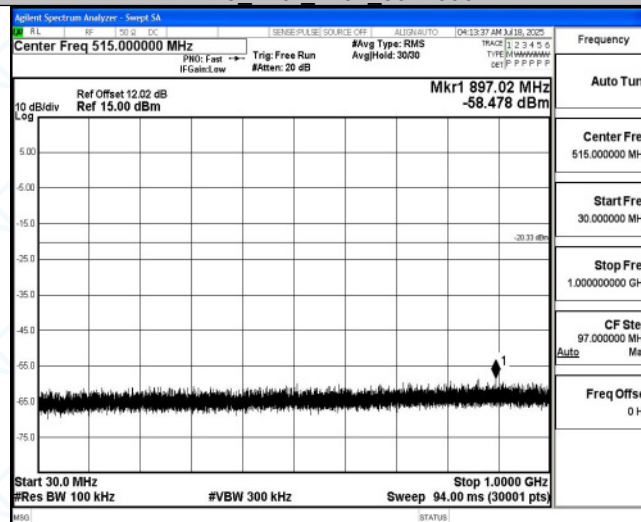
DH5\_Ant1\_2402\_30~1000

| TestMode | Antenna | Freq(MHz) | FreqRange [MHz] | RefLevel [dBm] | Result [dBm] | Limit [dBm] | Verdict |
|---|---|---|---|---|---|---|---|
| | | | 30~1000 | -0.33 | -58.48 | $\leq -20.33$ | PASS |

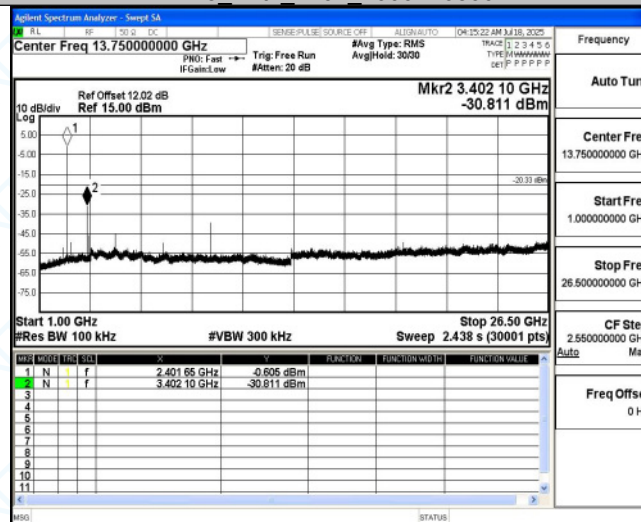
DH5\_Ant1\_2402\_1000~26500

| TestMode | Antenna | Freq(MHz) | FreqRange [MHz] | RefLevel [dBm] | Result [dBm] | Limit [dBm] | Verdict |
|---|---|---|---|---|---|---|---|
| | | | 1000~26500 | -0.33 | -30.81 | $\leq -20.33$ | PASS |

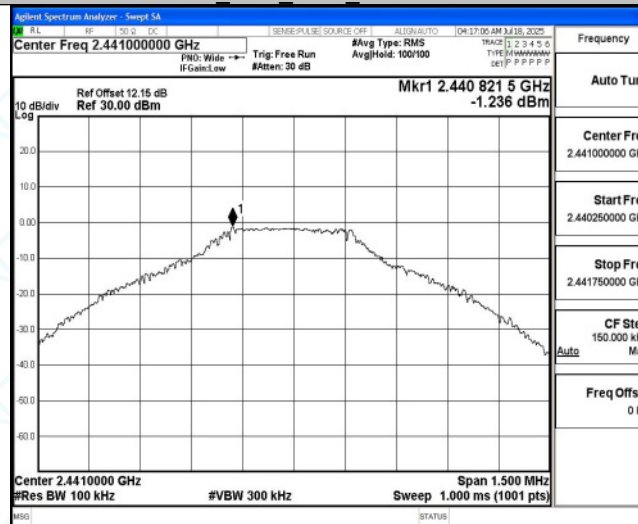
## DH5\_Ant1\_2441\_0~Reference

| TestMode | Antenna | Freq(MHz) | FreqRange [MHz] | RefLevel [dBm] | Result [dBm] | Limit [dBm] | Verdict |
|---|---|---|---|---|---|---|---|
| | | 2441 | Reference | -1.24 | -1.24 | --- | PASS |

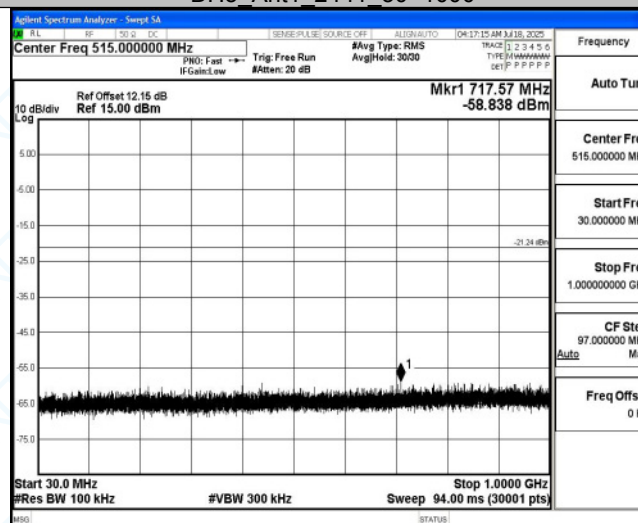
## DH5\_Ant1\_2441\_30~1000

| TestMode | Antenna | Freq(MHz) | FreqRange [MHz] | RefLevel [dBm] | Result [dBm] | Limit [dBm] | Verdict |
|---|---|---|---|---|---|---|---|
| | | | 30~1000 | -1.24 | -58.84 | $\leq -21.24$ | PASS |

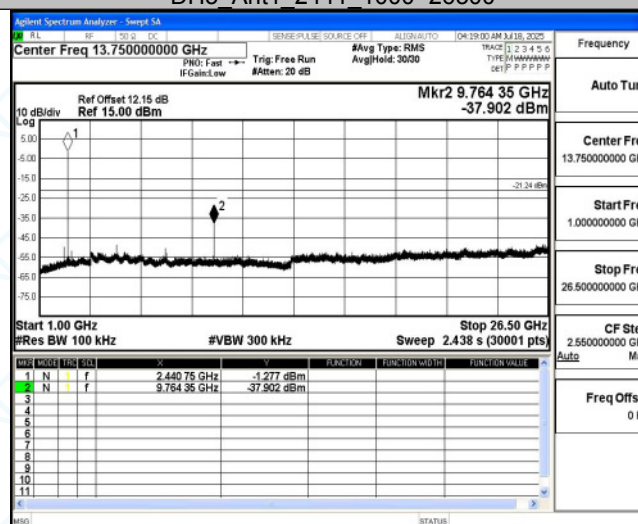
## DH5\_Ant1\_2441\_1000~26500

| TestMode | Antenna | Freq(MHz) | FreqRange [MHz] | RefLevel [dBm] | Result [dBm] | Limit [dBm] | Verdict |
|---|---|---|---|---|---|---|---|
| | | | 1000~26500 | -1.24 | -37.9 | $\leq -21.24$ | PASS |

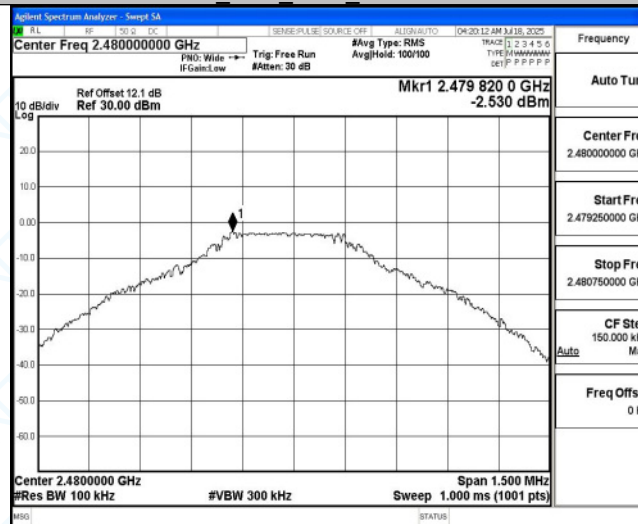
## DH5\_Ant1\_2480\_0~Reference

| TestMode | Antenna | Freq(MHz) | FreqRange [MHz] | RefLevel [dBm] | Result [dBm] | Limit [dBm] | Verdict |
|---|---|---|---|---|---|---|---|
| | | 2480 | Reference | -2.53 | -2.53 | --- | PASS |

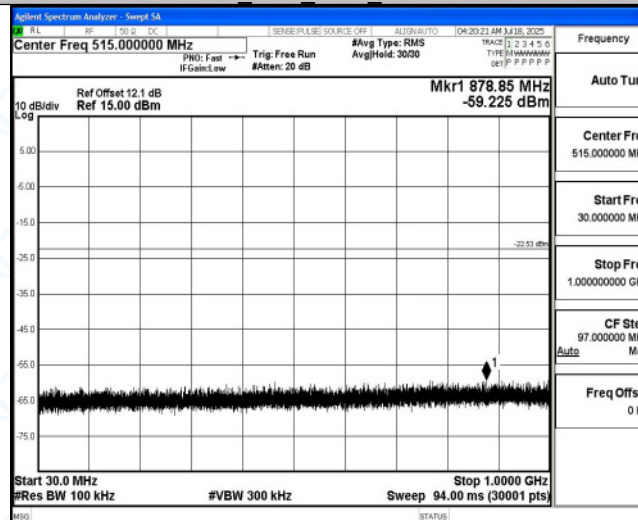
## DH5\_Ant1\_2480\_30~1000

| TestMode | Antenna | Freq(MHz) | FreqRange [MHz] | RefLevel [dBm] | Result [dBm] | Limit [dBm] | Verdict |
|---|---|---|---|---|---|---|---|
| | | | 30~1000 | -2.53 | -59.23 | $\leq -22.53$ | PASS |

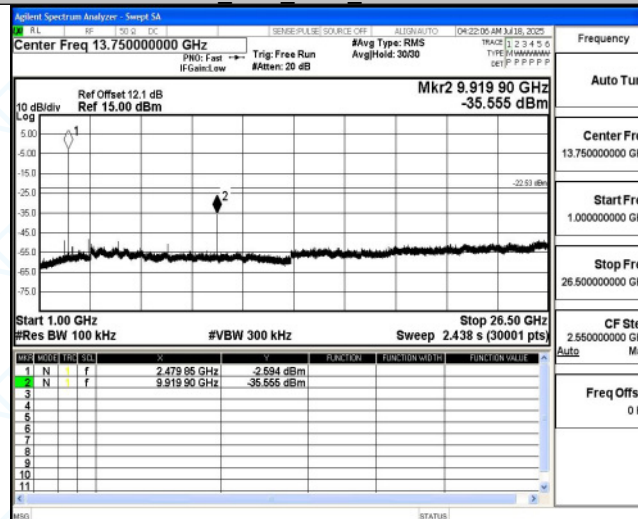
## DH5\_Ant1\_2480\_1000~26500

| TestMode | Antenna | Freq(MHz) | FreqRange [MHz] | RefLevel [dBm] | Result [dBm] | Limit [dBm] | Verdict |
|---|---|---|---|---|---|---|---|
| | | | 1000~26500 | -2.53 | -35.56 | $\leq -22.53$ | PASS |

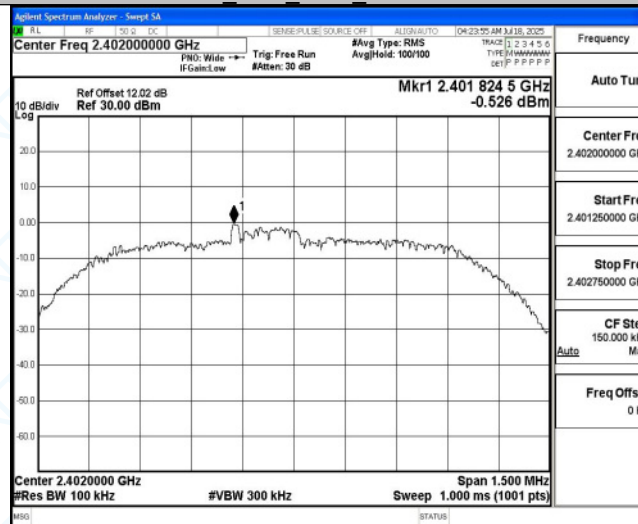
## 2DH5\_Ant1\_2402\_0~Reference

| TestMode | Antenna | Freq(MHz) | FreqRange [MHz] | RefLevel [dBm] | Result [dBm] | Limit [dBm] | Verdict |
|---|---|---|---|---|---|---|---|
| 2DH5 | Ant1 | 2402 | Reference | -0.53 | -0.53 | --- | PASS |

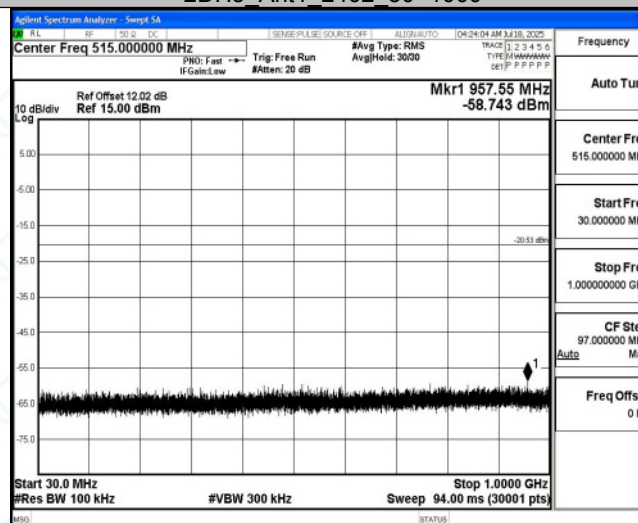
## 2DH5\_Ant1\_2402\_30~1000

| TestMode | Antenna | Freq(MHz) | FreqRange [MHz] | RefLevel [dBm] | Result [dBm] | Limit [dBm] | Verdict |
|---|---|---|---|---|---|---|---|
| | | | 30~1000 | -0.53 | -58.74 | $\leq -20.53$ | PASS |

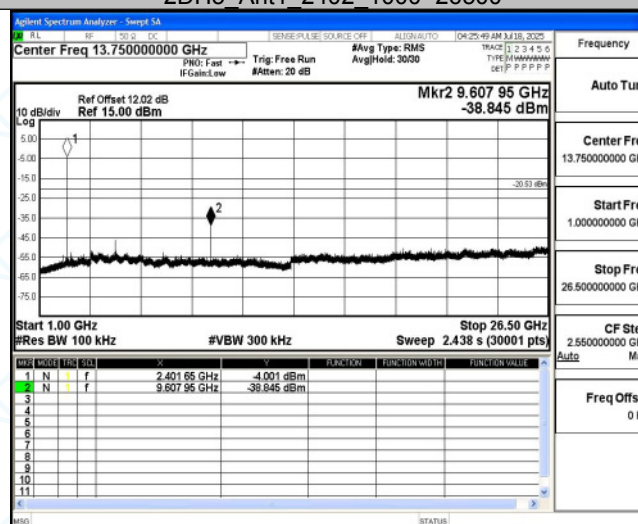
## 2DH5\_Ant1\_2402\_1000~26500

| TestMode | Antenna | Freq(MHz) | FreqRange [MHz] | RefLevel [dBm] | Result [dBm] | Limit [dBm] | Verdict |
|---|---|---|---|---|---|---|---|
| | | | 1000~26500 | -0.53 | -38.85 | $\leq -20.53$ | PASS |

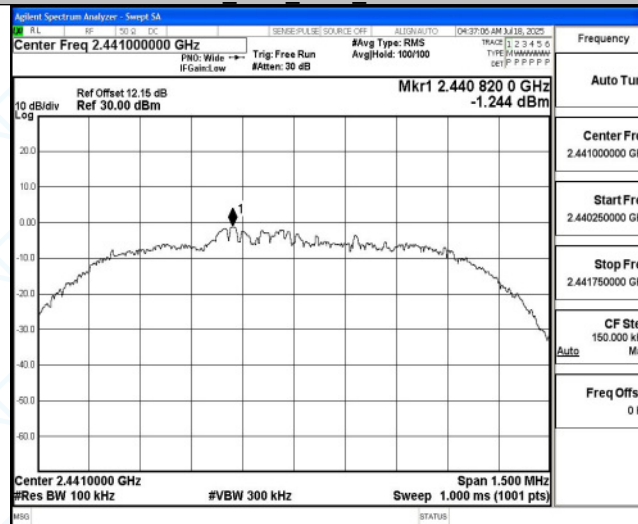
## 2DH5\_Ant1\_2441\_0~Reference

| TestMode | Antenna | Freq(MHz) | FreqRange [MHz] | RefLevel [dBm] | Result [dBm] | Limit [dBm] | Verdict |
|---|---|---|---|---|---|---|---|
| | | 2441 | Reference | -1.24 | -1.24 | --- | PASS |

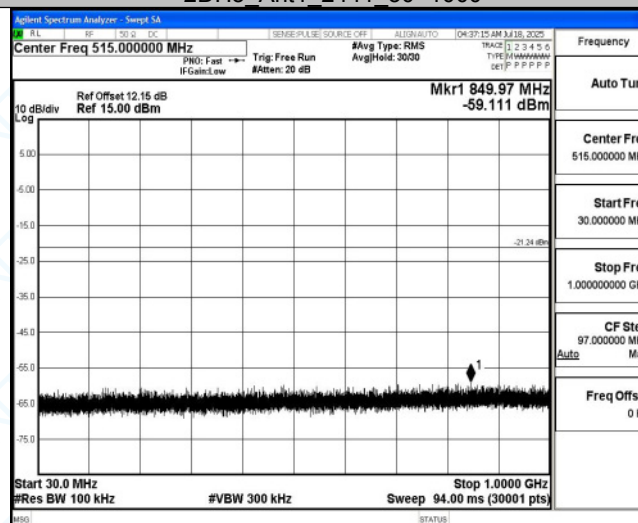
## 2DH5\_Ant1\_2441\_30~1000

| TestMode | Antenna | Freq(MHz) | FreqRange [MHz] | RefLevel [dBm] | Result [dBm] | Limit [dBm] | Verdict |
|---|---|---|---|---|---|---|---|
| | | | 30~1000 | -1.24 | -59.11 | $\leq -21.24$ | PASS |

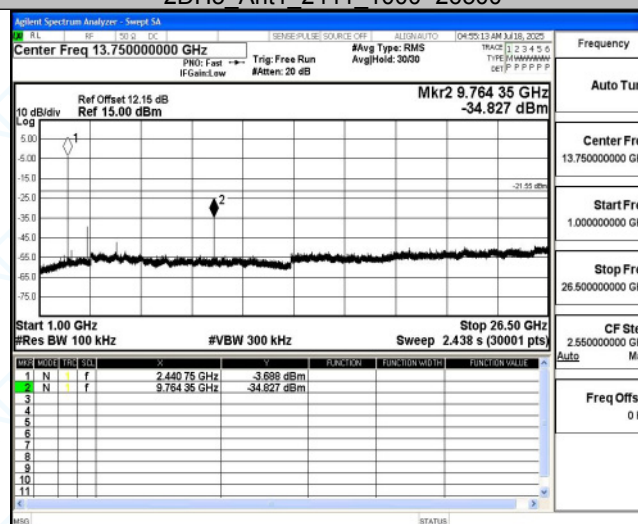
## 2DH5\_Ant1\_2441\_1000~26500

| TestMode | Antenna | Freq(MHz) | FreqRange [MHz] | RefLevel [dBm] | Result [dBm] | Limit [dBm] | Verdict |
|---|---|---|---|---|---|---|---|
| | | | 1000~26500 | -1.24 | -34.83 | $\leq -21.24$ | PASS |

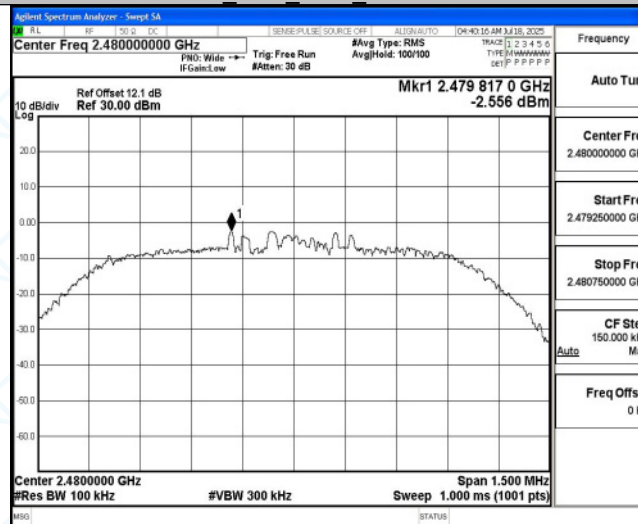
## 2DH5\_Ant1\_2480\_0~Reference

| TestMode | Antenna | Freq(MHz) | FreqRange [MHz] | RefLevel [dBm] | Result [dBm] | Limit [dBm] | Verdict |
|---|---|---|---|---|---|---|---|
| | | 2480 | Reference | -2.56 | -2.56 | --- | PASS |

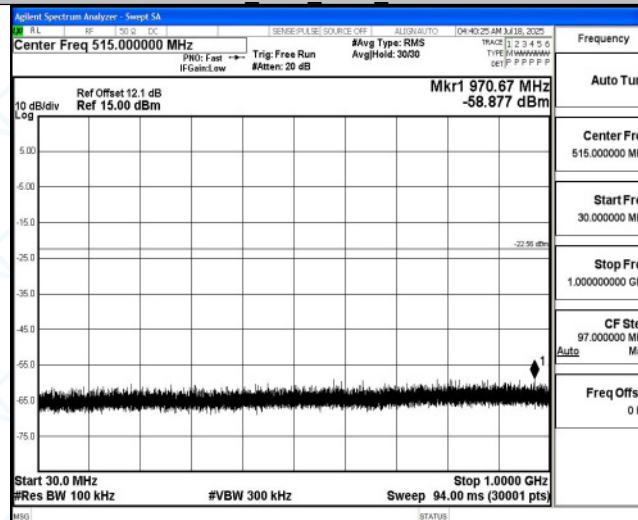
## 2DH5\_Ant1\_2480\_30~1000

| TestMode | Antenna | Freq(MHz) | FreqRange [MHz] | RefLevel [dBm] | Result [dBm] | Limit [dBm] | Verdict |
|---|---|---|---|---|---|---|---|
| | | | 30~1000 | -2.56 | -58.88 | $\leq -22.56$ | PASS |

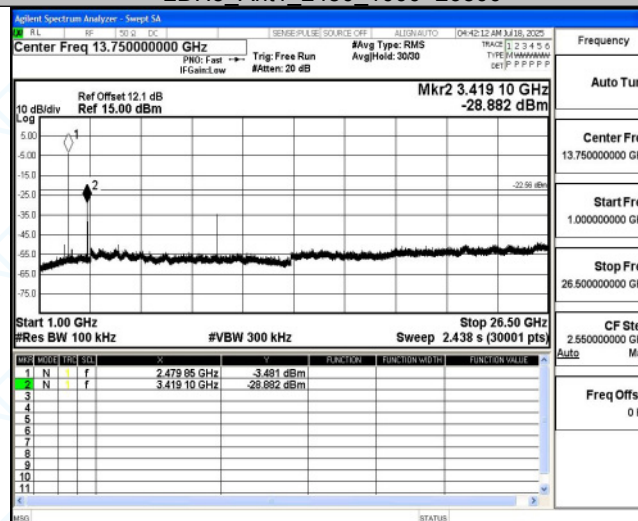
## 2DH5\_Ant1\_2480\_1000~26500

| TestMode | Antenna | Freq(MHz) | FreqRange [MHz] | RefLevel [dBm] | Result [dBm] | Limit [dBm] | Verdict |
|---|---|---|---|---|---|---|---|
| | | | 1000~26500 | -2.56 | -28.88 | $\leq -22.56$ | PASS |
