## Appendix B: photographs of test setup

## Appendix C: photographs of EUT

Reference to the test report no. BLA-EMC-202403-A10301

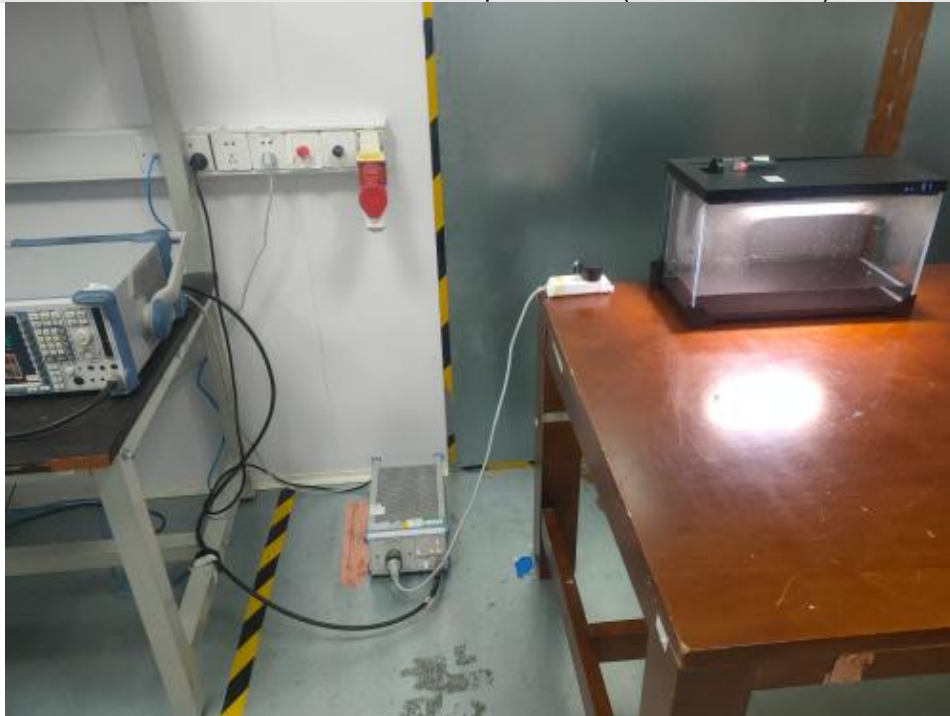
Conducted emissions at AC power line (150kHz-30MHz)
