## PHOTOGRAPHS OF TEST SETUP

## **PHOTOGRAPHS OF EUT Constructional Details**

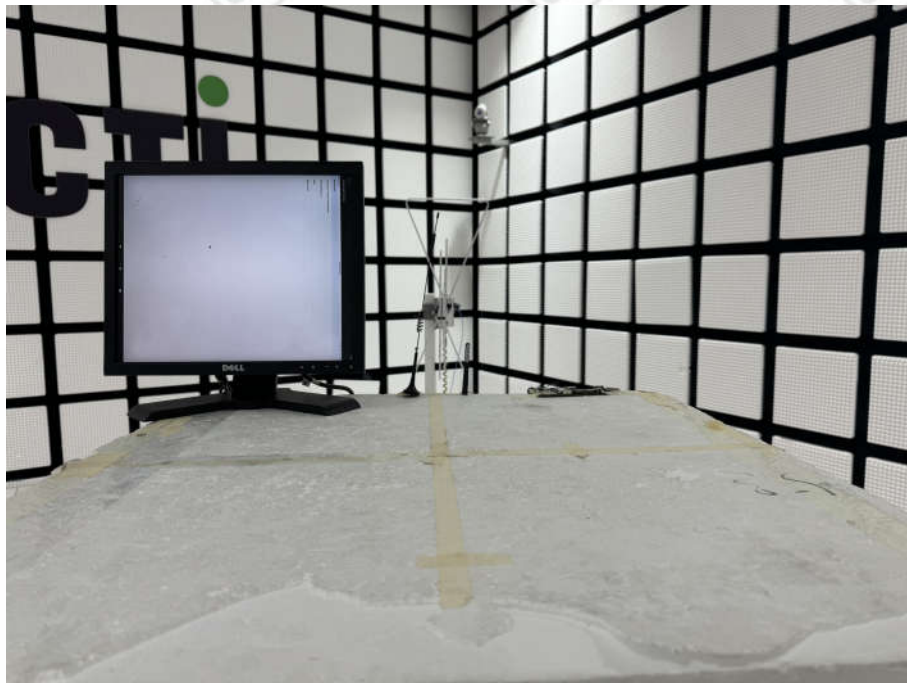
**Radiated spurious emission Test Setup-1(Below 1GHz)**

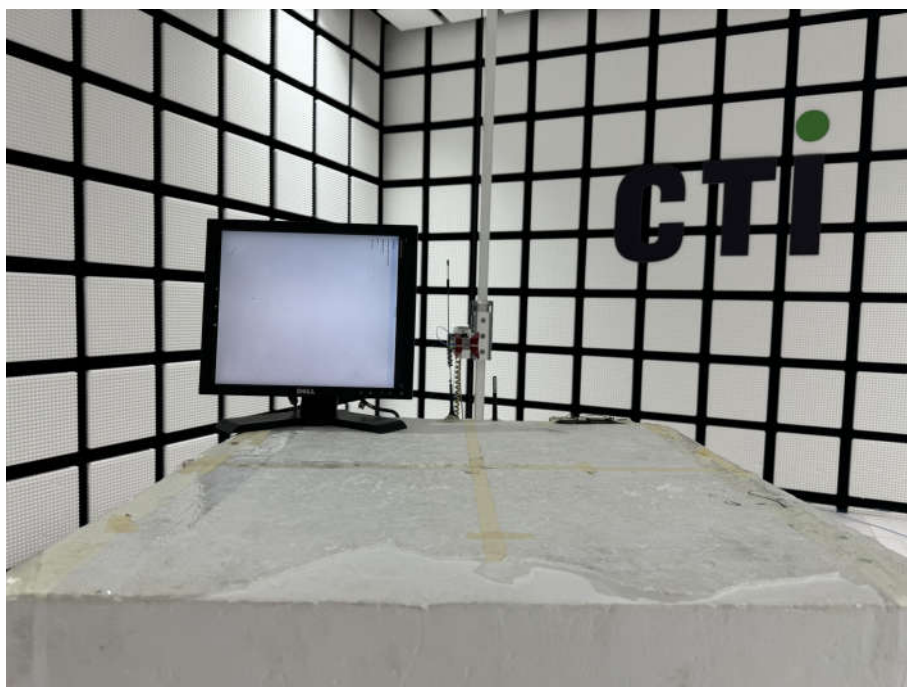
**Radiated spurious emission Test Setup-2(Above 1GHz)**

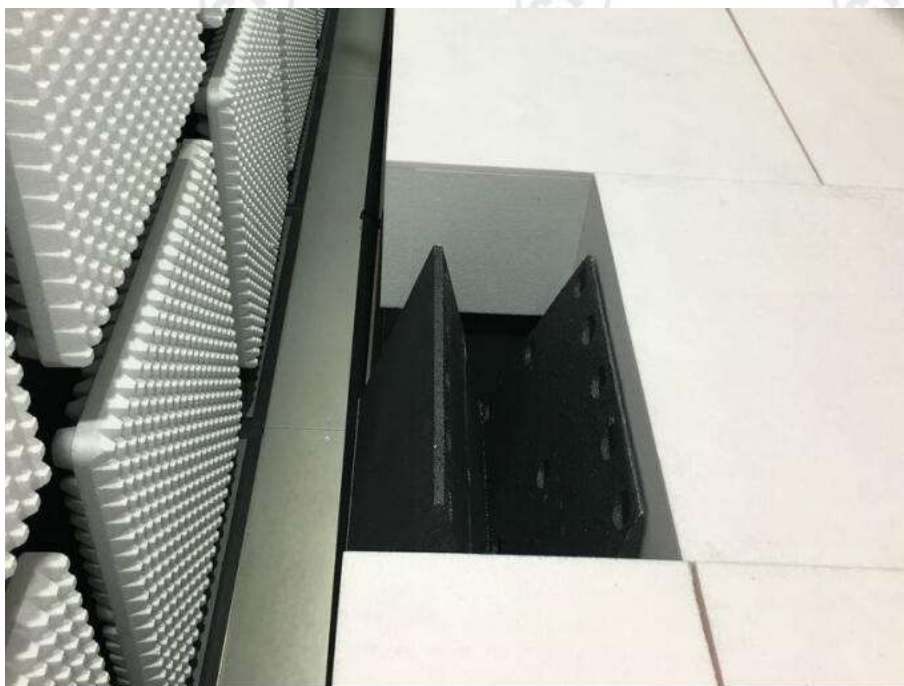
**Radiated spurious emission Test Setup-3(Above 1GHz)**  
**There are absorbing materials under the ground.**
