# TEST REPORT

Report No.: SHE24110067-02CE

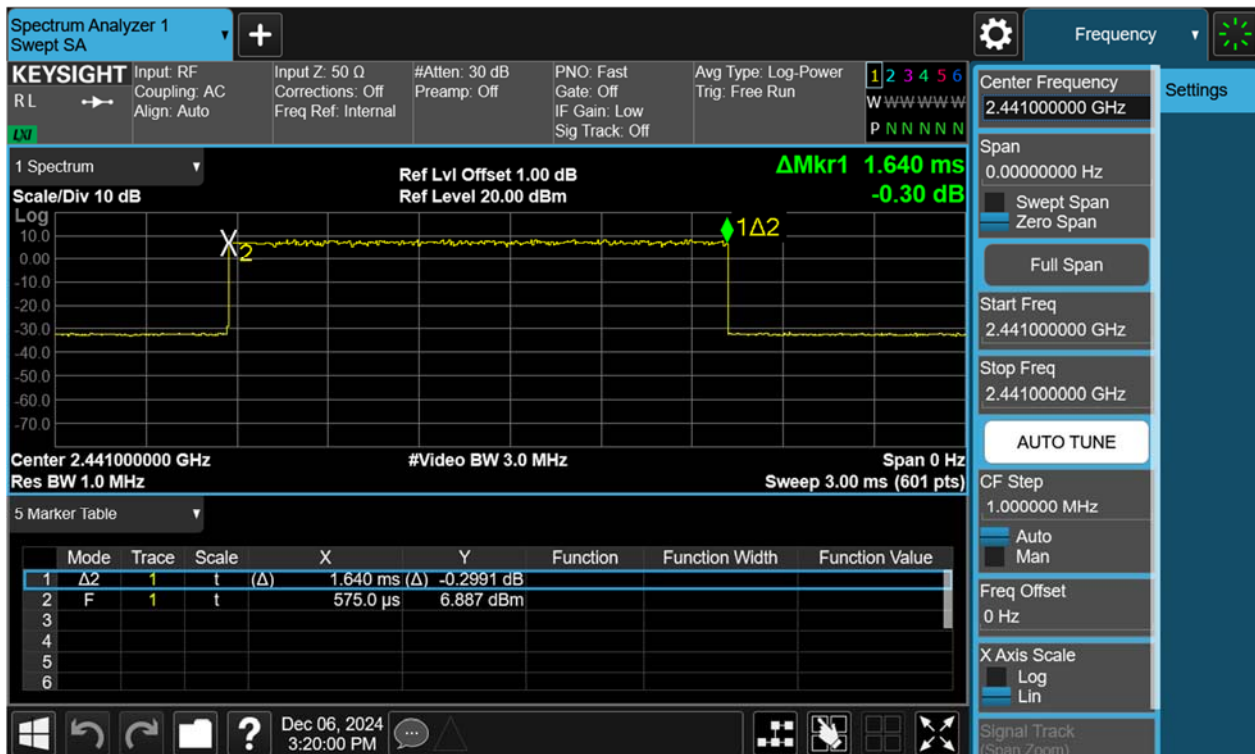
Figure 44: Time of Occupancy, 2441MHz, 8-DPSK DH3

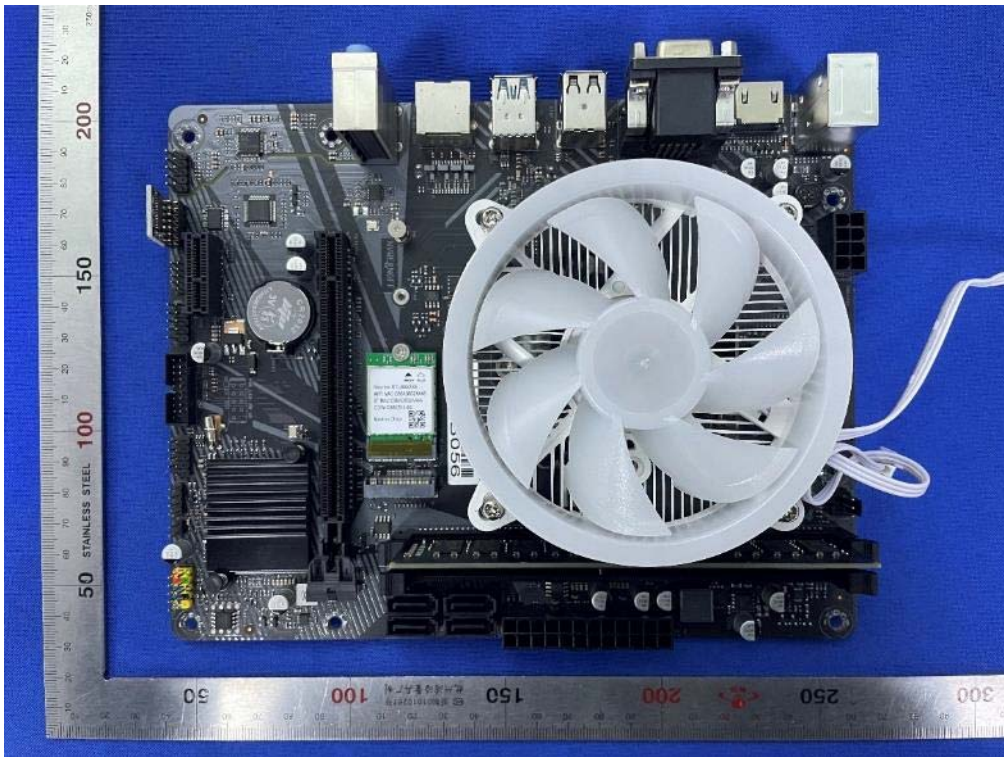
Internal-1 of the sample

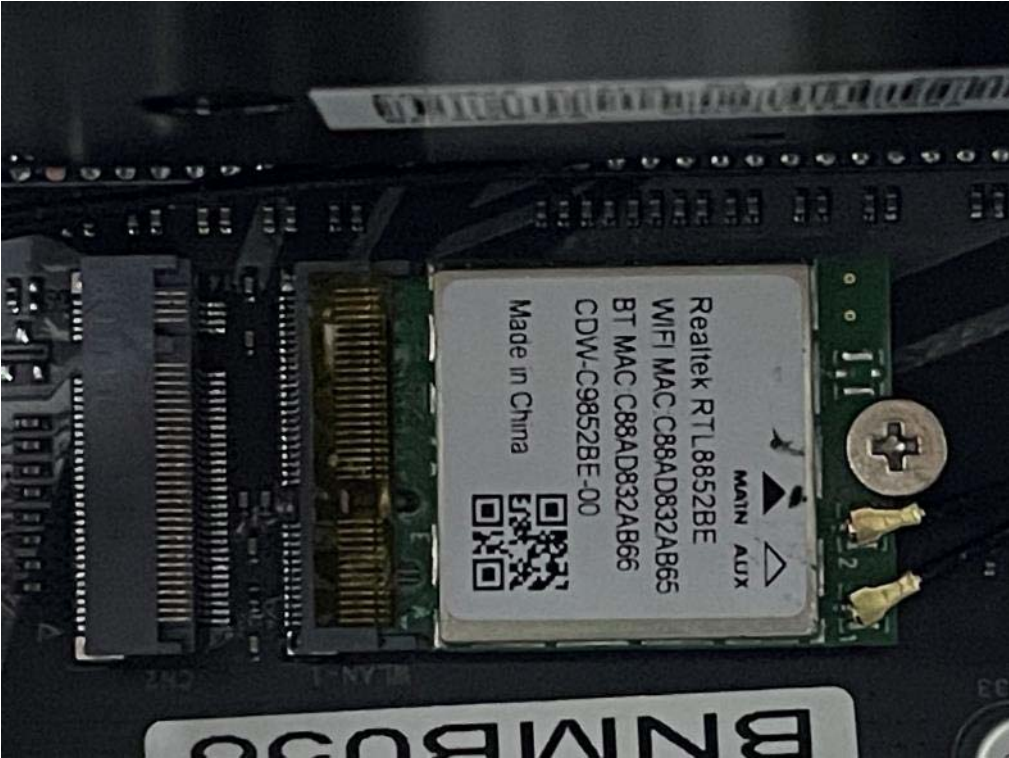
Antenna Interface

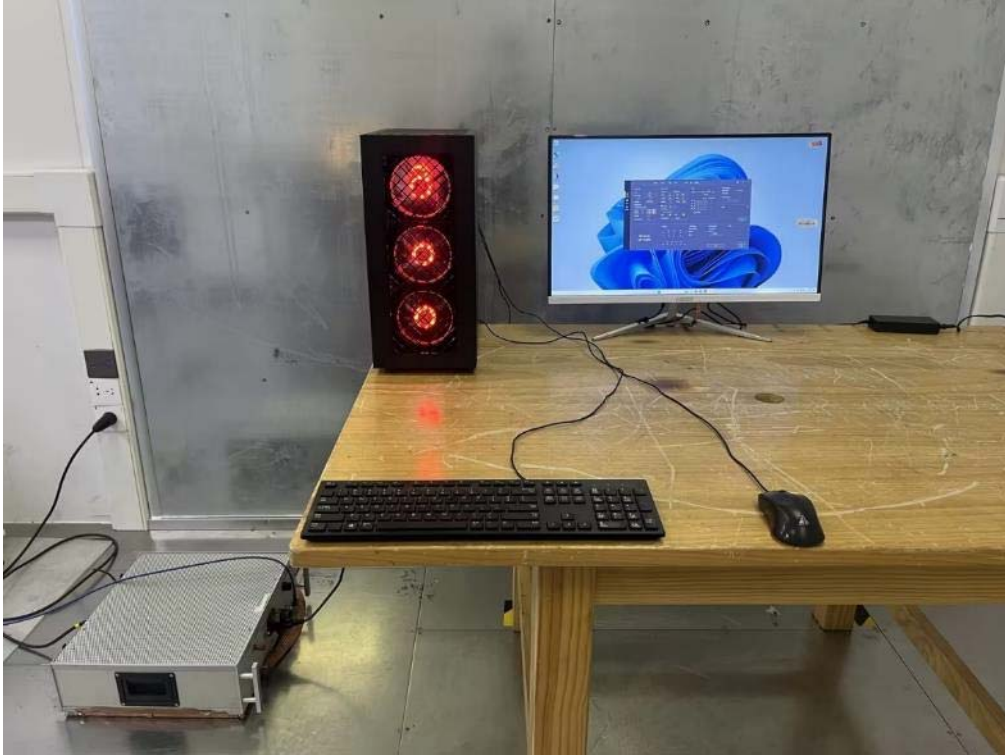
## 5.2 Set-up for Conducted Emission on AC Mains

Input Voltage : which received AC 120V, 60Hz Power  
Operation Mode : A.1.a  
Earthing : Connected to GND  
Ambient temperature : 21.6°C  
Relative humidity : 49%

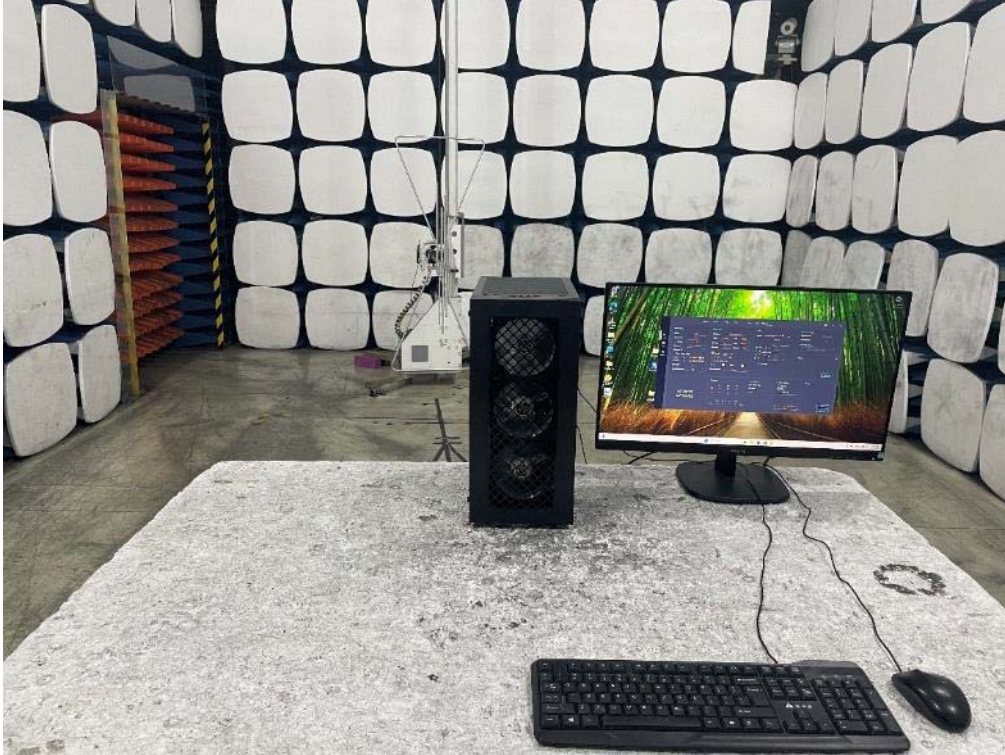
## 5.4 Set-up for Radiated Spurious Emissions below 1GHz
