## Appendix B: photographs of test setup

## Appendix C: photographs of EUT

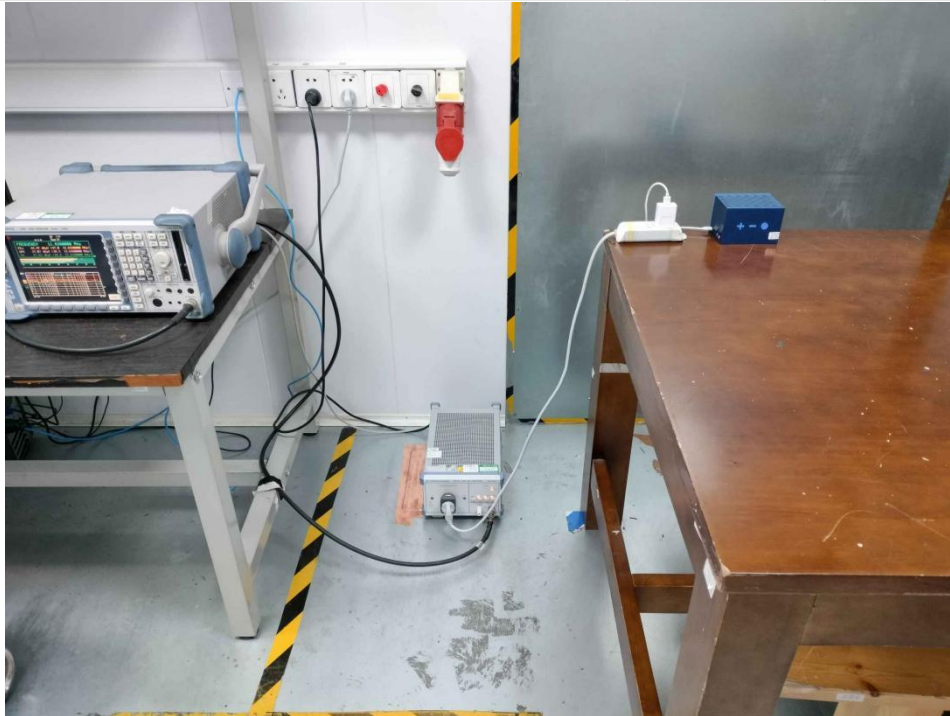
Conducted emissions at AC power line (150kHz-30MHz)

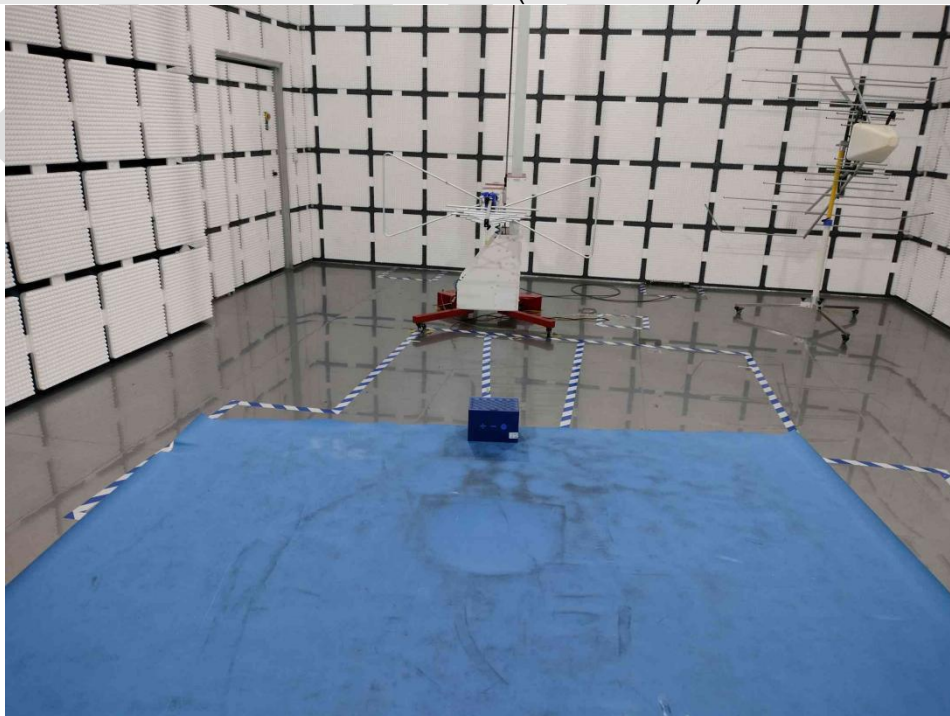
Radiated Emissions (30MHz-1GHz)

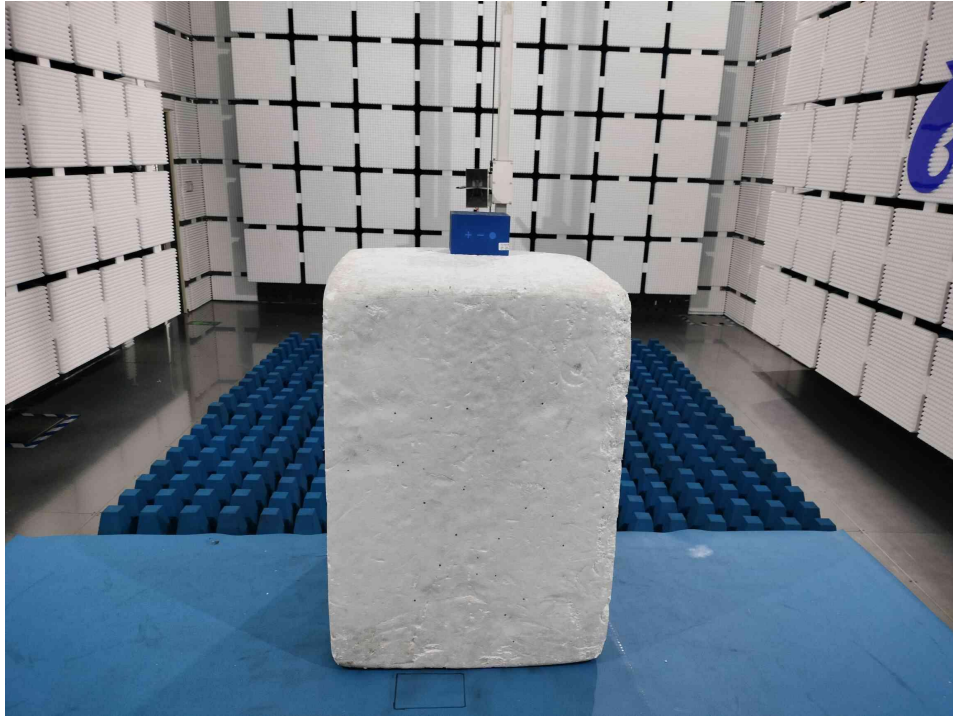
Radiated Emissions (above 1GHz)
