## Appendix B: photographs of test setup

Reference to the test report no. BLA-EMC-202507-A1301

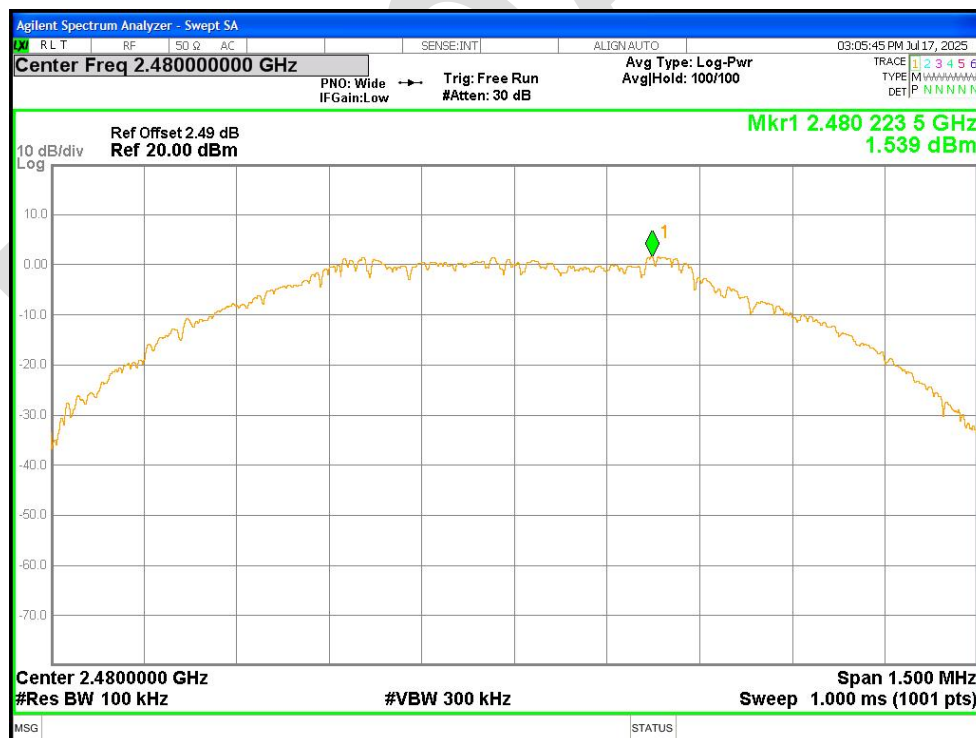
Tx. Spurious NVNT BLE 1M 2480MHz Ant1 Ref

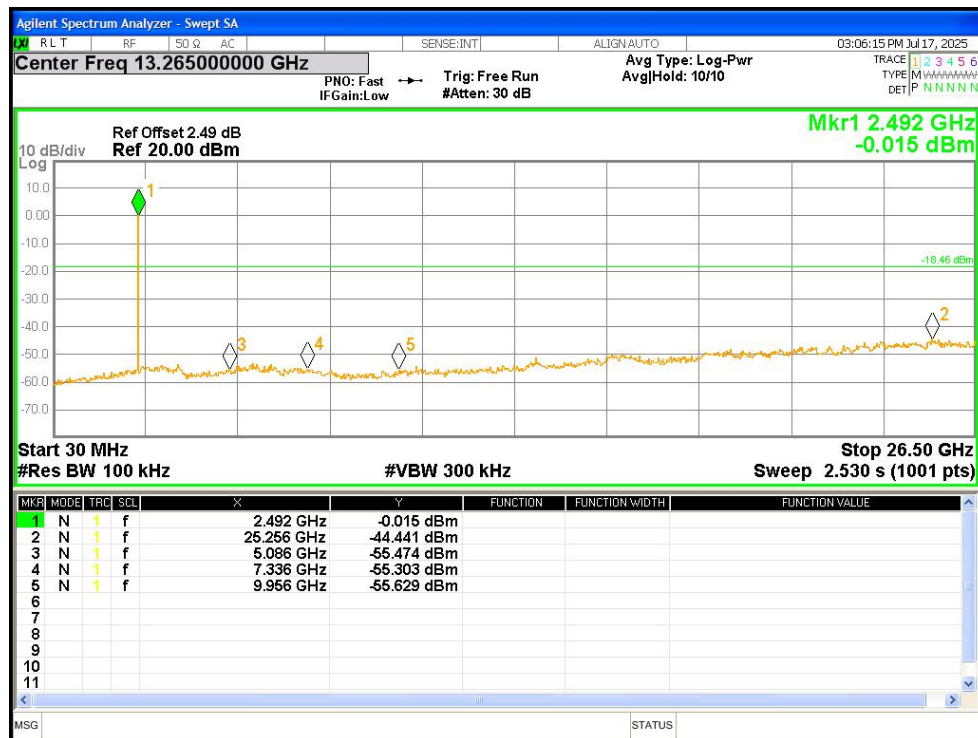
Tx. Spurious NVNT BLE 1M 2480MHz Ant1 Emission

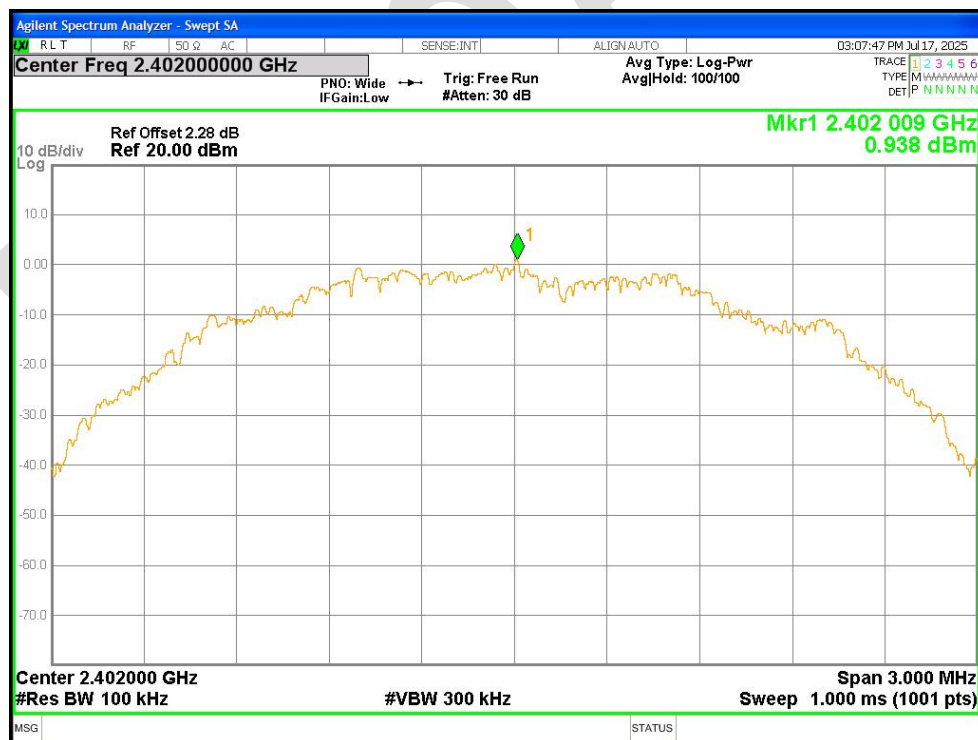
Tx. Spurious NVNT BLE 2M 2402MHz Ant1 Ref

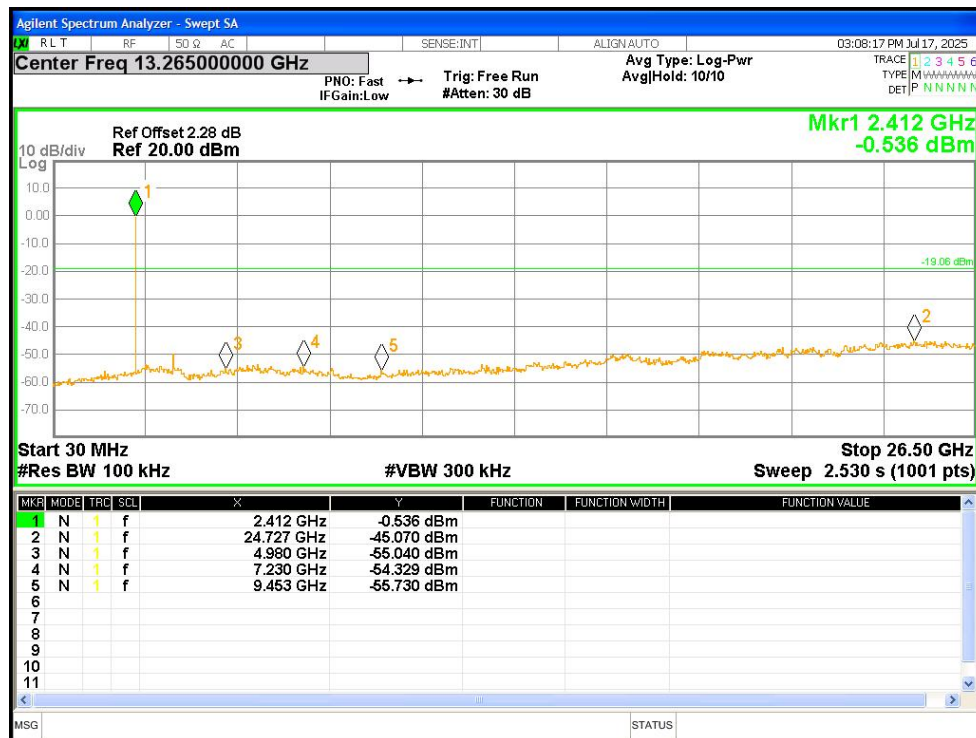
Tx. Spurious NVNT BLE 2M 2402MHz Ant1 Emission

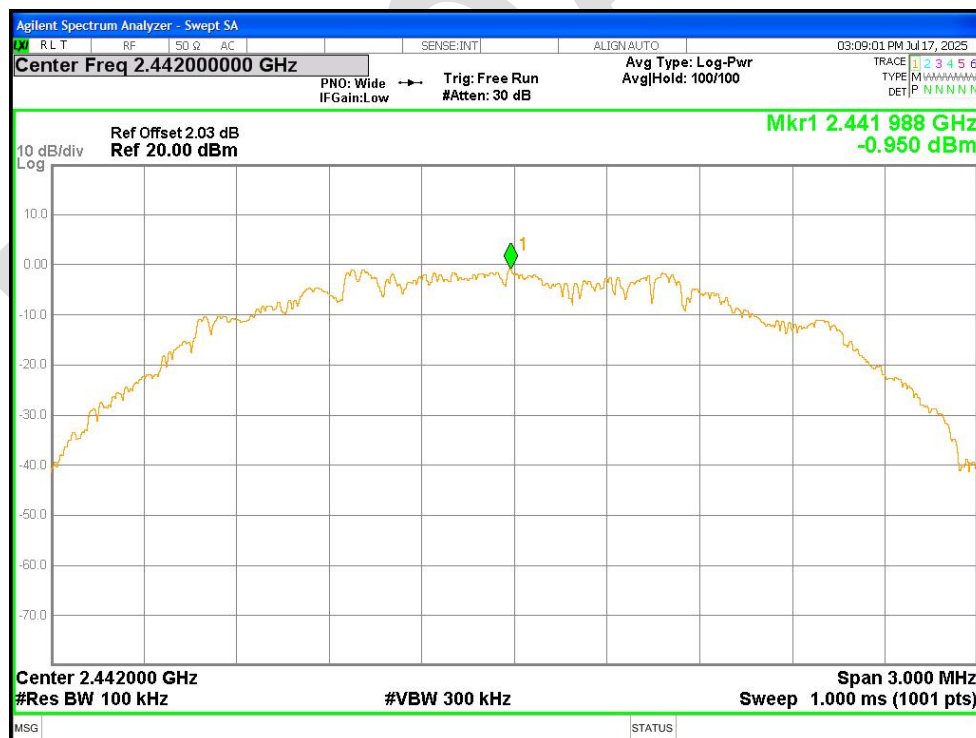
Tx. Spurious NVNT BLE 2M 2442MHz Ant1 Ref

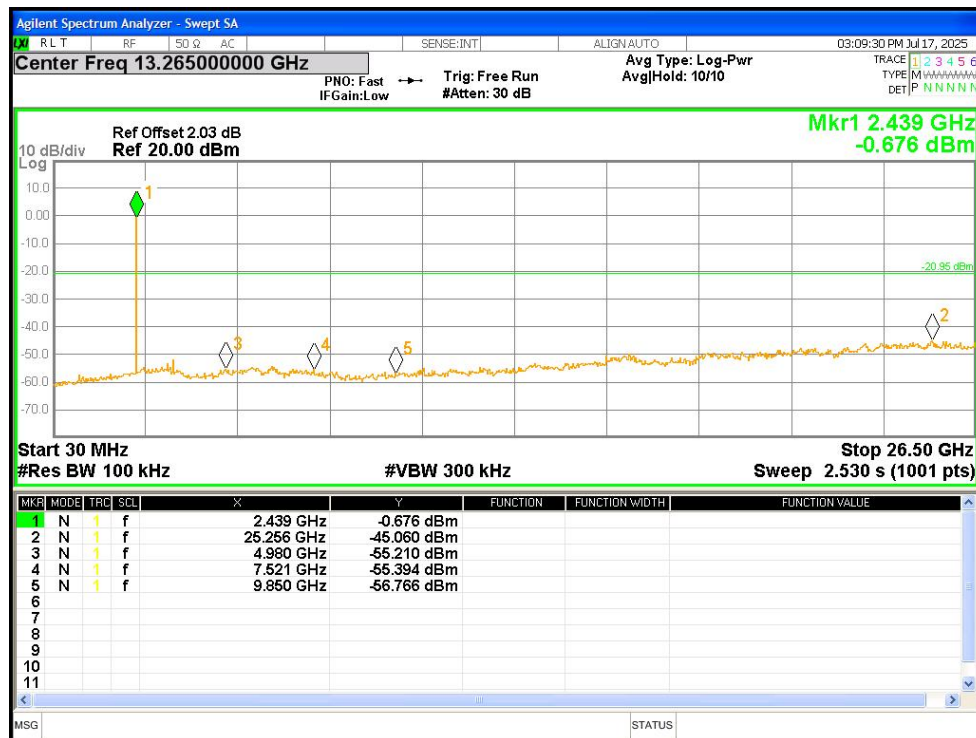
Tx. Spurious NVNT BLE 2M 2442MHz Ant1 Emission

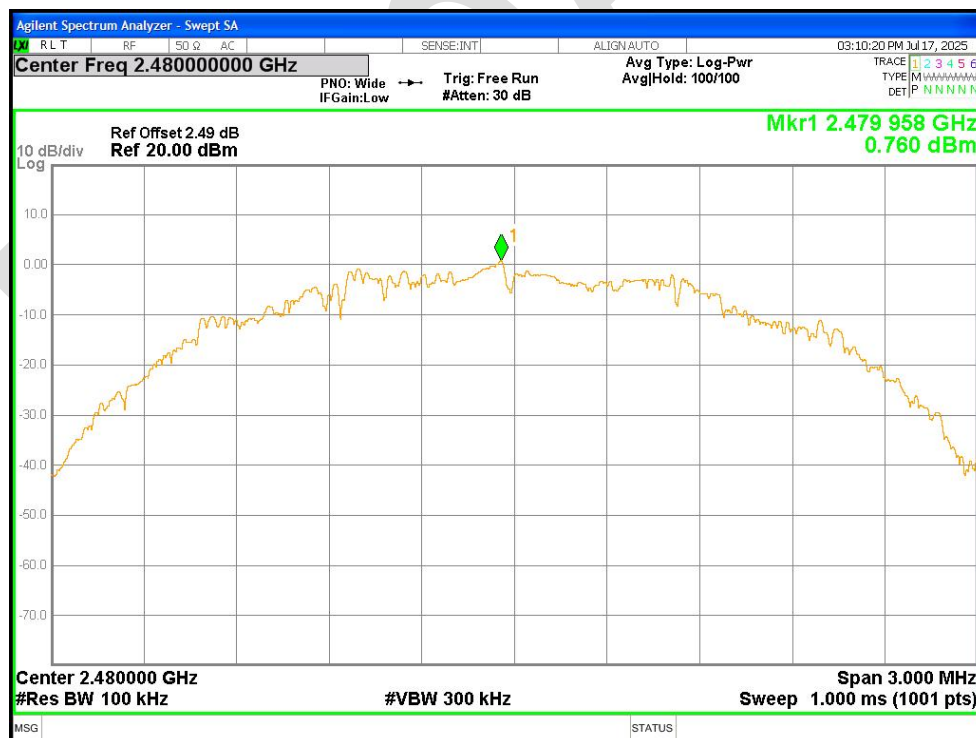
Tx. Spurious NVNT BLE 2M 2480MHz Ant1 Ref

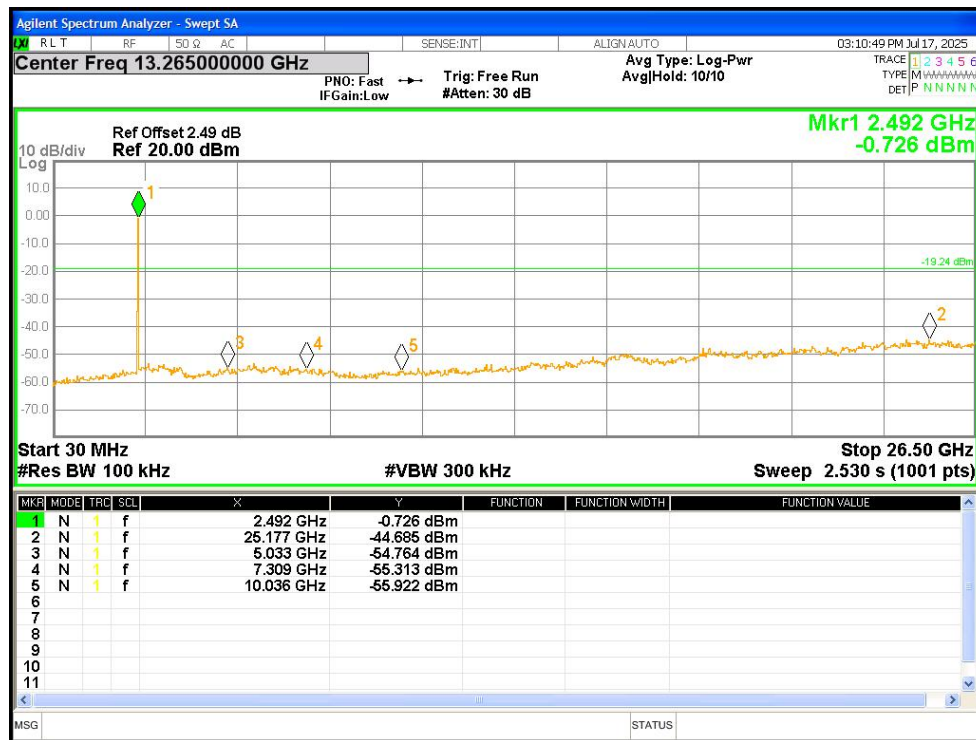
Tx. Spurious NVNT BLE 2M 2480MHz Ant1 Emission

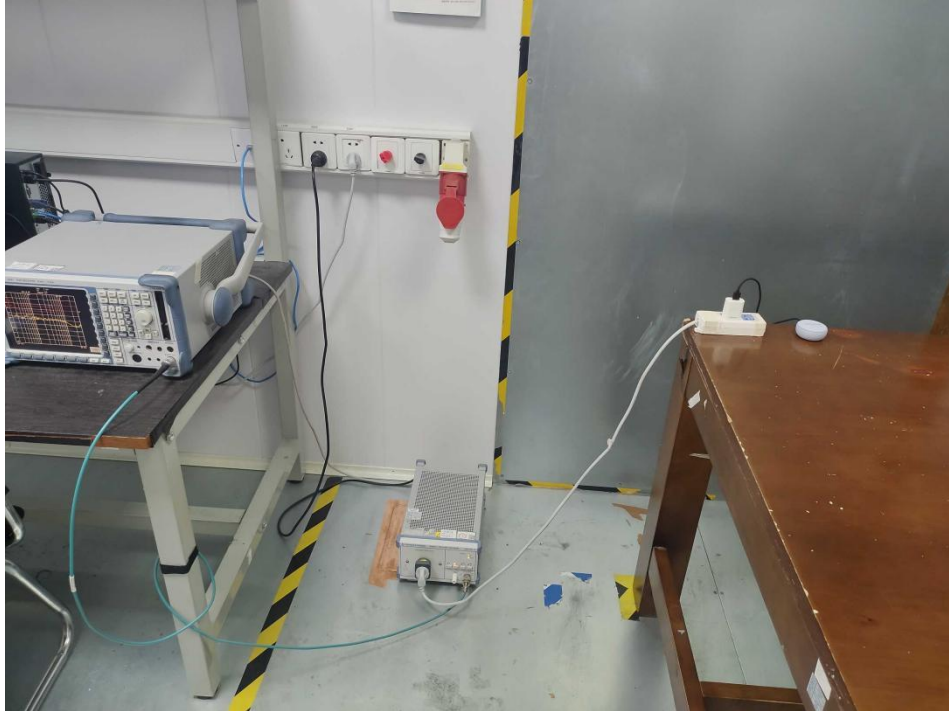
Conducted emissions at AC power line (150kHz-30MHz)

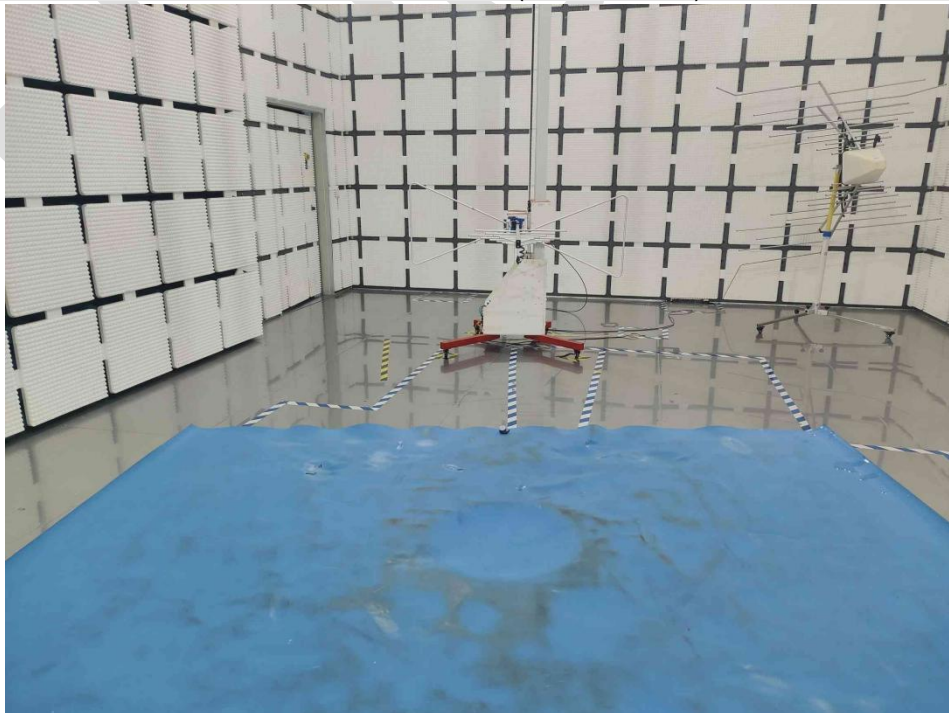
Radiated Emissions (30MHz-1GHz)

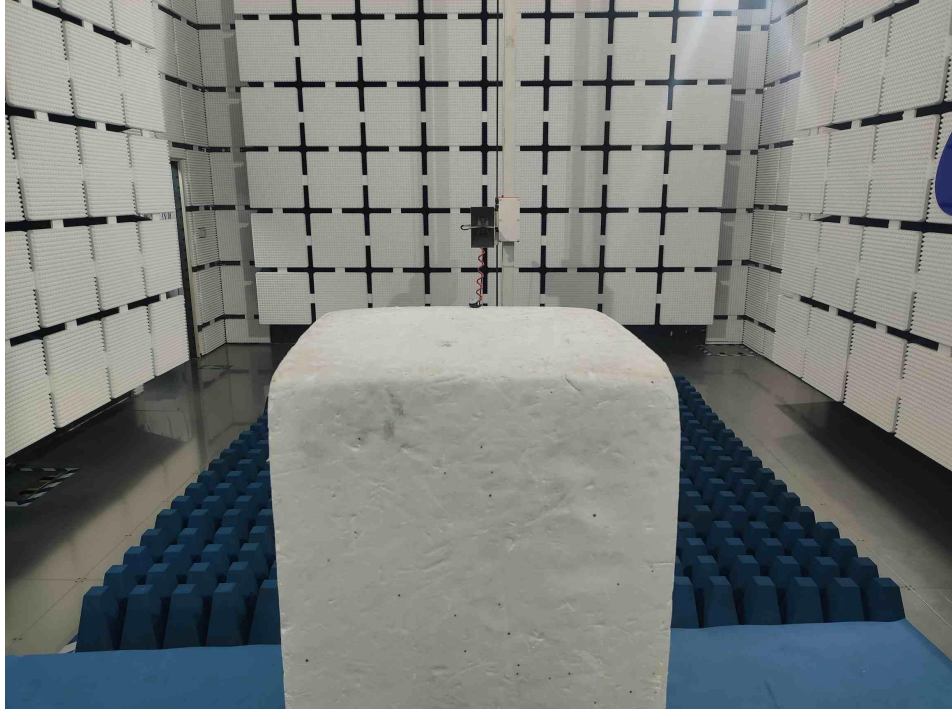
Radiated Emissions (above 1GHz)
