## Appendix B: photographs of test setup

Reference to the test report no. BLA-EMC-202507-A1301

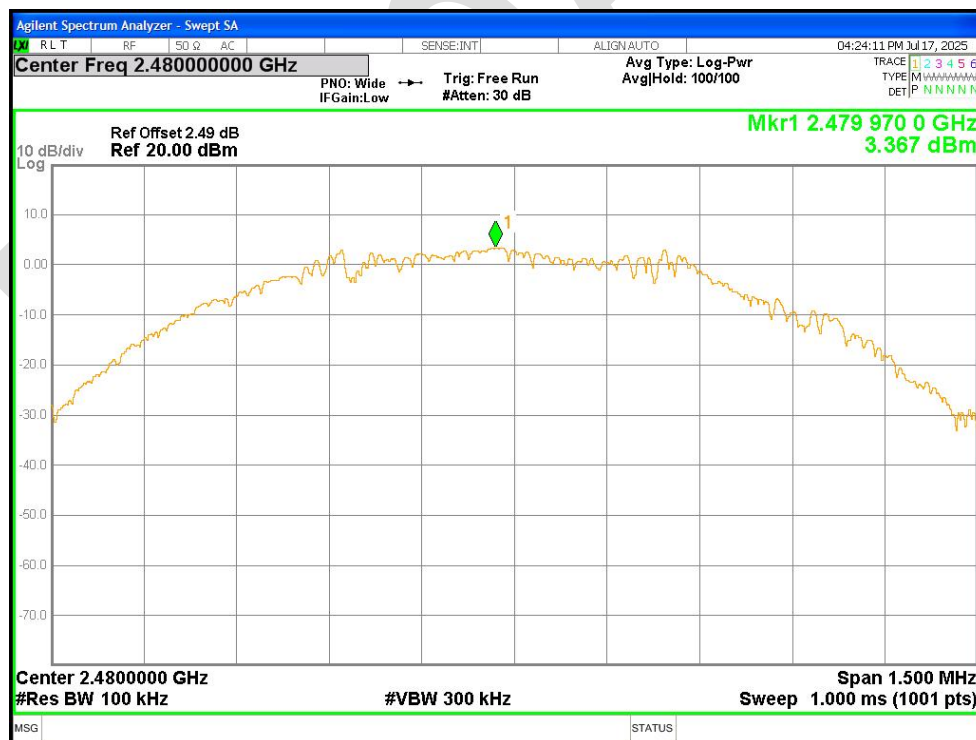
Tx. Spurious NVNT BLE 1M 2480MHz Ant1 Ref

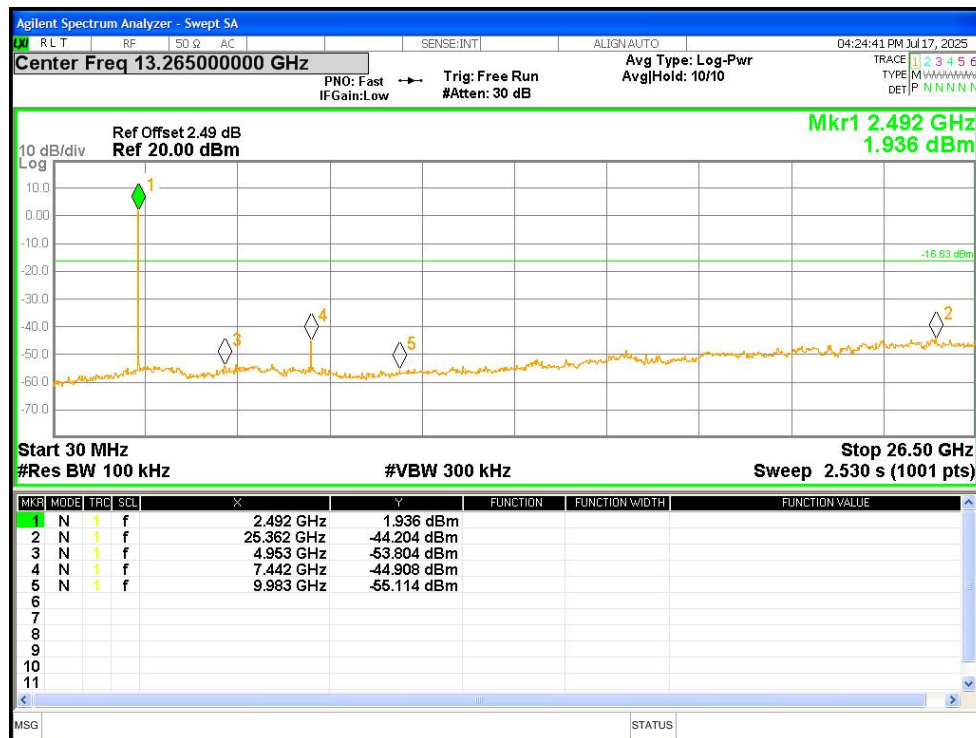
Tx. Spurious NVNT BLE 1M 2480MHz Ant1 Emission

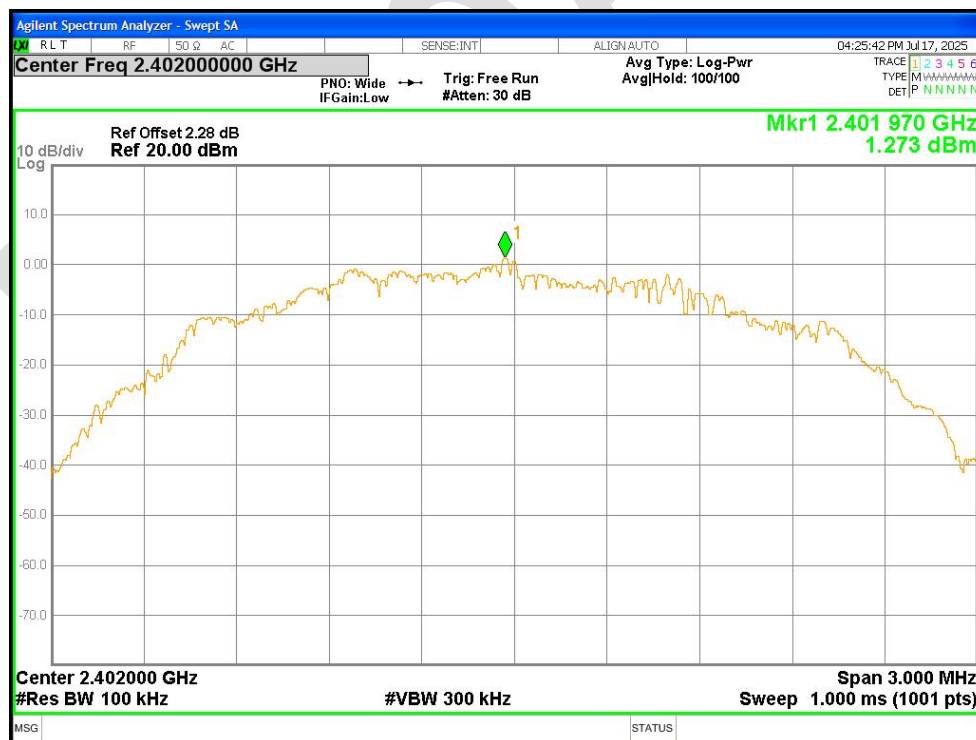
Tx. Spurious NVNT BLE 2M 2402MHz Ant1 Ref

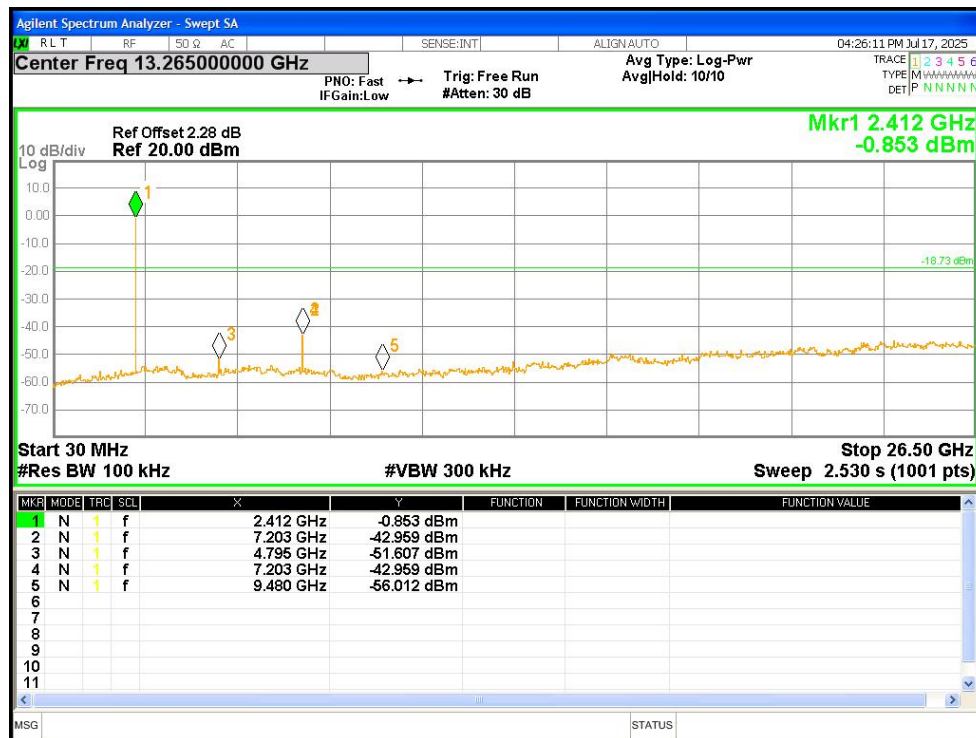
Tx. Spurious NVNT BLE 2M 2402MHz Ant1 Emission

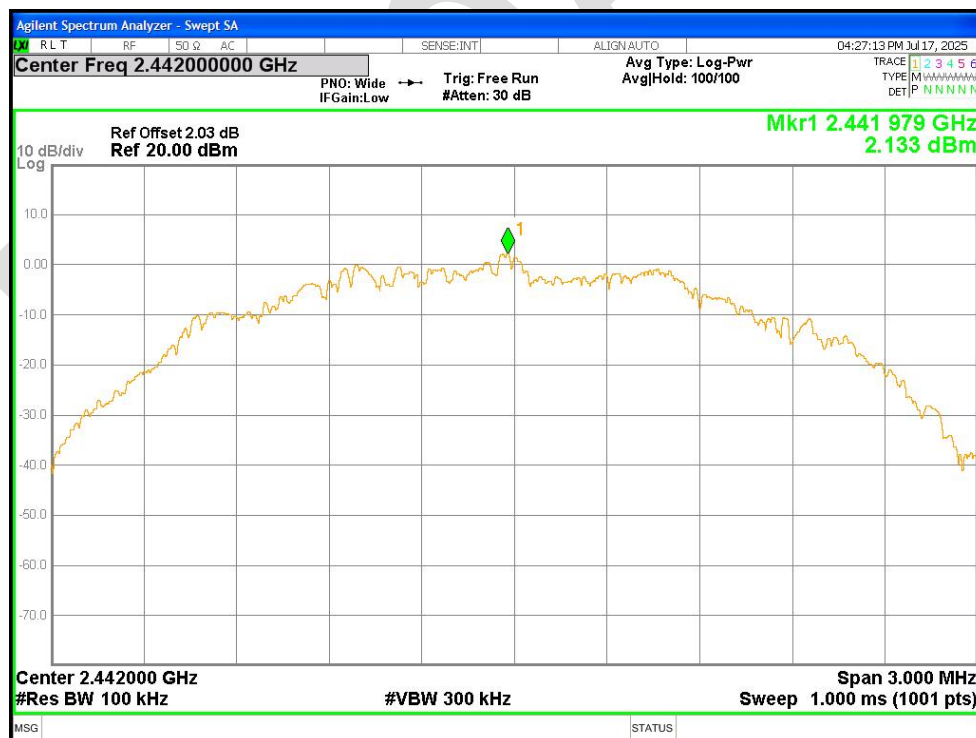
Tx. Spurious NVNT BLE 2M 2442MHz Ant1 Ref

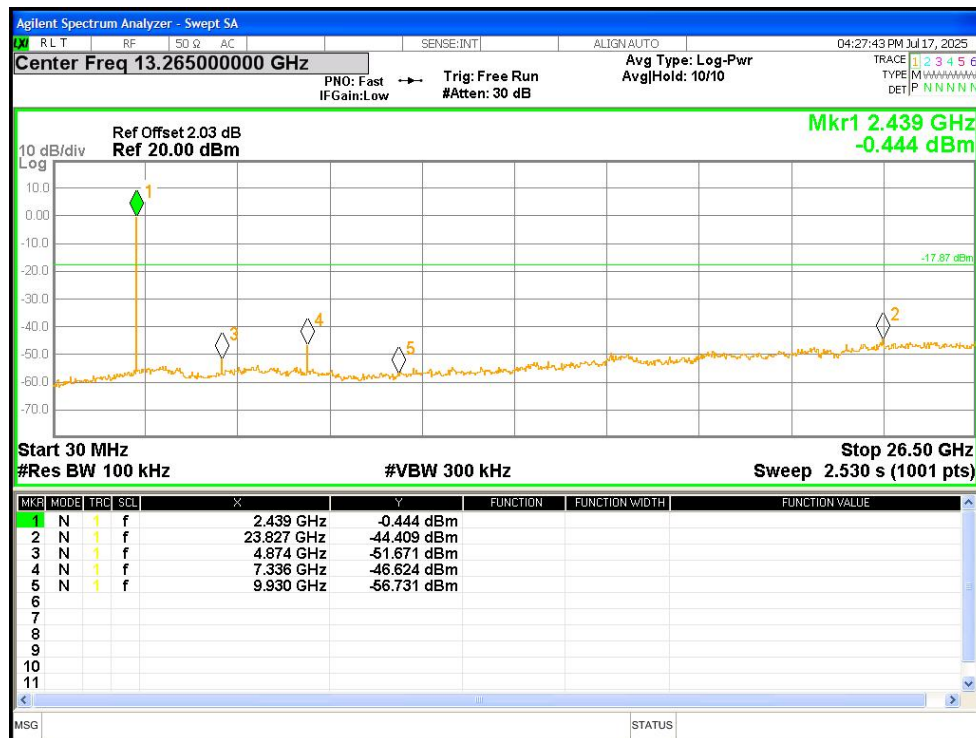
Tx. Spurious NVNT BLE 2M 2442MHz Ant1 Emission

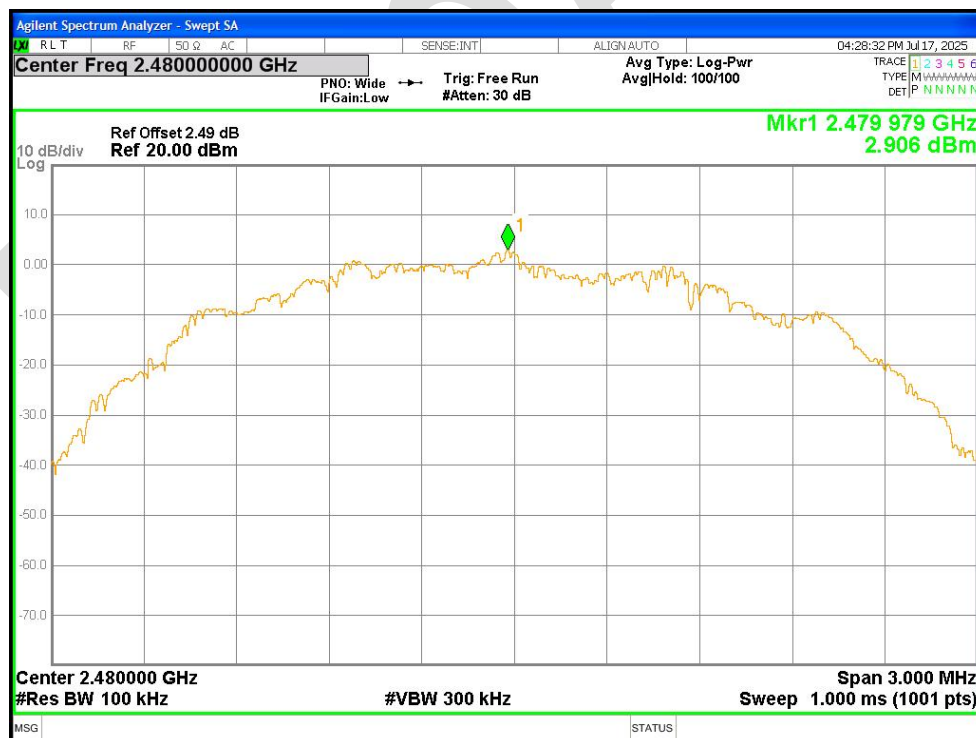
Tx. Spurious NVNT BLE 2M 2480MHz Ant1 Ref

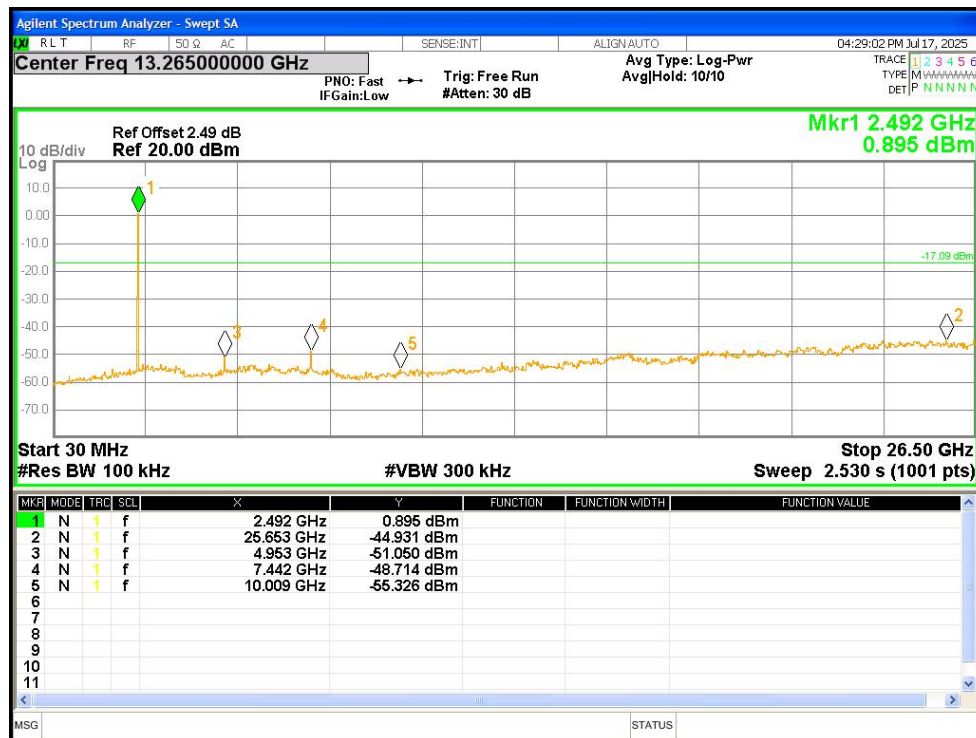
Tx. Spurious NVNT BLE 2M 2480MHz Ant1 Emission

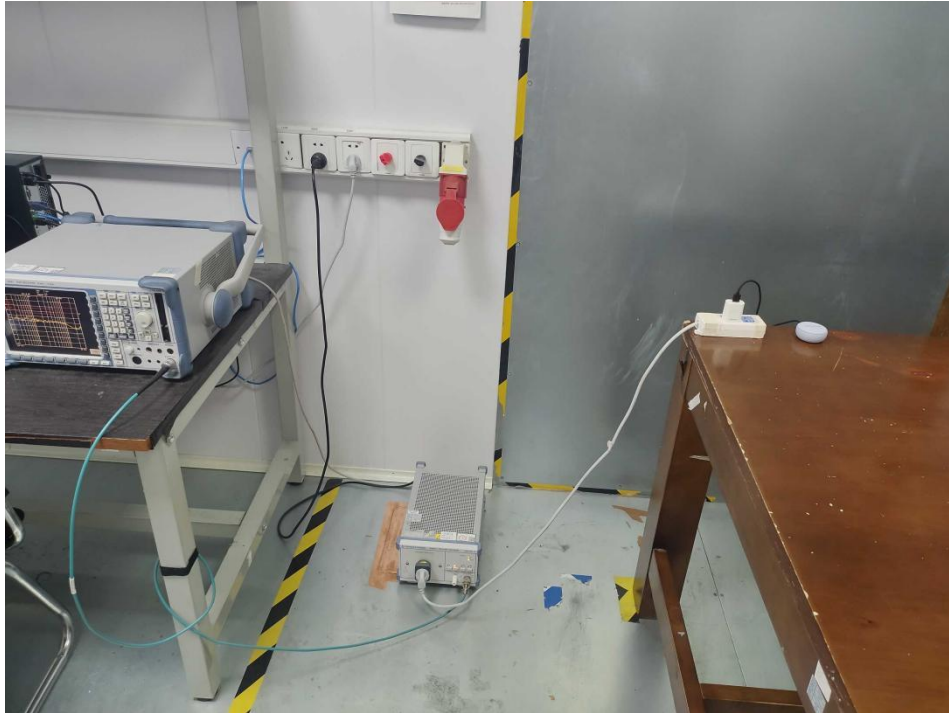
Conducted emissions at AC power line (150kHz-30MHz)

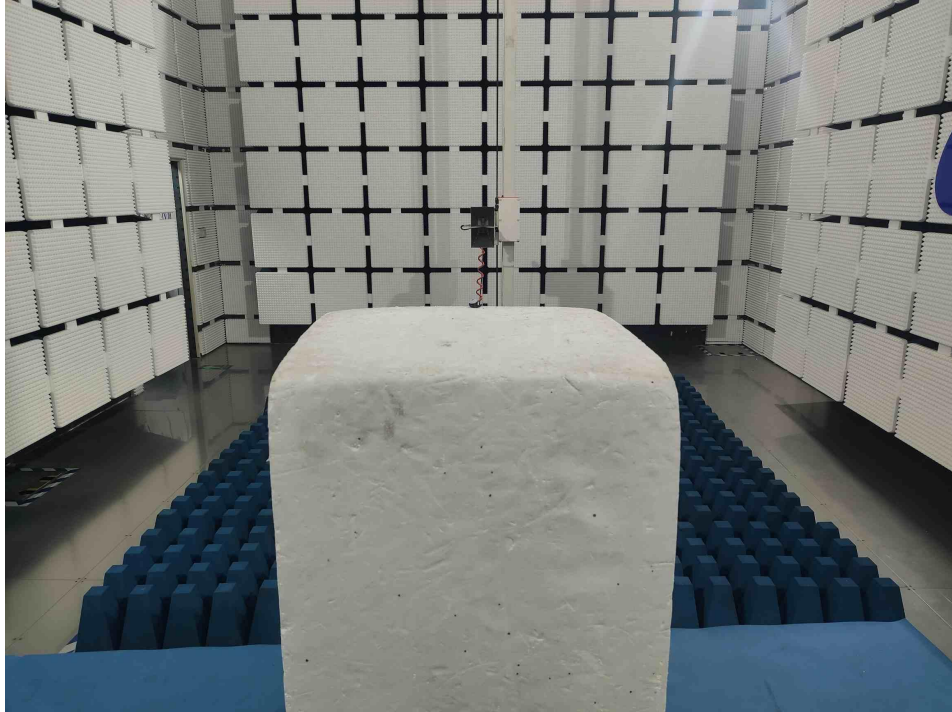
Radiated Emissions (above 1GHz)
