Report No. :EED32Q81407201 Page 46 of 81

8 PHOTOGRAPHS OF TEST SETUP

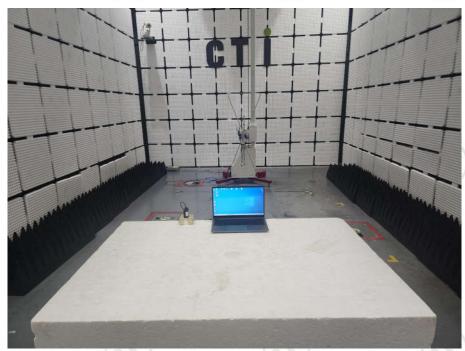
Radiated spurious emission Test Setup-1(Below 1GHz)

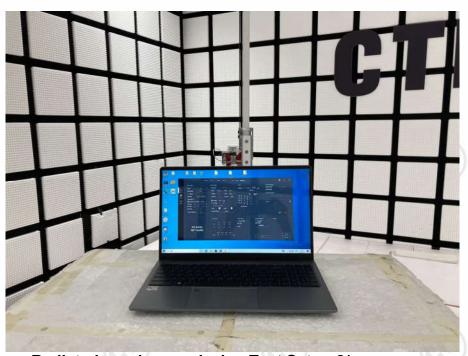
Radiated spurious emission Test Setup-2(Above 1GHz)

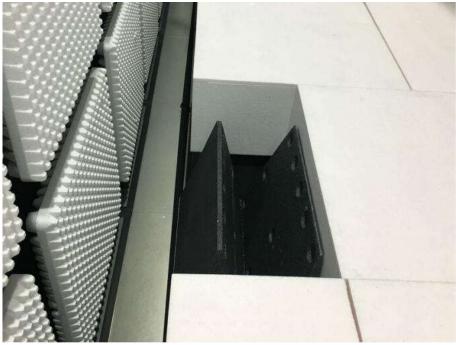
Radiated spurious emission Test Setup-3(Above 1GHz) There are absorbing materials under the ground.

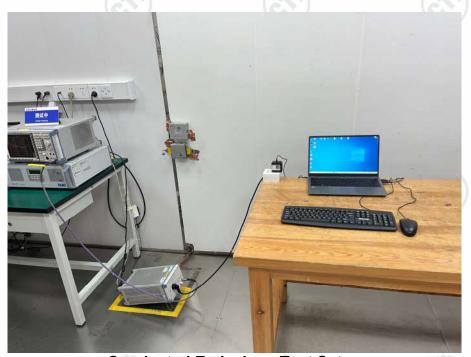
Conducted Emissions Test Setup
