## 7. Conducted RF Spurious Emission

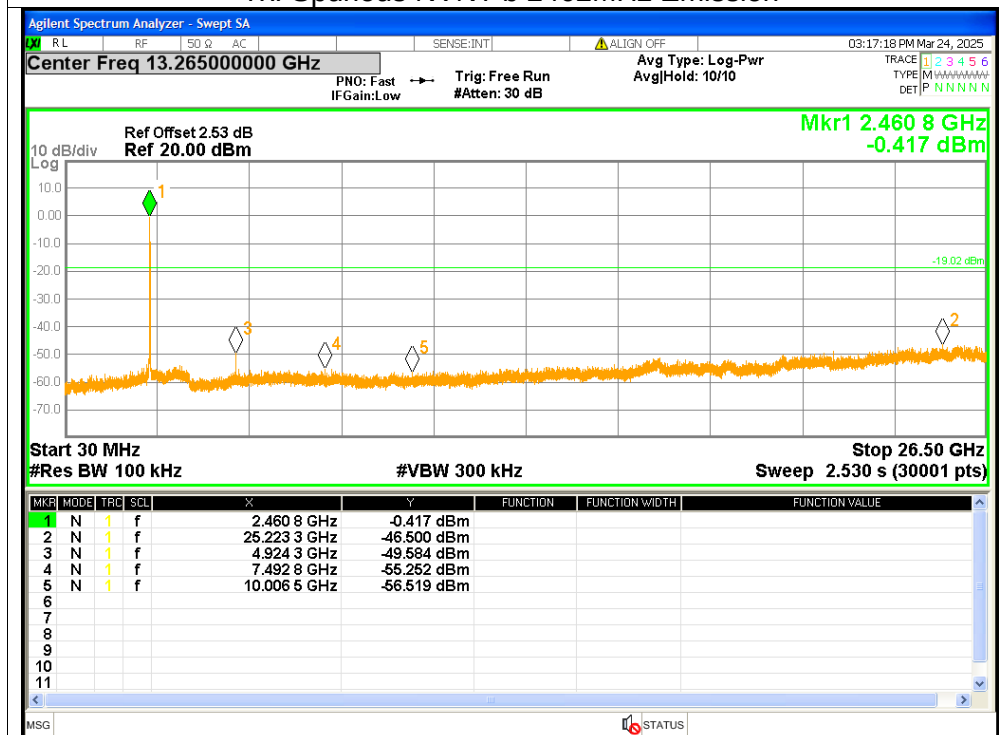
## Tx. Spurious NVNT b 2462MHz Emission

| Condition | Mode | Frequency (MHz) | Max Value (dBc) | Limit (dBc) | Verdict |
|---|---|---|---|---|---|
| NVNT | b | 2462 | -47.47 | <=-20 | Pass |

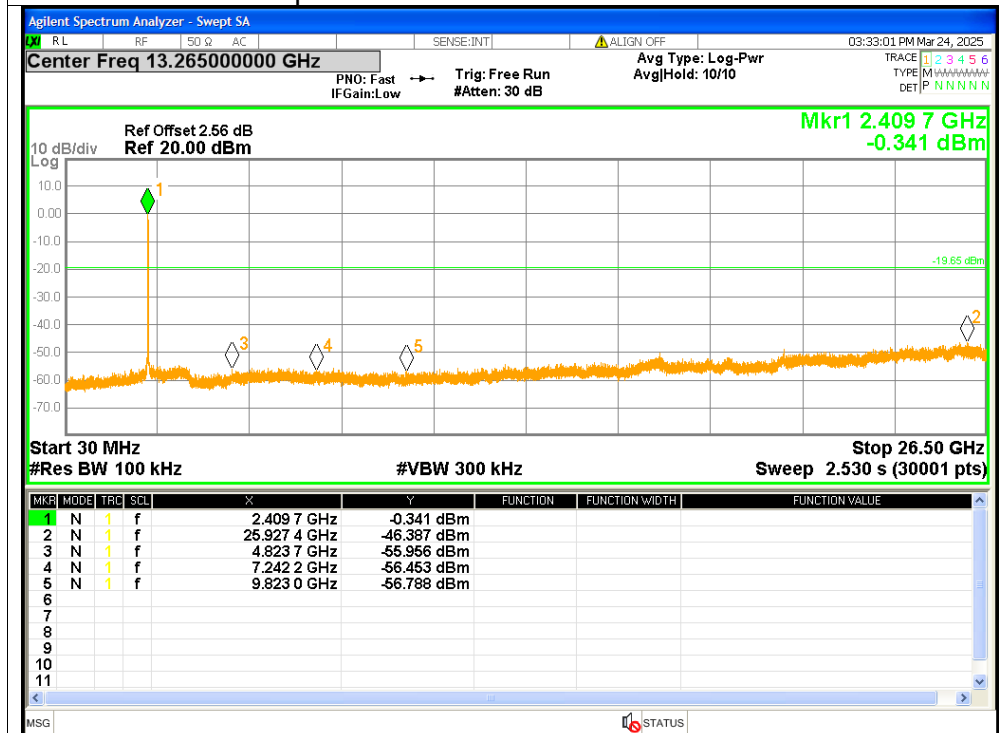
## Tx. Spurious NVNT n20 2412MHz Emission

| Condition | Mode | Frequency (MHz) | Max Value (dBc) | Limit (dBc) | Verdict |
|---|---|---|---|---|---|
| NVNT | n20 | 2412 | -46.73 | <=-20 | Pass |

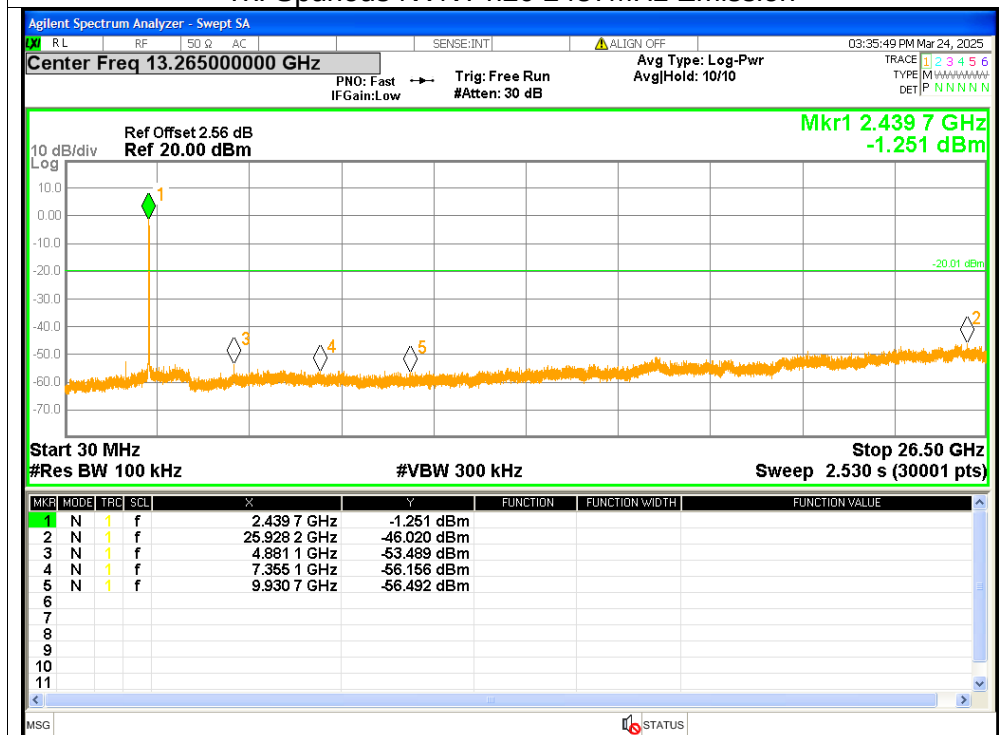
## Tx. Spurious NVNT n20 2437MHz Emission

| Condition | Mode | Frequency (MHz) | Max Value (dBc) | Limit (dBc) | Verdict |
|---|---|---|---|---|---|
| NVNT | n20 | 2437 | -46.01 | <=-20 | Pass |

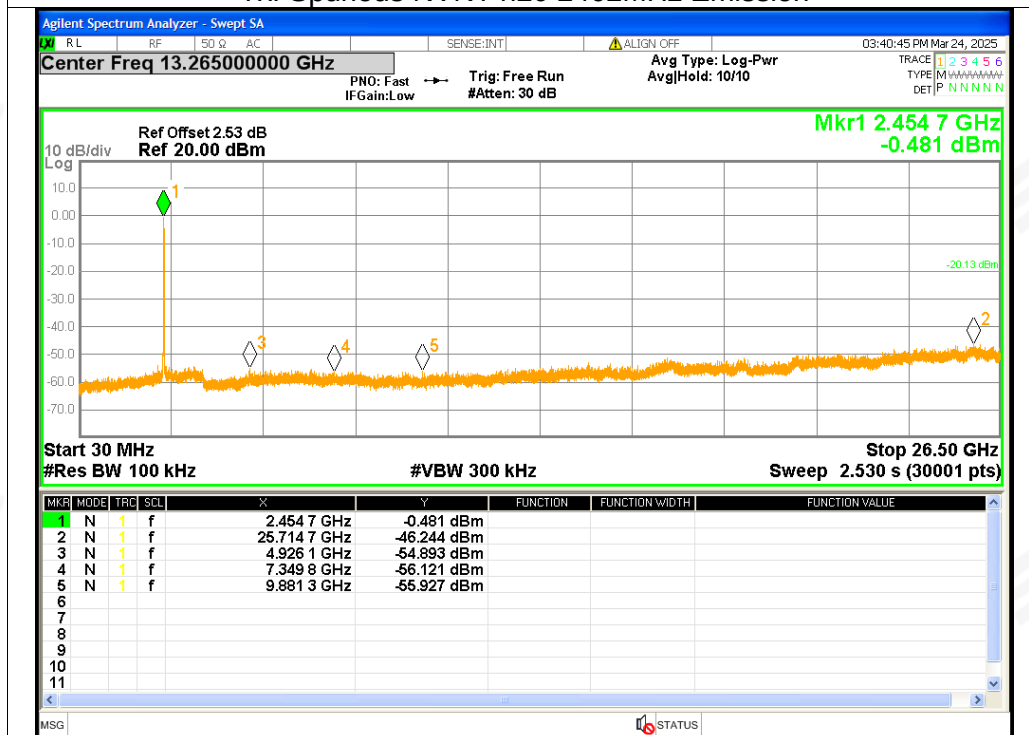
## Tx. Spurious NVNT n20 2462MHz Emission

| Condition | Mode | Frequency (MHz) | Max Value (dBc) | Limit (dBc) | Verdict |
|---|---|---|---|---|---|
| NVNT | n20 | 2462 | -46.12 | <=-20 | Pass |
