## Appendix B: photographs of test setup

Reference to the test report no. BLA-EMC-202502-A6101

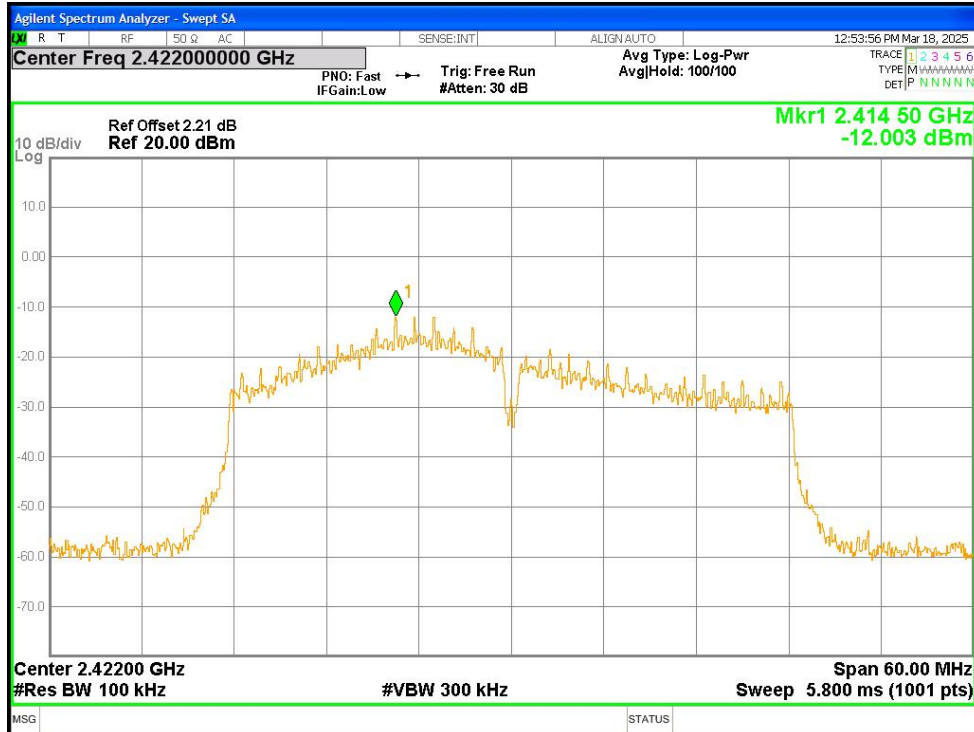
## Tx. Spurious NVNT n40 2422MHz Ant1 Ref

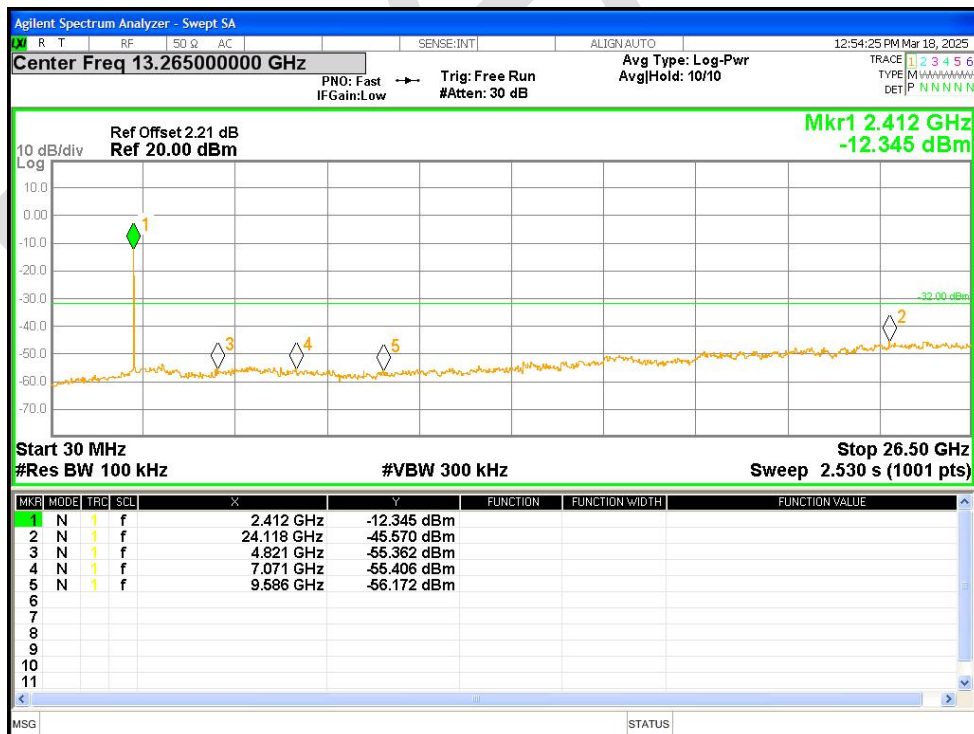
## Tx. Spurious NVNT n40 2422MHz Ant1 Emission

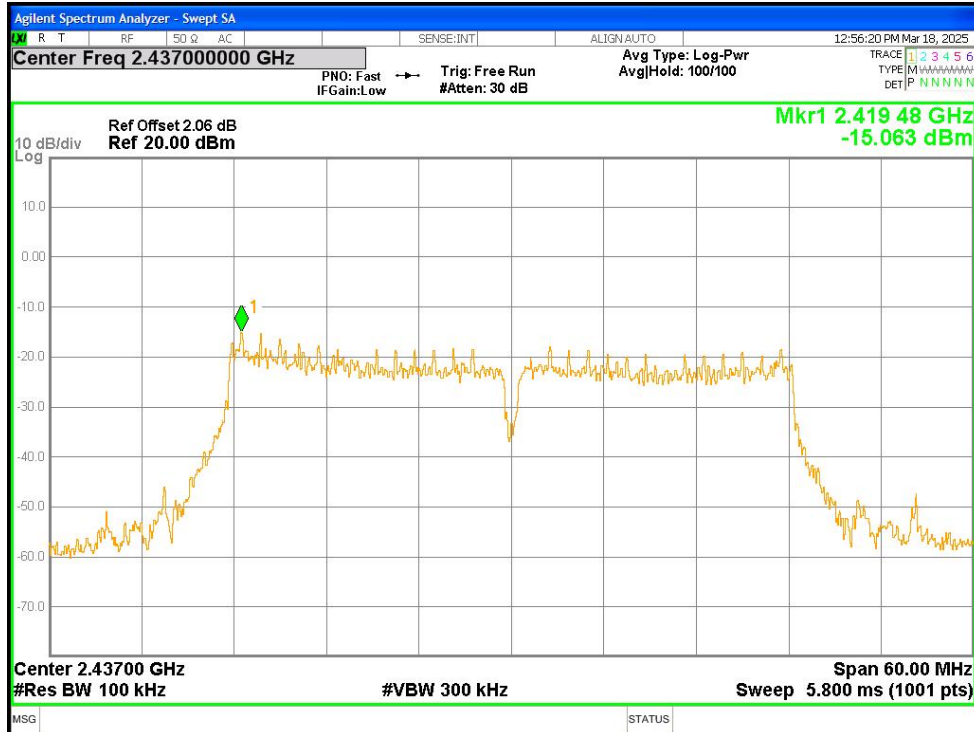
Tx. Spurious NVNT n40 2437MHz Ant1 Ref

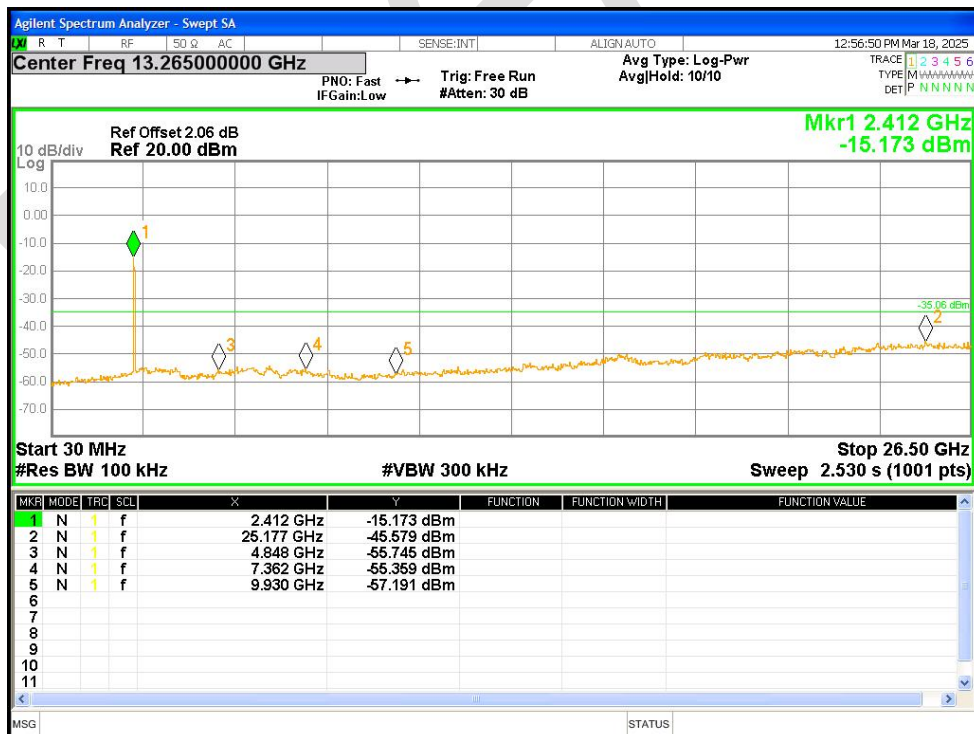
Tx. Spurious NVNT n40 2437MHz Ant1 Emission

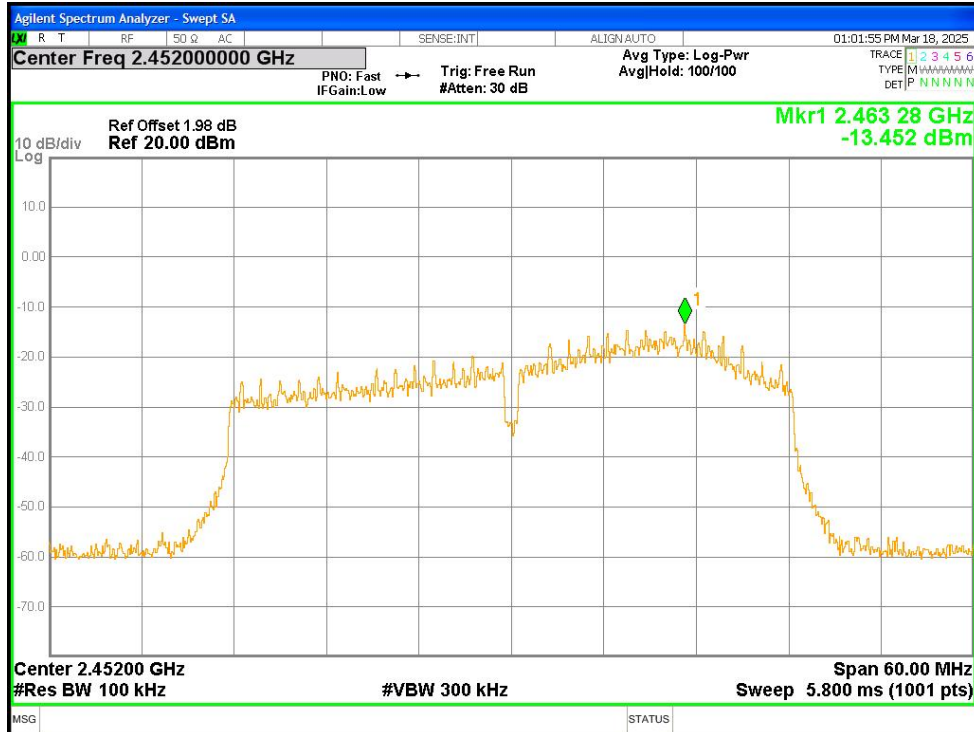
Tx. Spurious NVNT n40 2452MHz Ant1 Ref

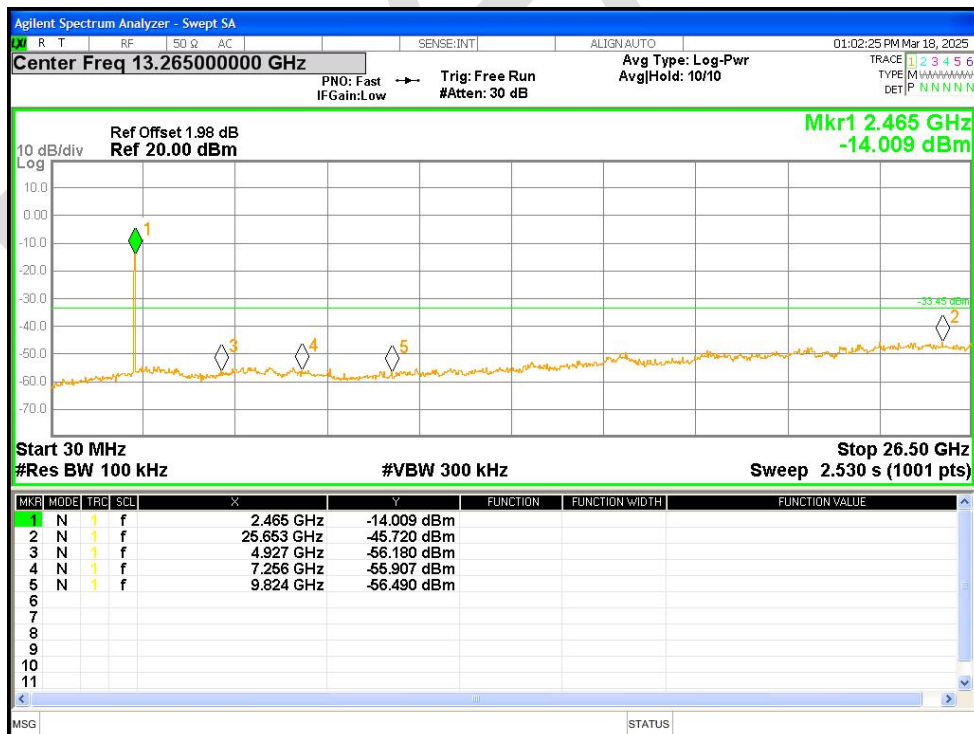
Tx. Spurious NVNT n40 2452MHz Ant1 Emission

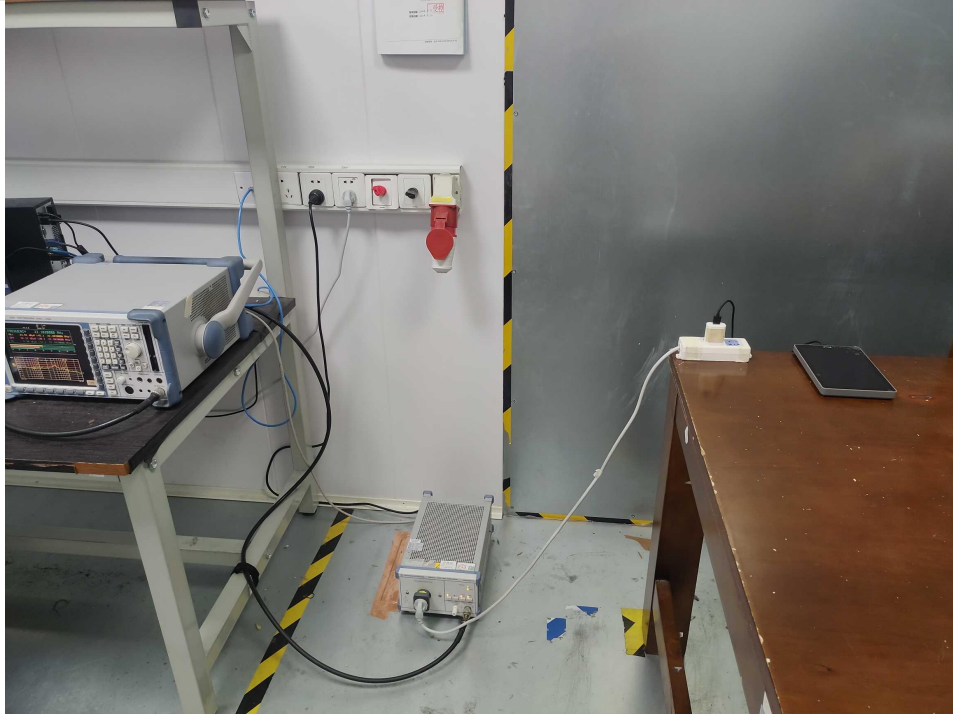
Conducted emissions at AC power line (150kHz-30MHz)

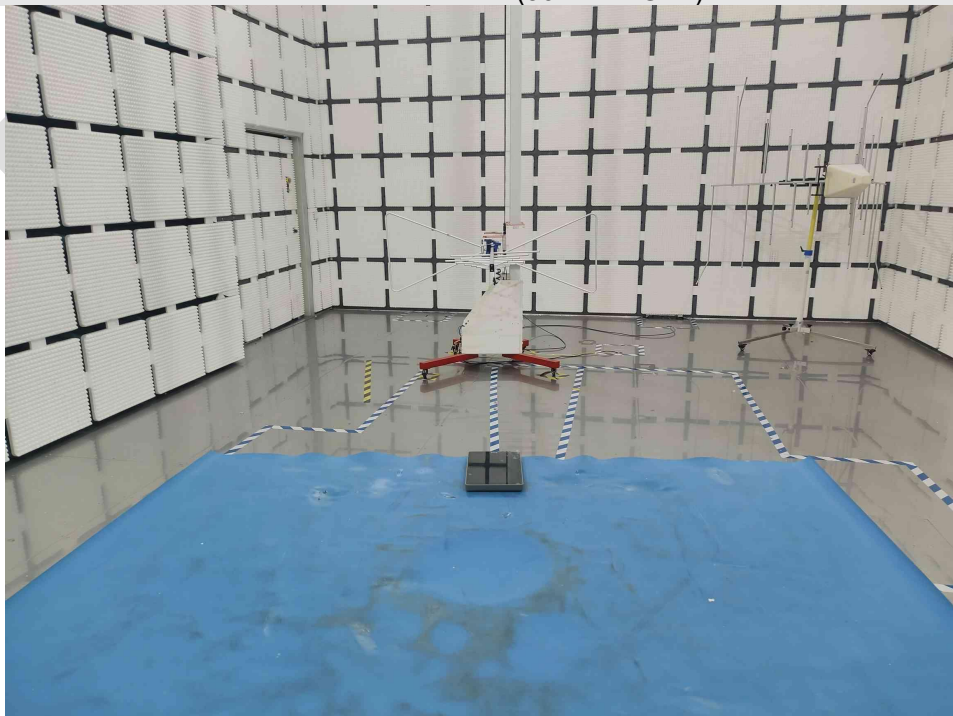
Radiated Emissions (30MHz-1GHz)

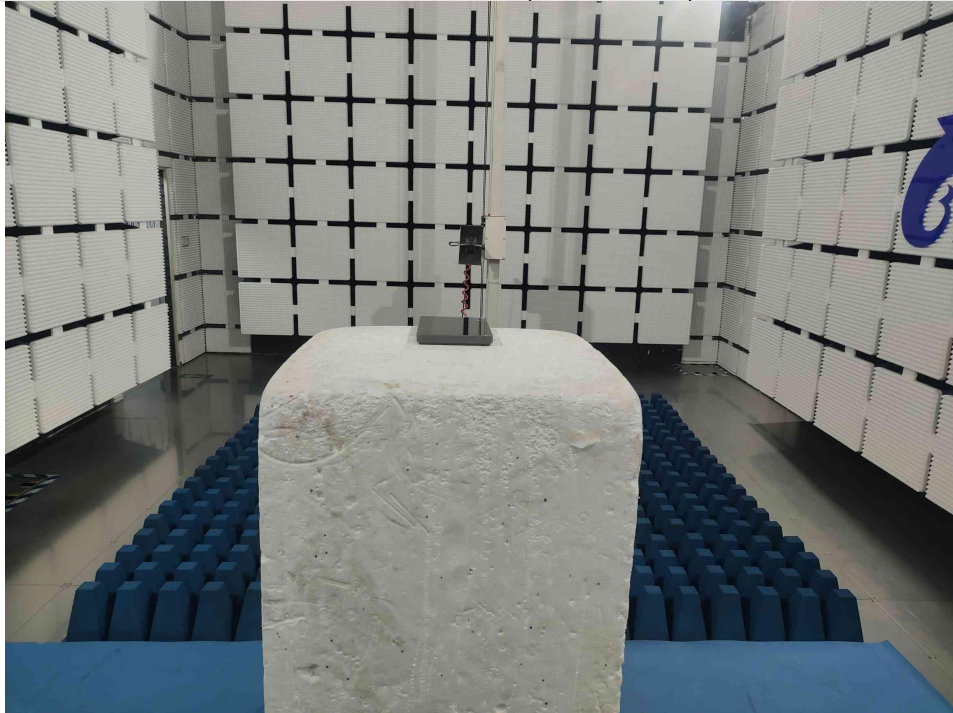
Radiated Emissions (above 1GHz)
