Appendix B: photographs of test setup

Appendix C: photographs of EUT

BlueAsia of Technical Services (Shenzhen) Co.,Ltd.

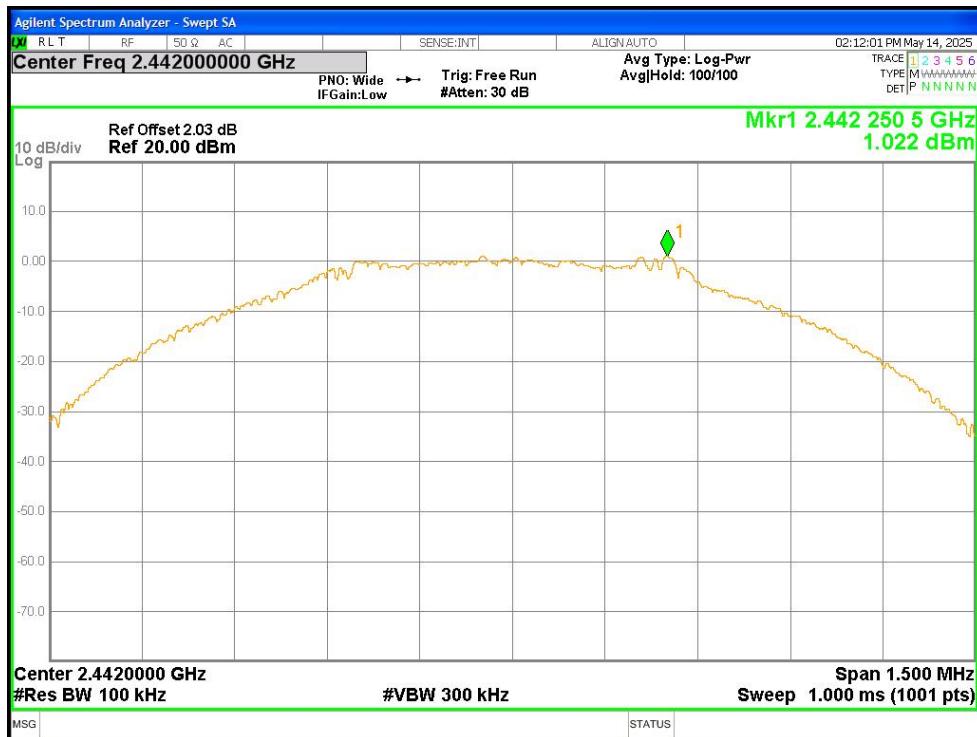
Tx. Spurious NVNT BLE 1M 2442MHz Ant1 Ref

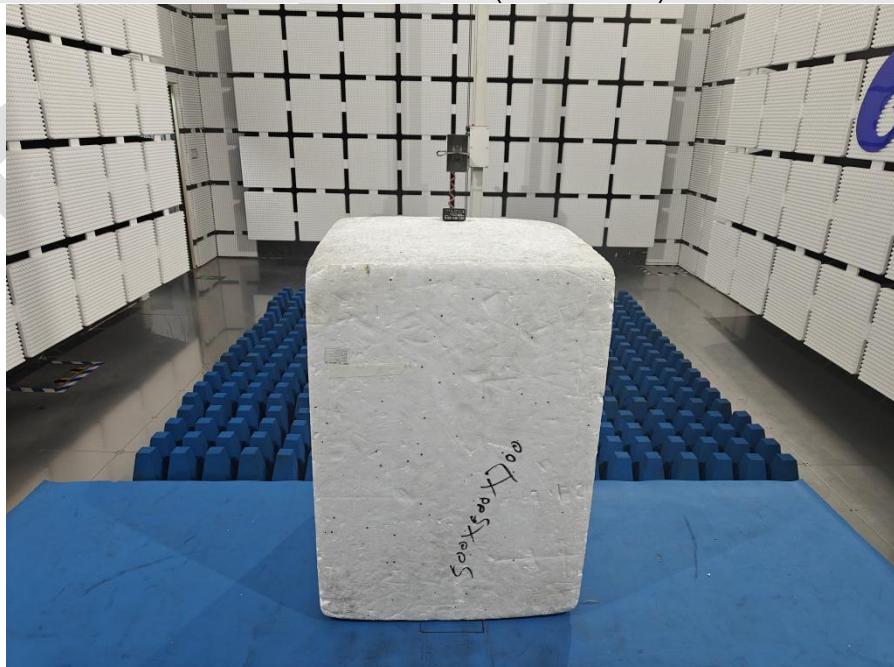
Radiated Emissions (above 1GHz)

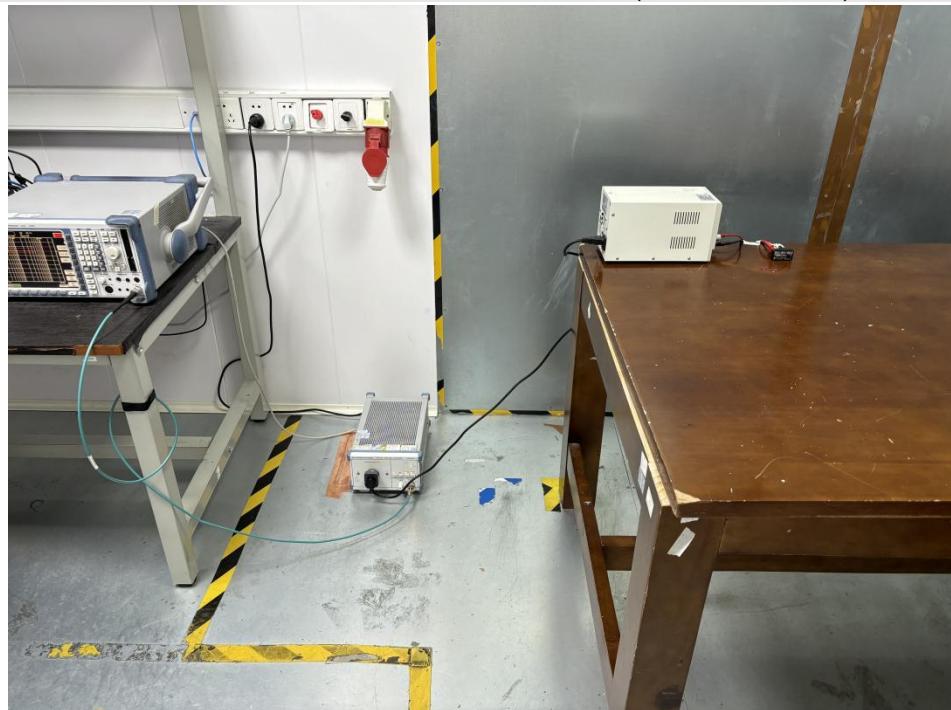
Conducted Emissions at Mains Terminals (150 kHz-30MHz)
