APPENDIX 3: Photographs of test setup

Radiated Spurious Emission

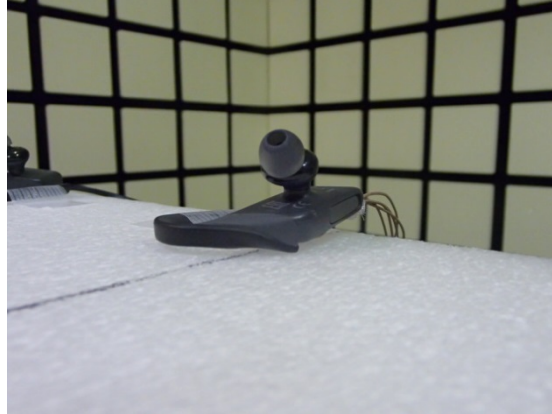
X-axis

Worst Case Position

Above 1GHz (Horizontal: X-axis/ Vertical: Z-axis)

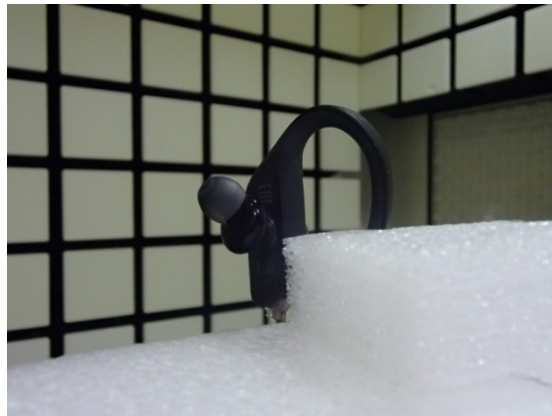
Z-axis

Below 1GHz (Horizontal: Z-axis/ Vertical: Z-axis)
