TDK Test Report No. : TDJ - 12 - 0502 - 01  
Kind of EUT : Multimedia System  
Model No. : UN-W700

## Photograph of Radiated Emission

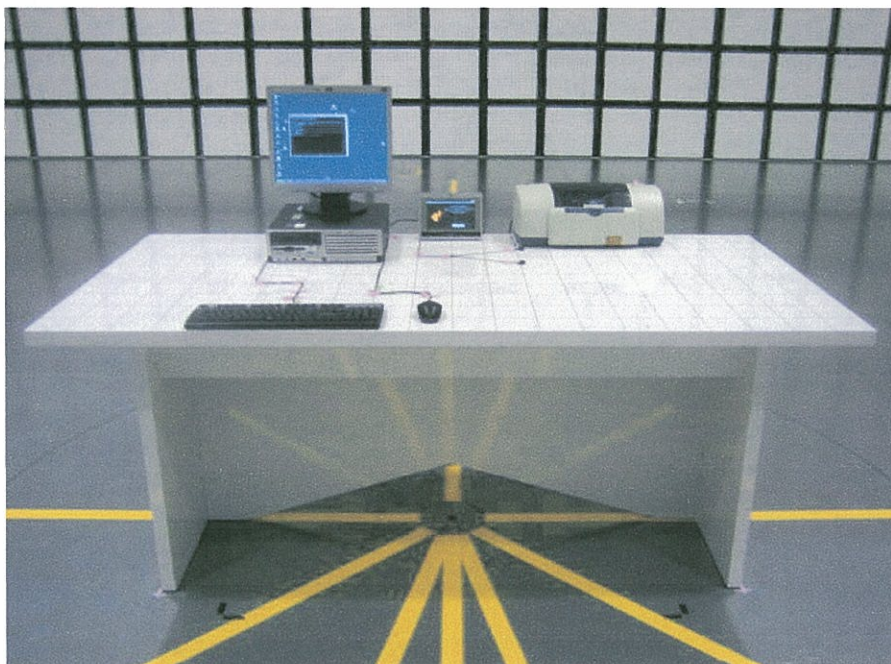
Test Configuration - Front View

Remark : 1) Photograph show that the test configuration of EUT is worst case.

Radiated Emission Below 1GHz ( D 1.0 m × W 2.0 m × H 0.8 m ) Polystyrene foam + PVC seat table  
 Radiated Emission Above 1GHz ( D 1.0 m × W 1.5 m × H 0.8 m ) Foamed styrol table

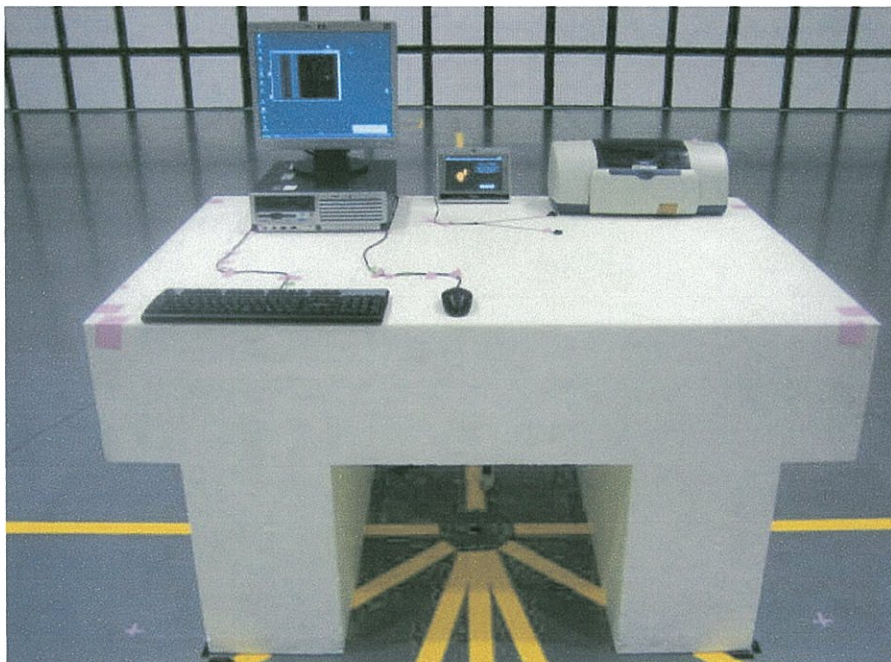
Test Configuration - Front View

Remark : 1) Photograph show that the test configuration of EUT is worst case.

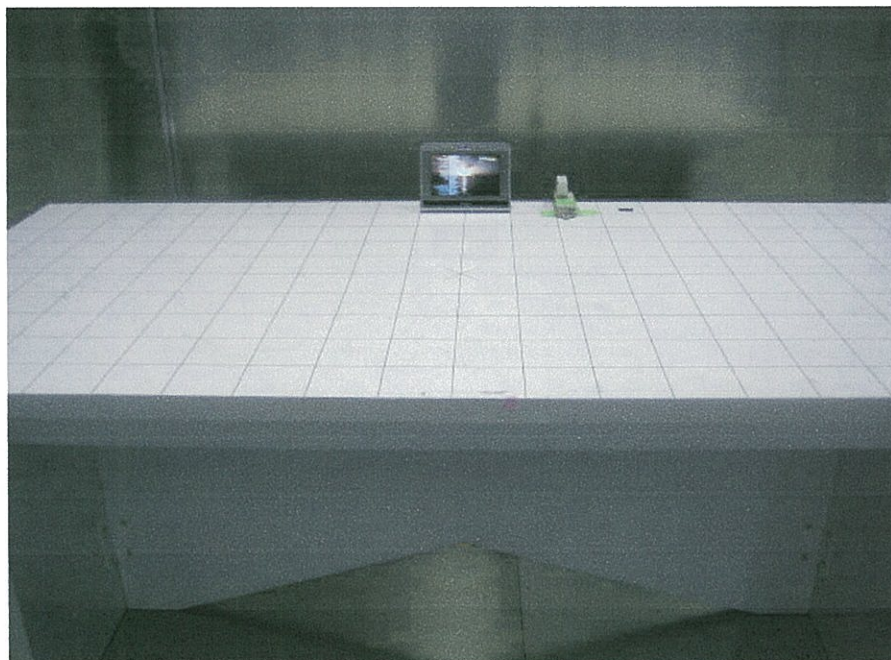
Test Configuration - Front View

Remark : 1) Photograph show that the test configuration of EUT is worst case.

Conducted Emission ( D 1.0 m × W 2.0 m × H 0.8 m ). Polystyrene foam + PVC seat table
