APPENDIX 3: Photographs of test setup

Radiated Emission

4.2 Configuration and peripherals

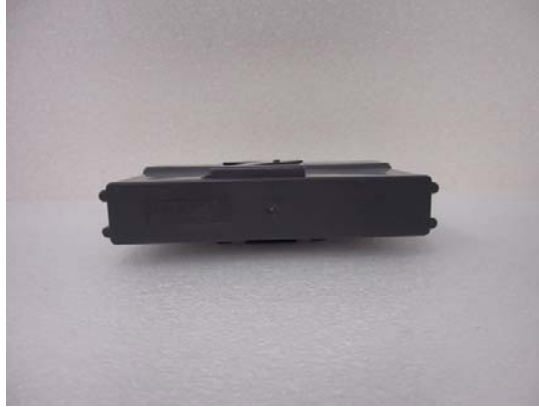
X-axis

Worst Case Position (Horizontal: X-axis/ Vertical:X-axis)
