APPENDIX 3: Photographs of test setup

Radiated Emission

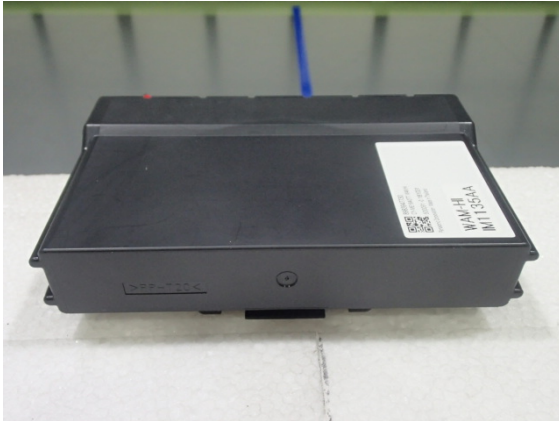
ECU

Below 30 MHz: X-axis

Above 30 MHz

Horizontal: X-axis / Vertical: X-axis

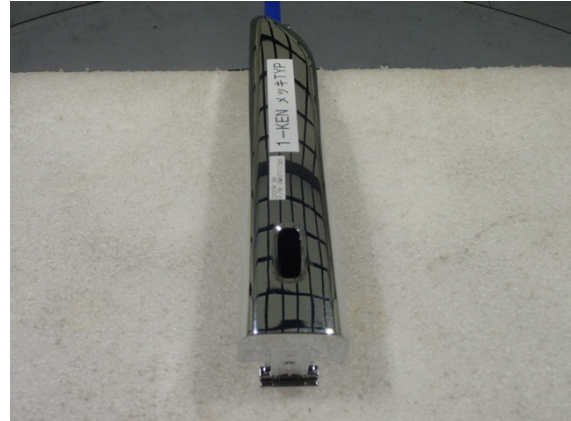
DOOR DR

Above 30 MHz

Horizontal: X-axis / Vertical: X-axis

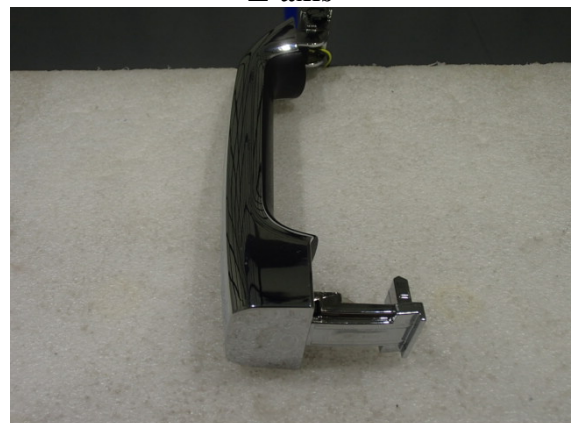
Below 30 MHz: Z-axis

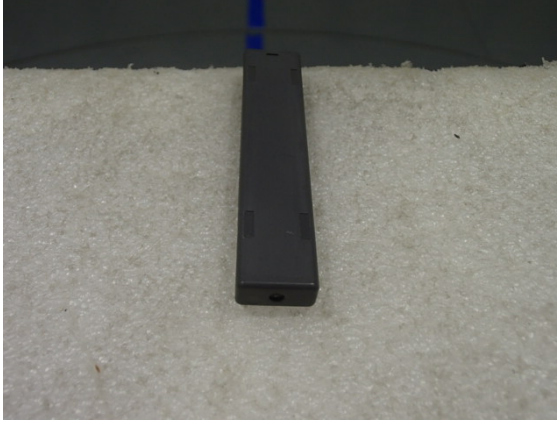
CENTER / REAR DR / DOOR AS

Below 30 MHz: X-axis

Above 30 MHz

Horizontal: X-axis / Vertical: X-axis

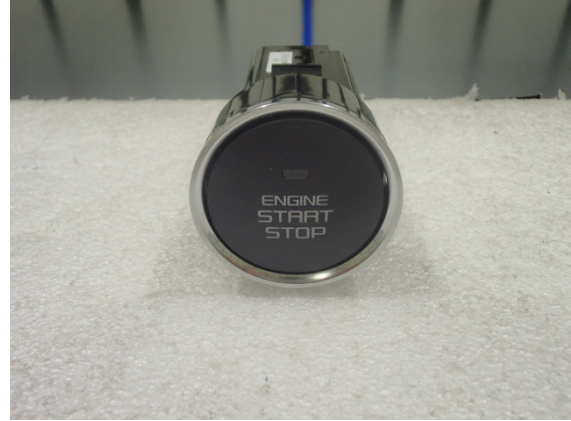
START SW

Above 30 MHz

Horizontal: X-axis / Vertical: X-axis

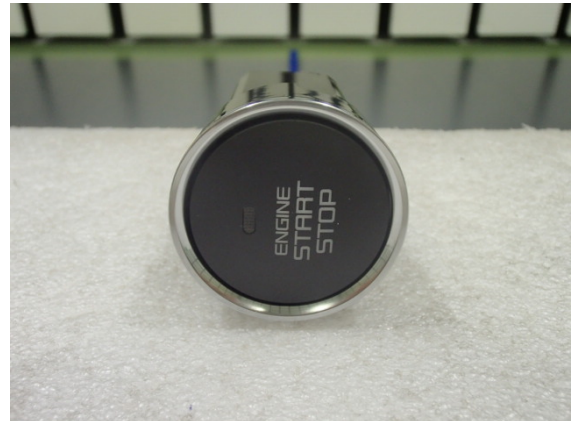
Below 30 MHz: Z-axis

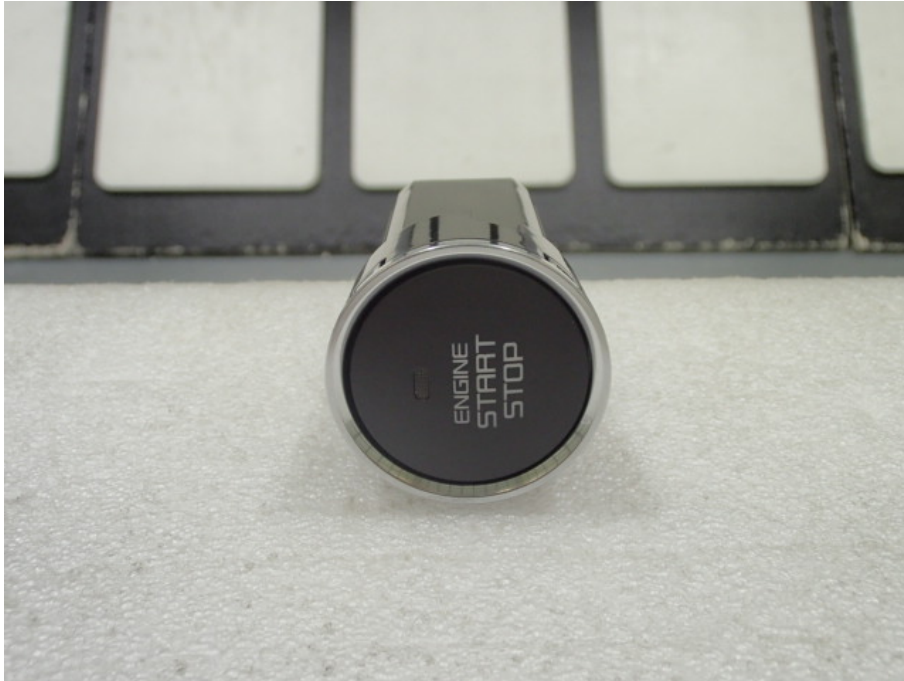
Worst case position

Without Mechanical Key (Worst)

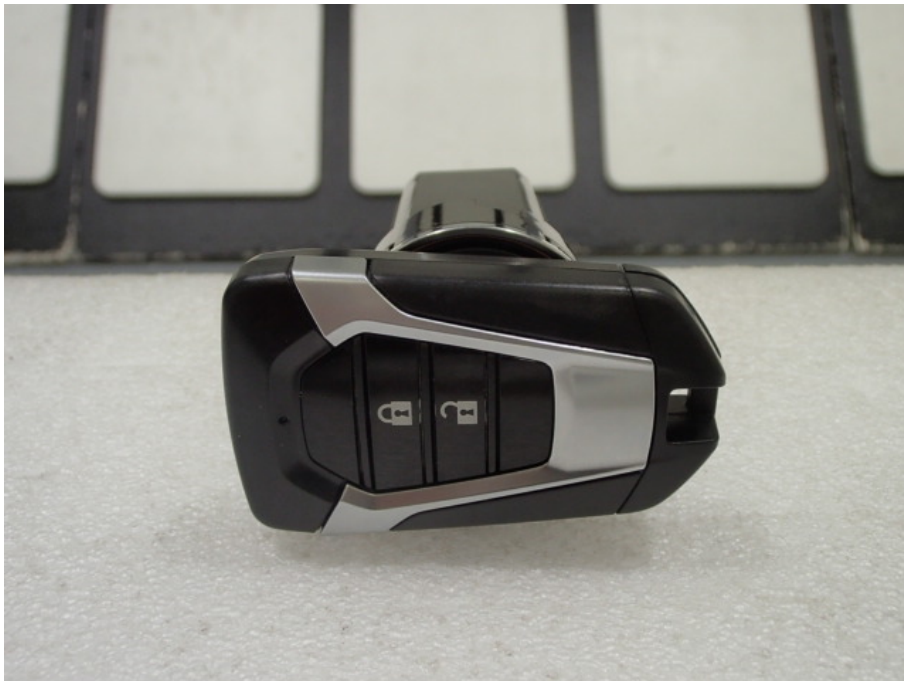
With Mechanical Key
