Prüfbericht - Nr.: 12701036 001
Test Report No.:

7. Photographs of test setup

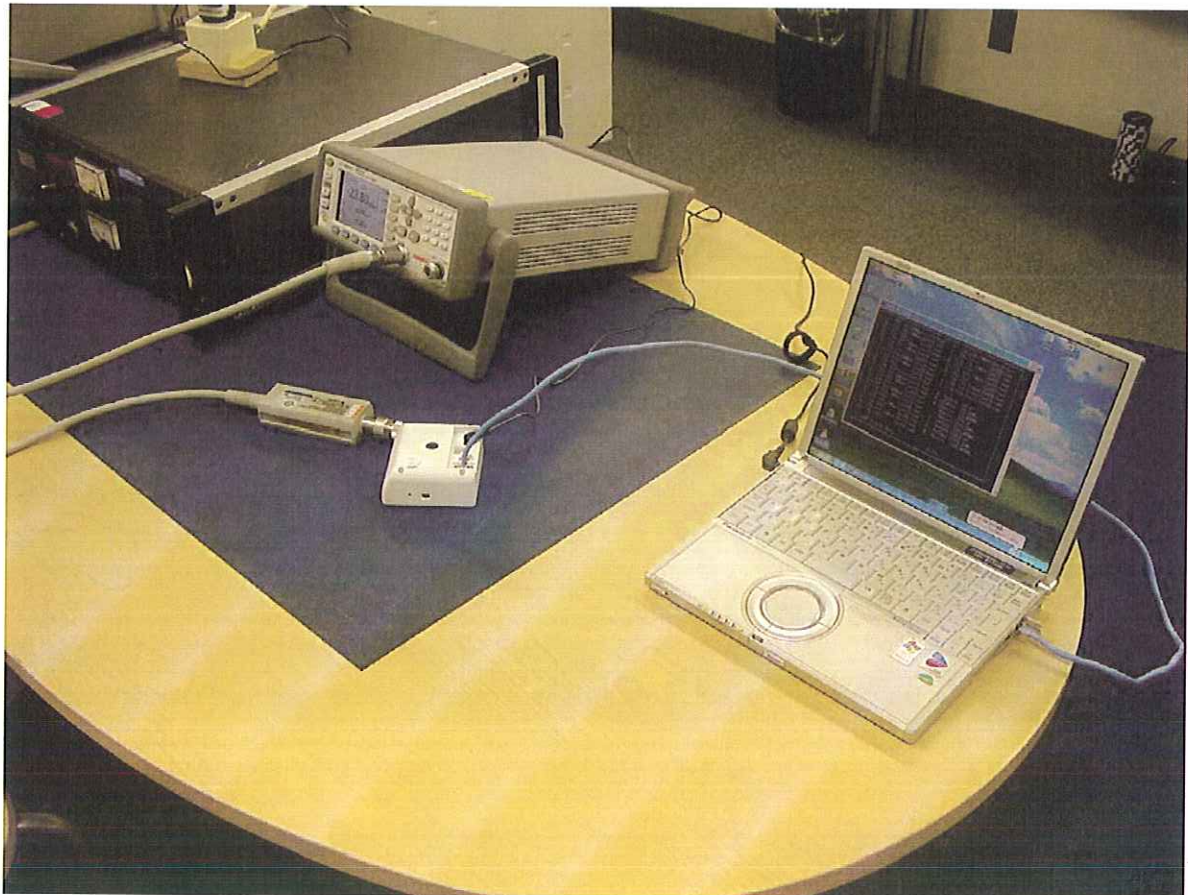
Photograph 1: Set-up for Conducted Testing

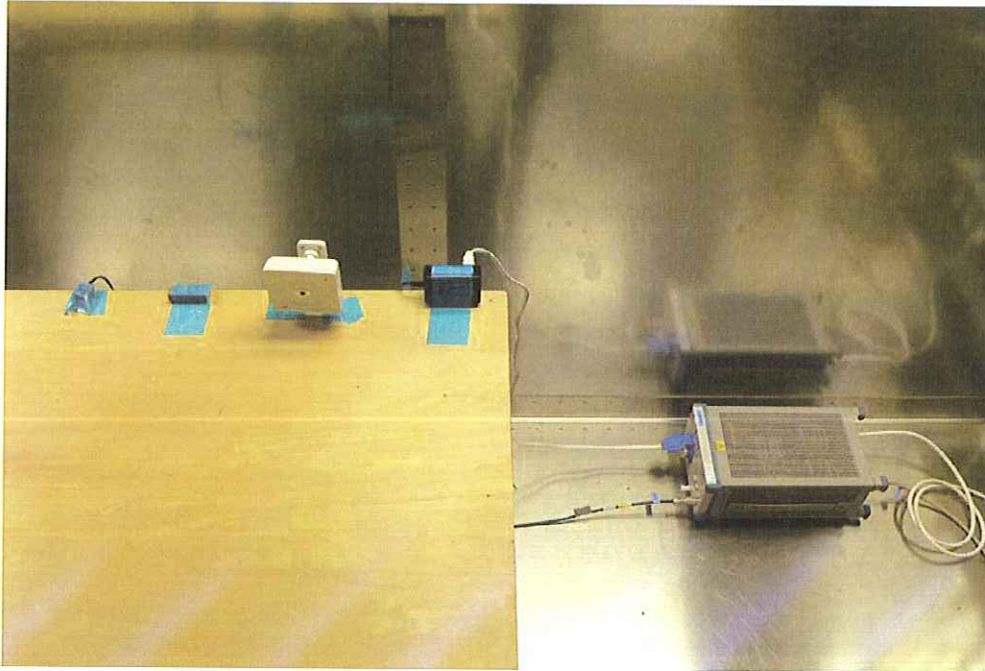
Photograph 2: Set-up for AC Conducted Emission, EUT Configuration Front View

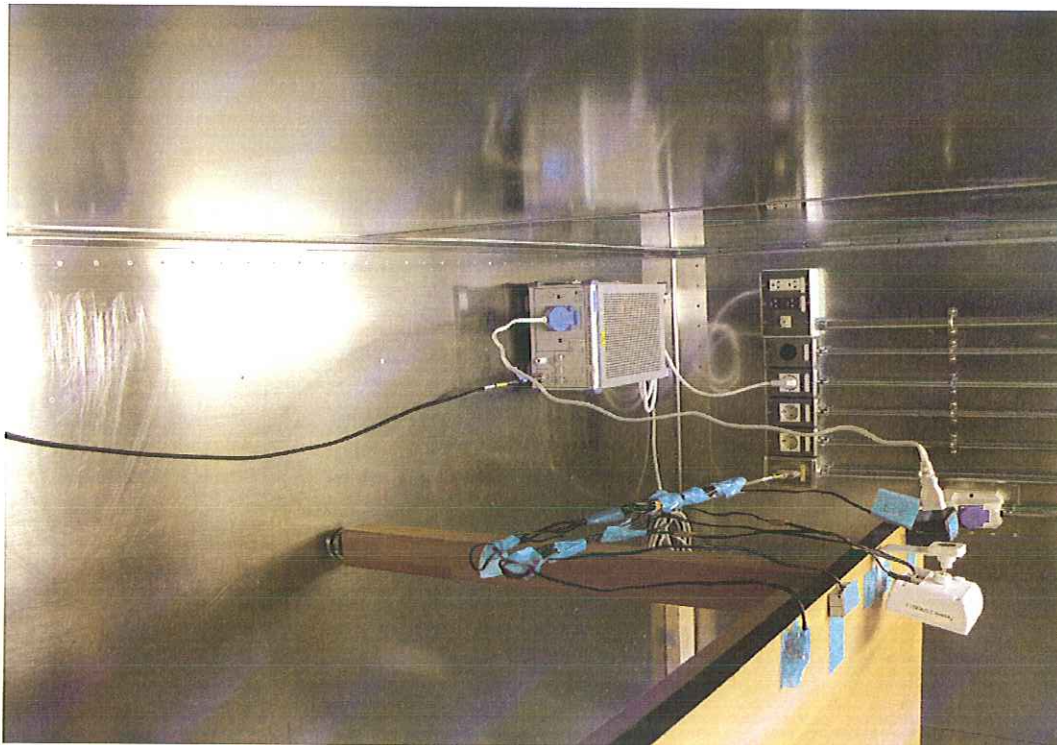
Photograph 3: Set-up for AC Conducted Emission, EUT Configuration Back View

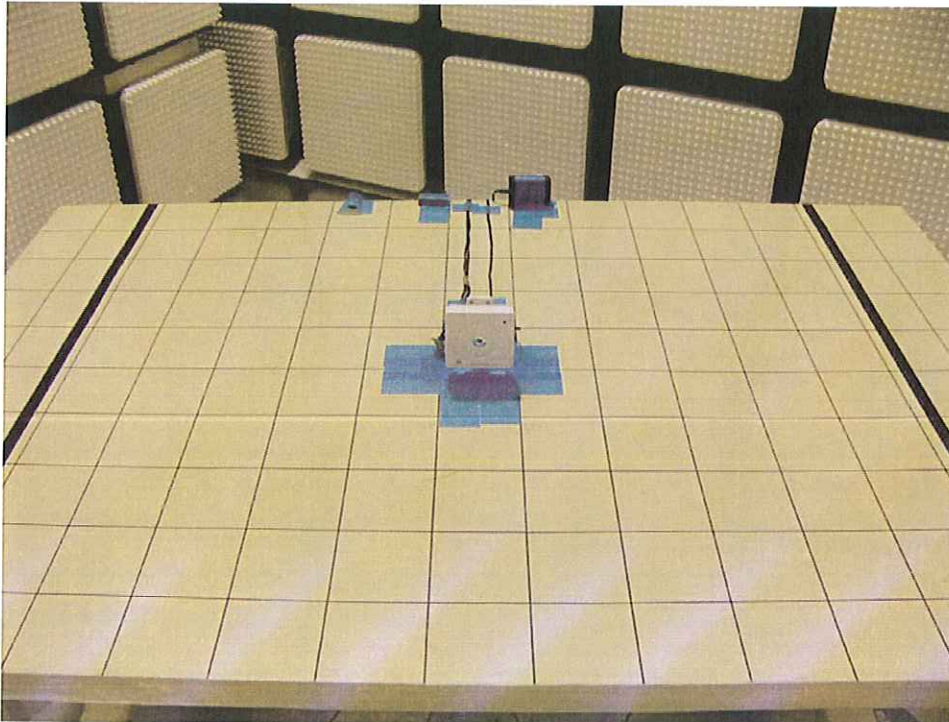
Photograph 4: Set-up for Radiated Emission, EUT Configuration X-axis

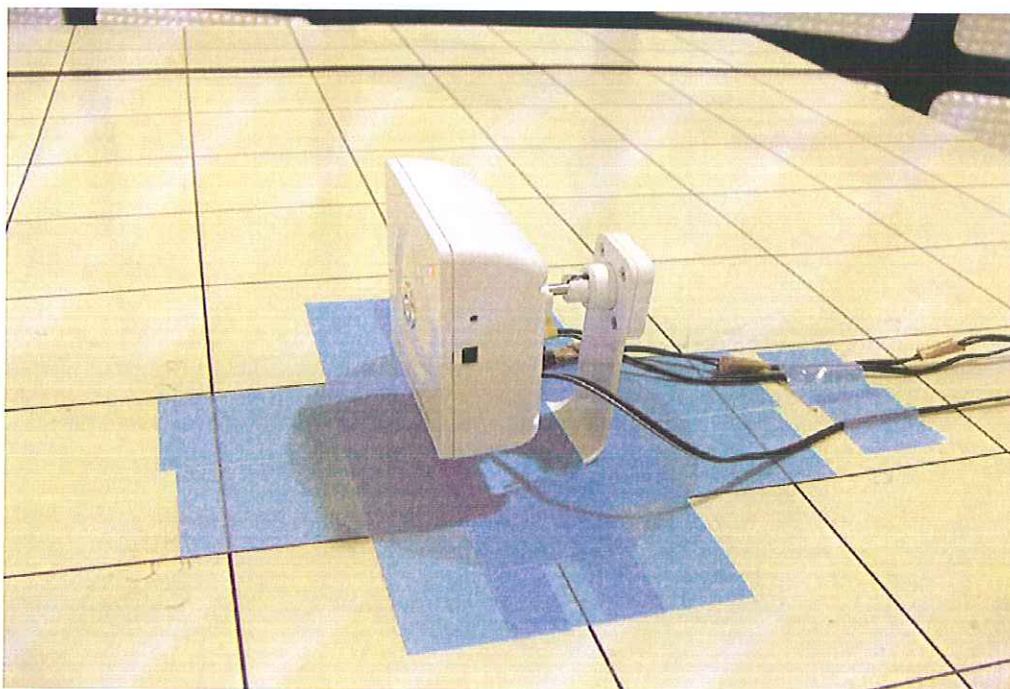
Photograph 5: Set-up for Radiated Emission, EUT Configuration Y-axis

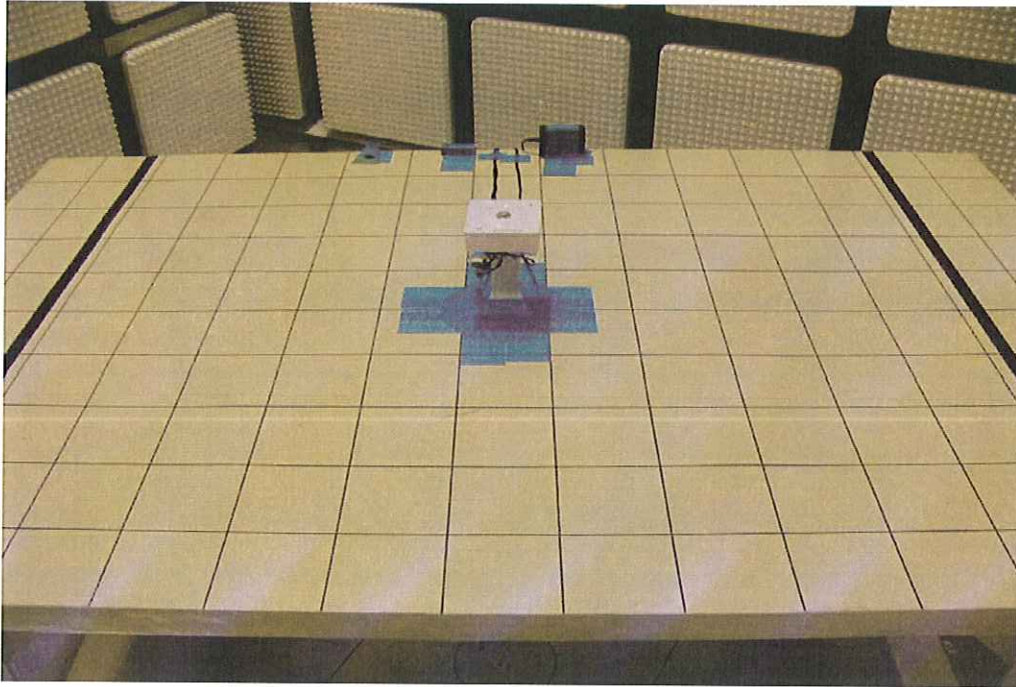
Photograph 6: Set-up for Radiated Emission, EUT Configuration Z-axis

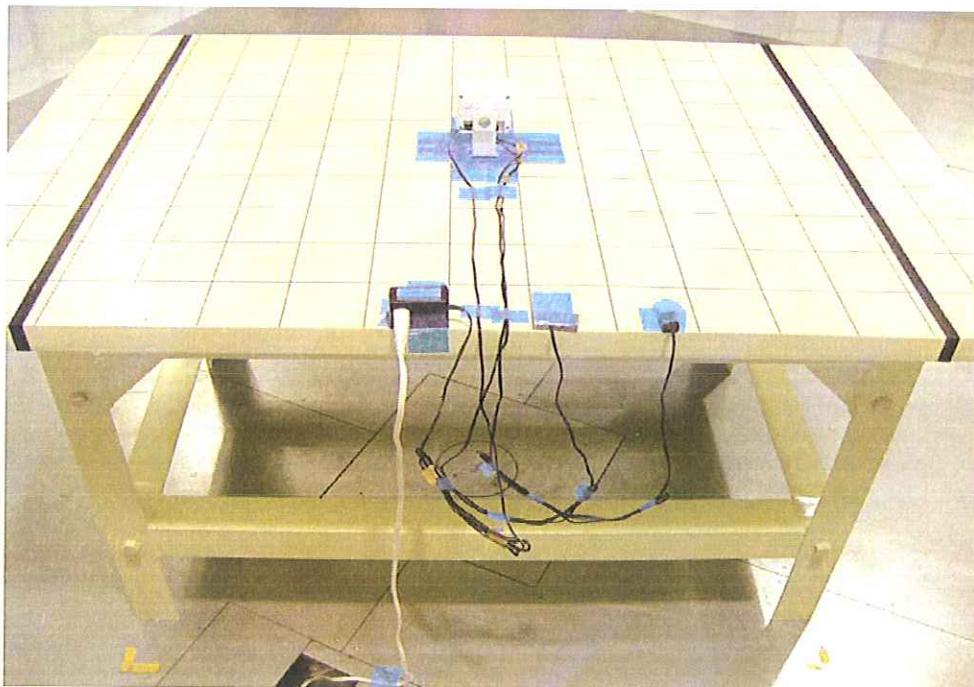
Photograph 7: Set-up for Radiated Emission, EUT Configuration back view
