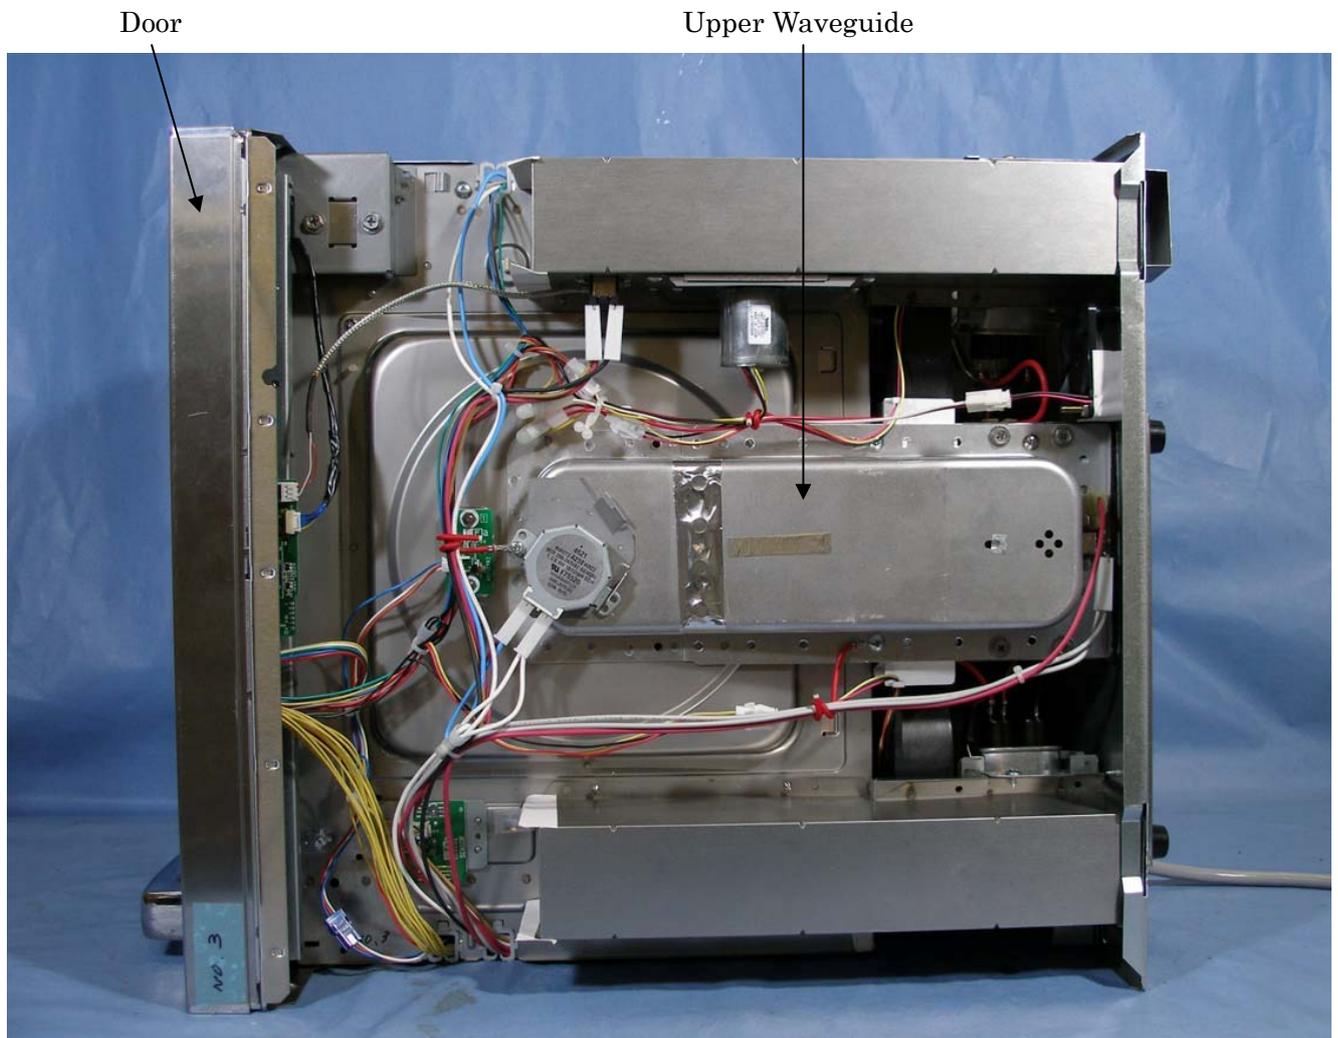
Fig. 5

Shows top side view of appliance with outer enclosure removed., and shows upper waveguide location.

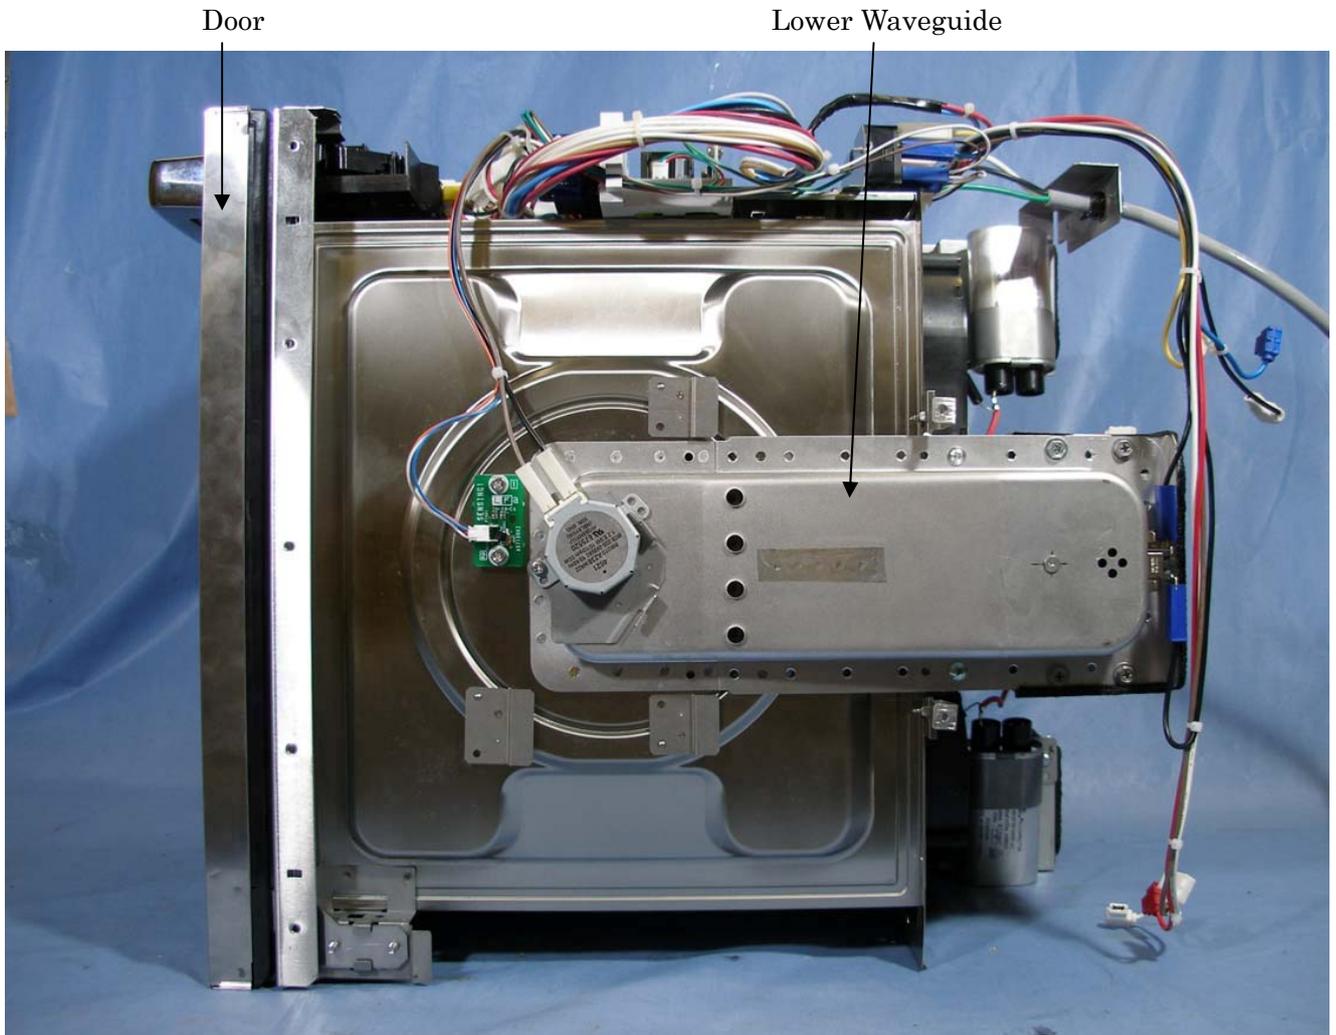
Fig. 6

Shows bottom side view of oven with disassembled condition, and shows lower waveguide location.

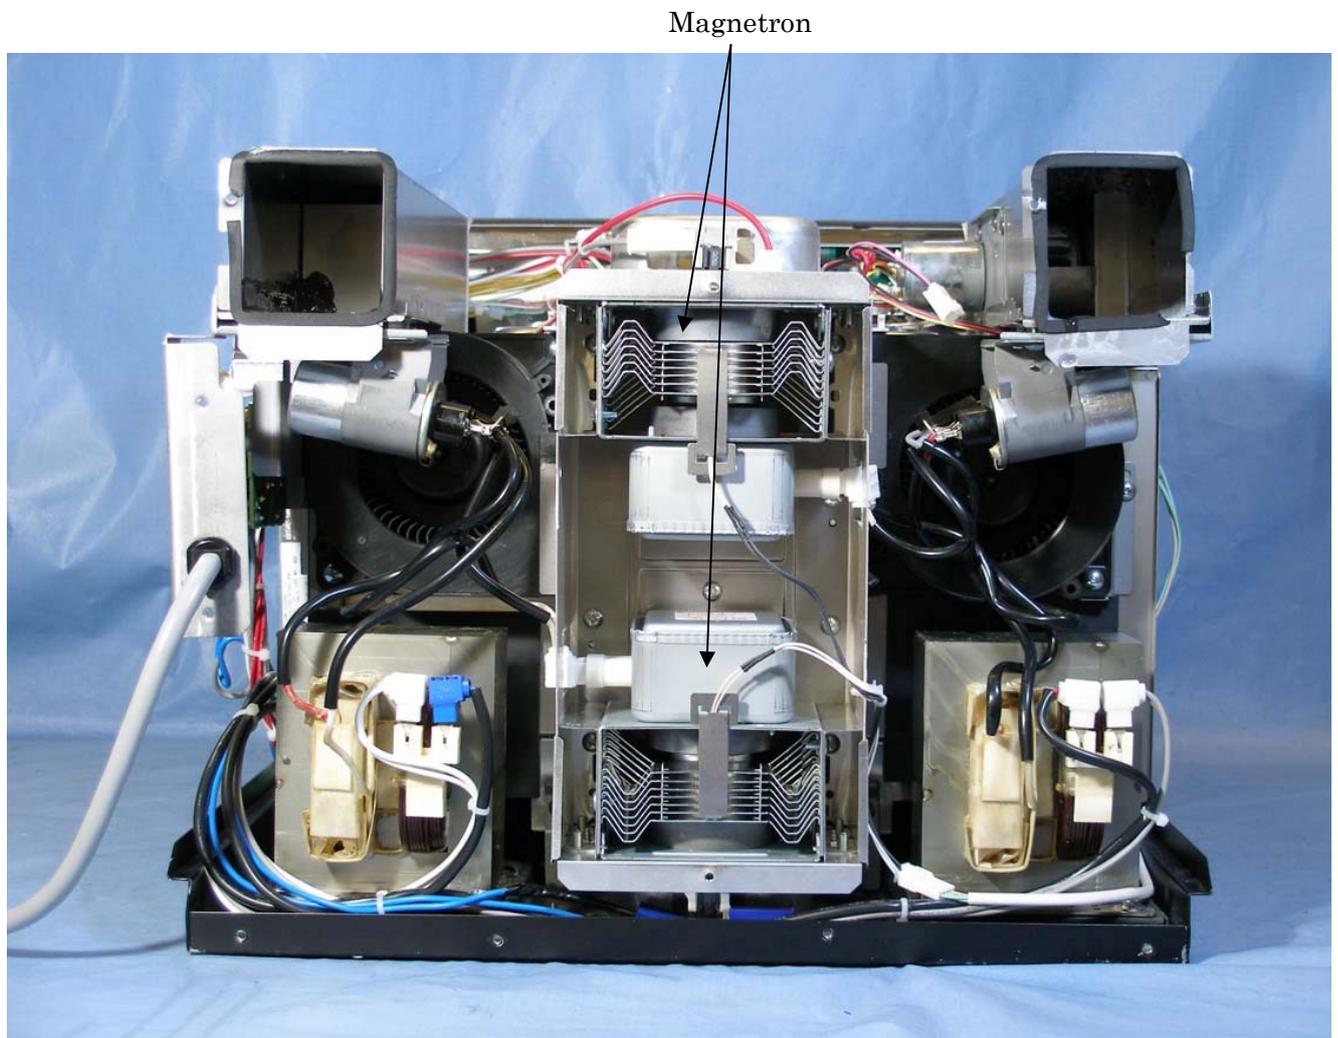
Fig. 7

Shows rear side view of appliance with rear enclosure is removed, and shows magnetron.

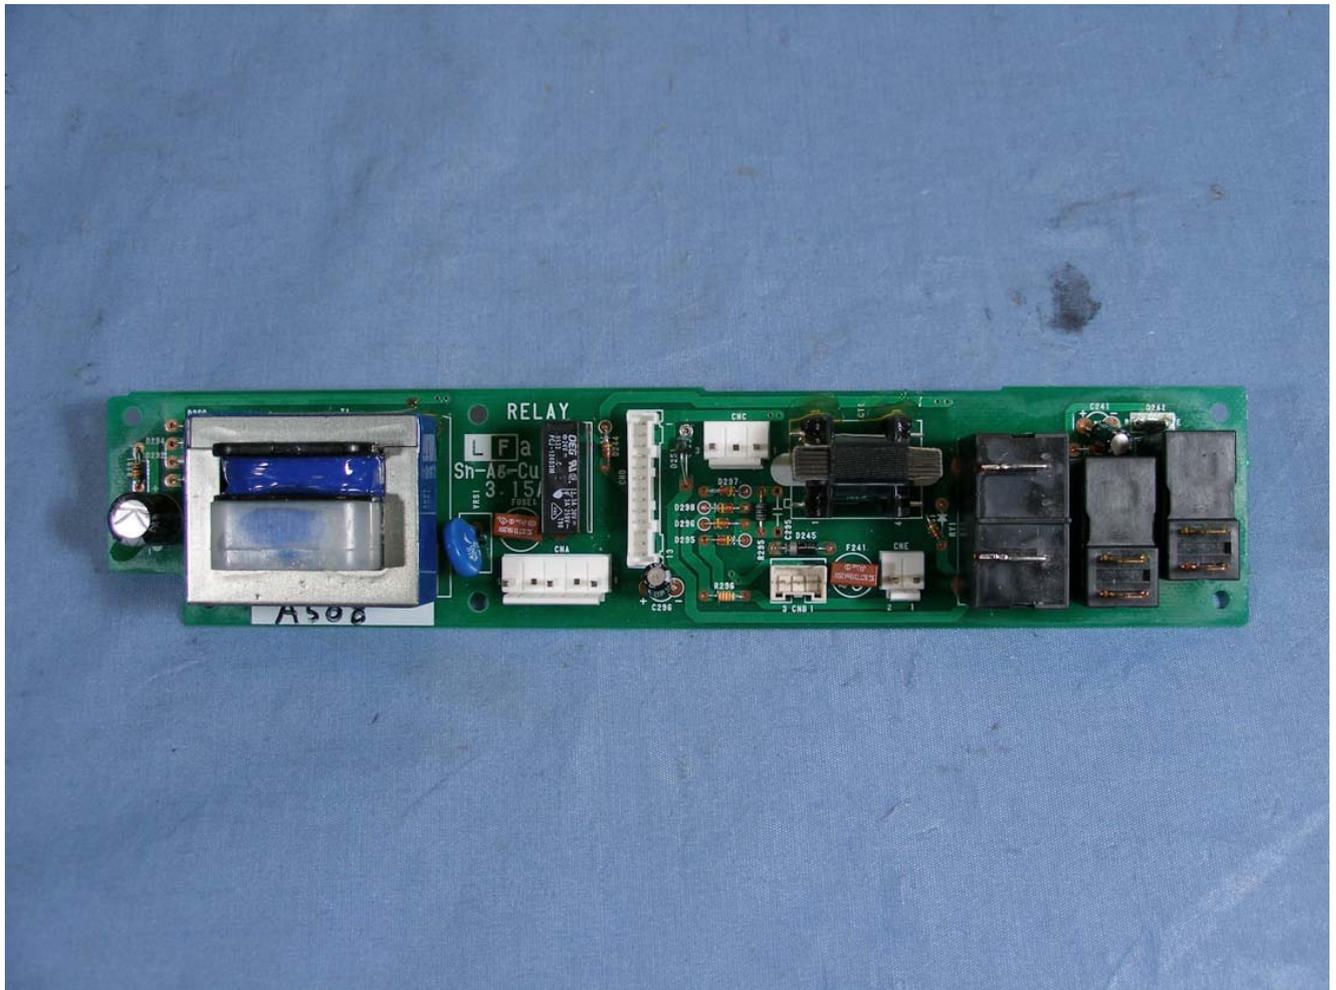
Fig. 8

Shows relay unit P.W.B. assembly.

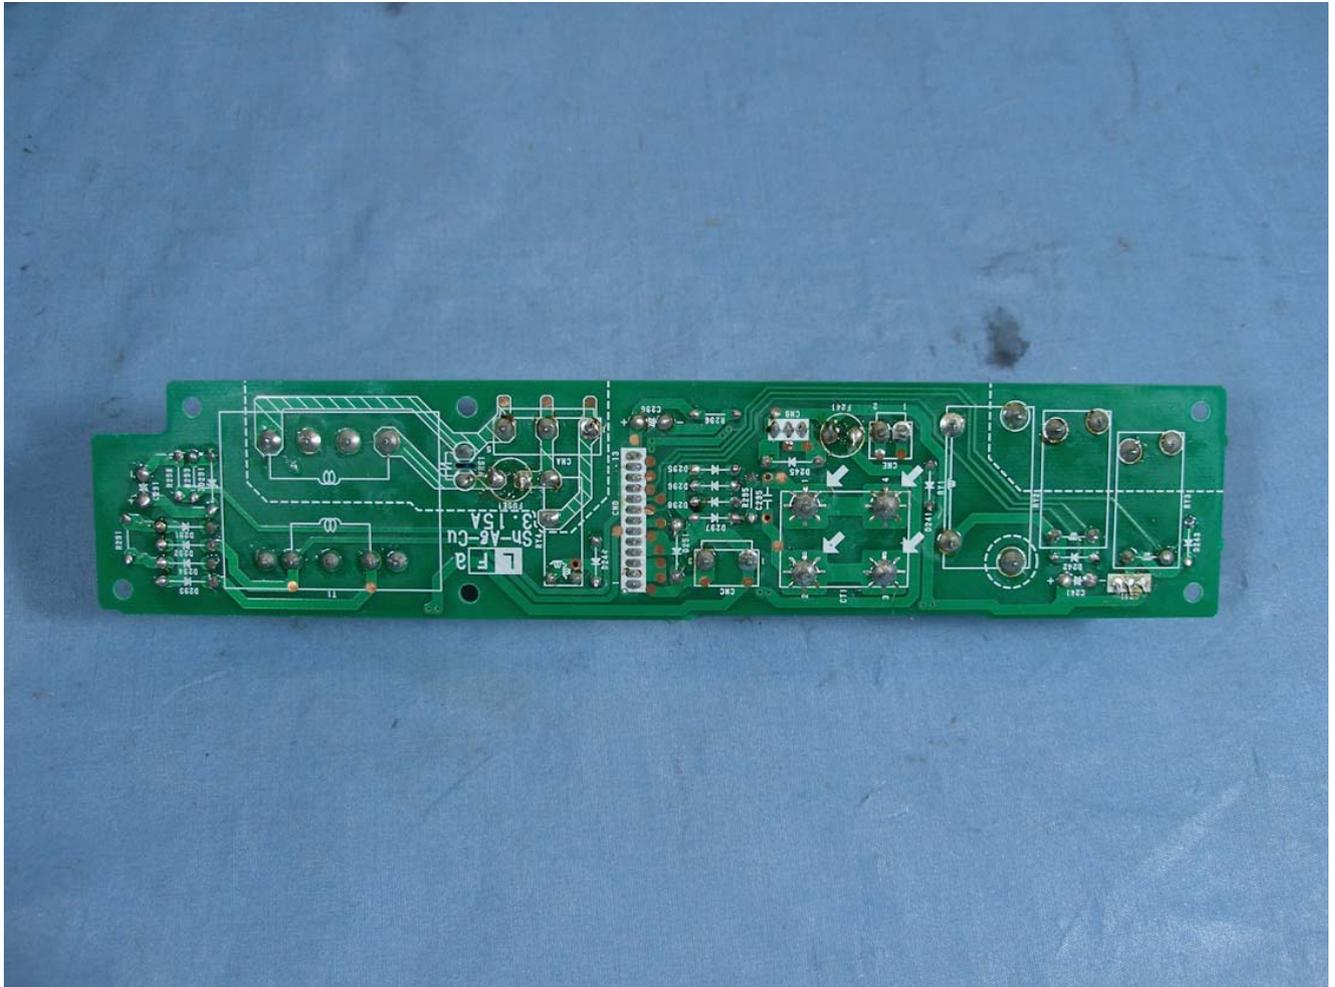
Fig. 9

Shows back-side of relay unit PWB assembly.

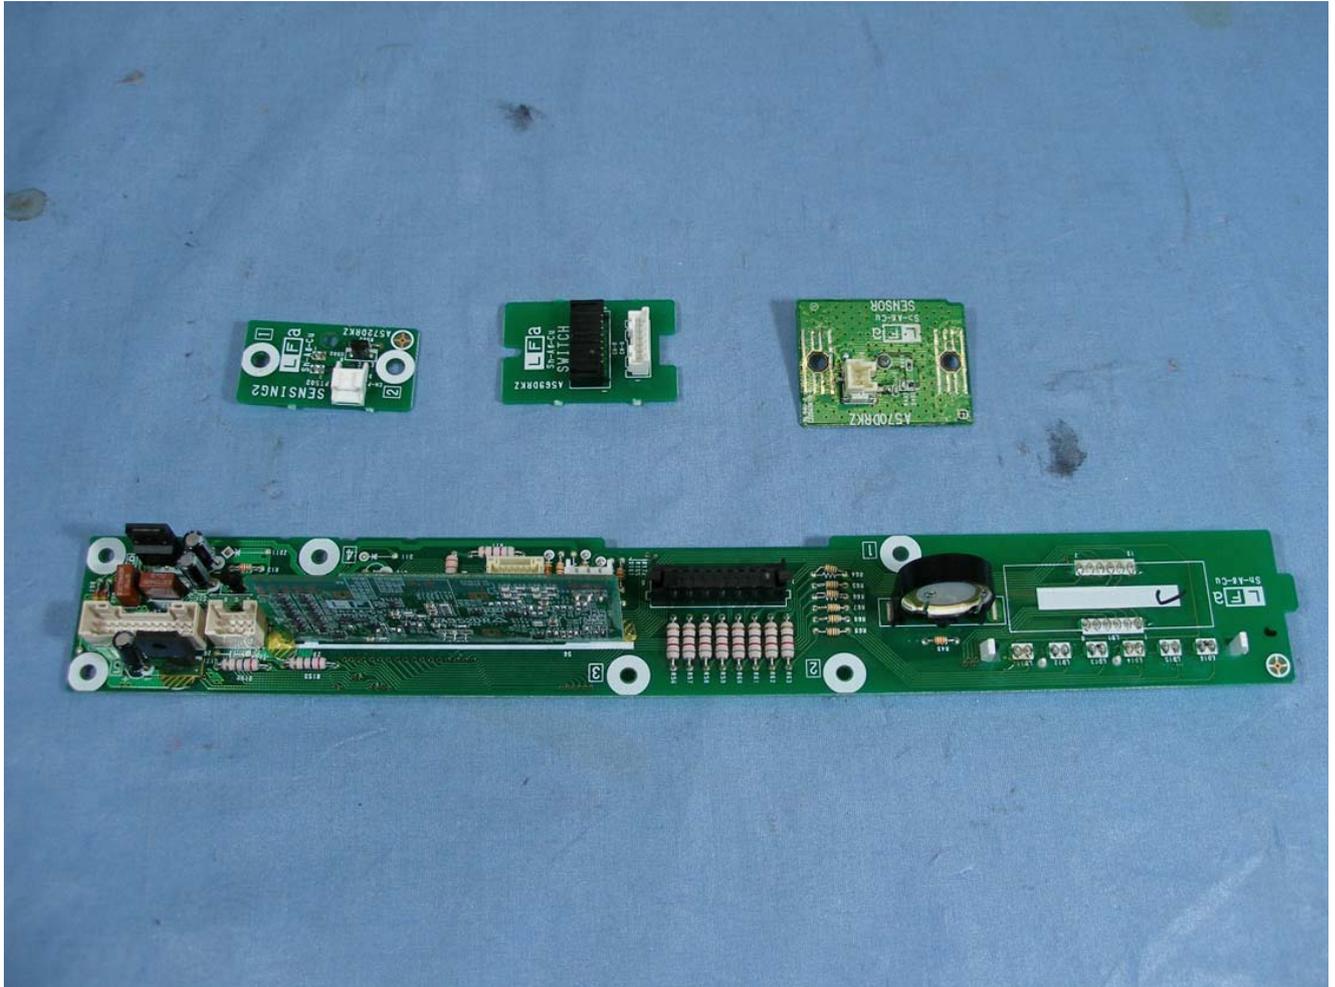
Fig. 10

Shows control unit PWB assembly.

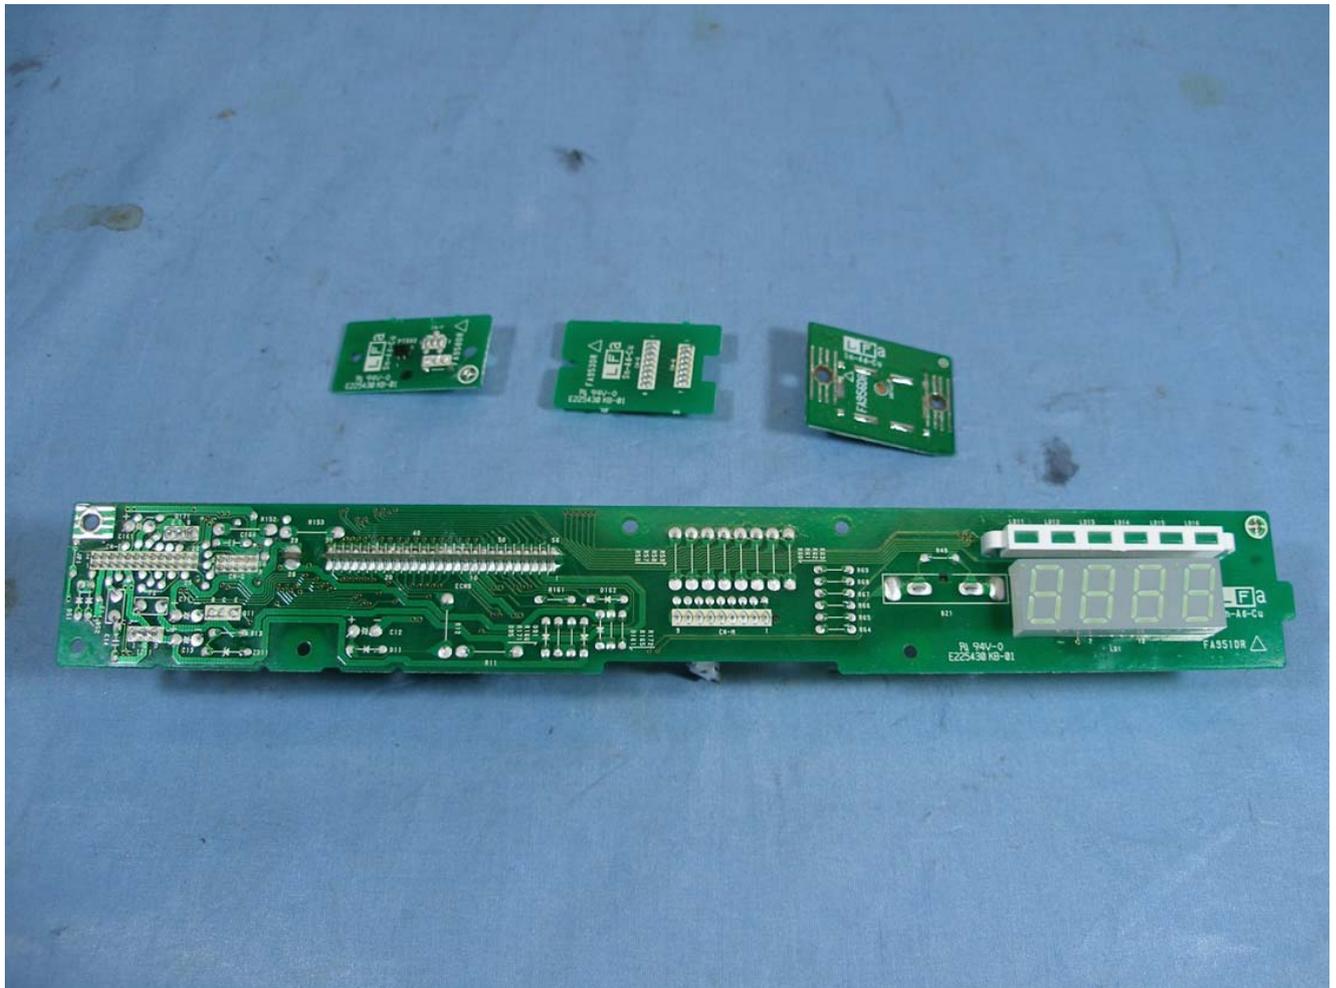
Fig. 11

Shows back-side of control unit PWB assembly.
