**Prüfbericht - Nr.: 15053322 001**  
Test Report No.:

## 7. Photographs of the Test Setup

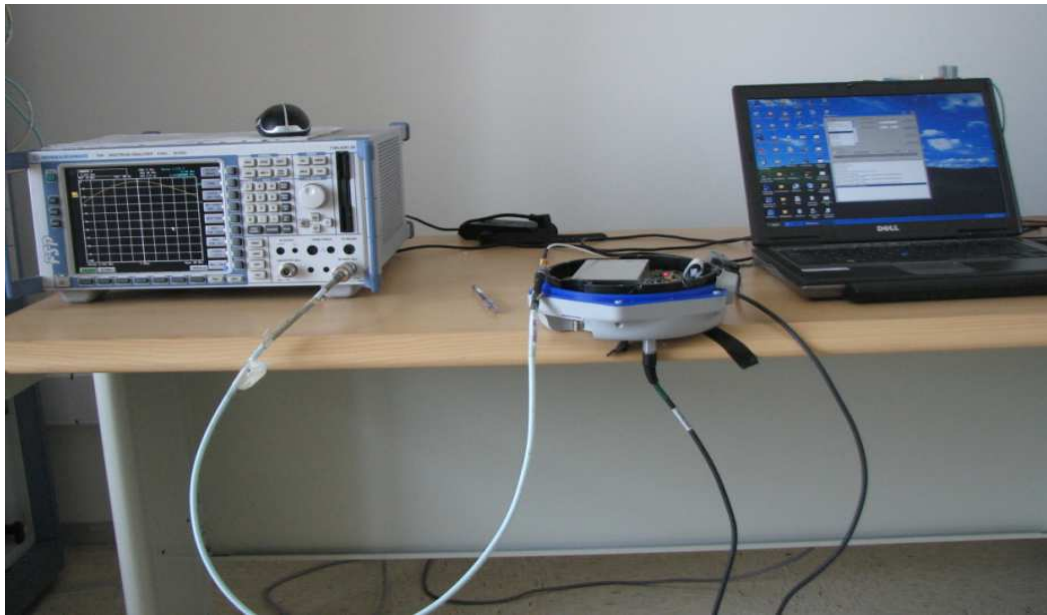
**Photograph 1: Set-up for Conducted Emission at Antenna Port**

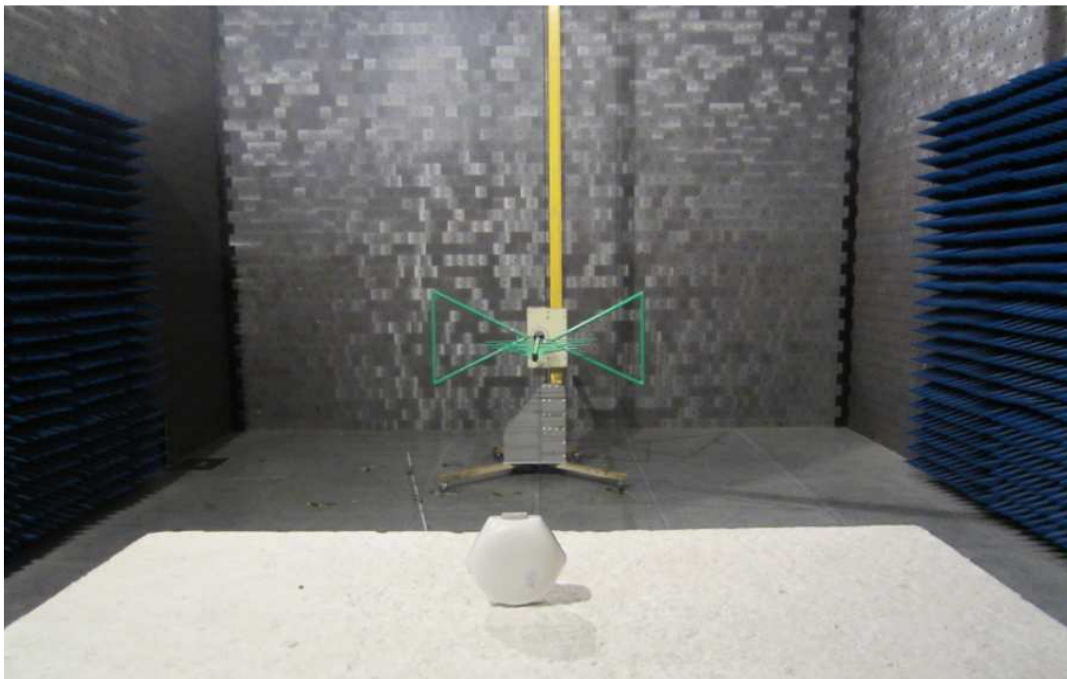
**Photograph 2: Set-up for Radiated Emission of Bluetooth, 30MHz-1000MHz**

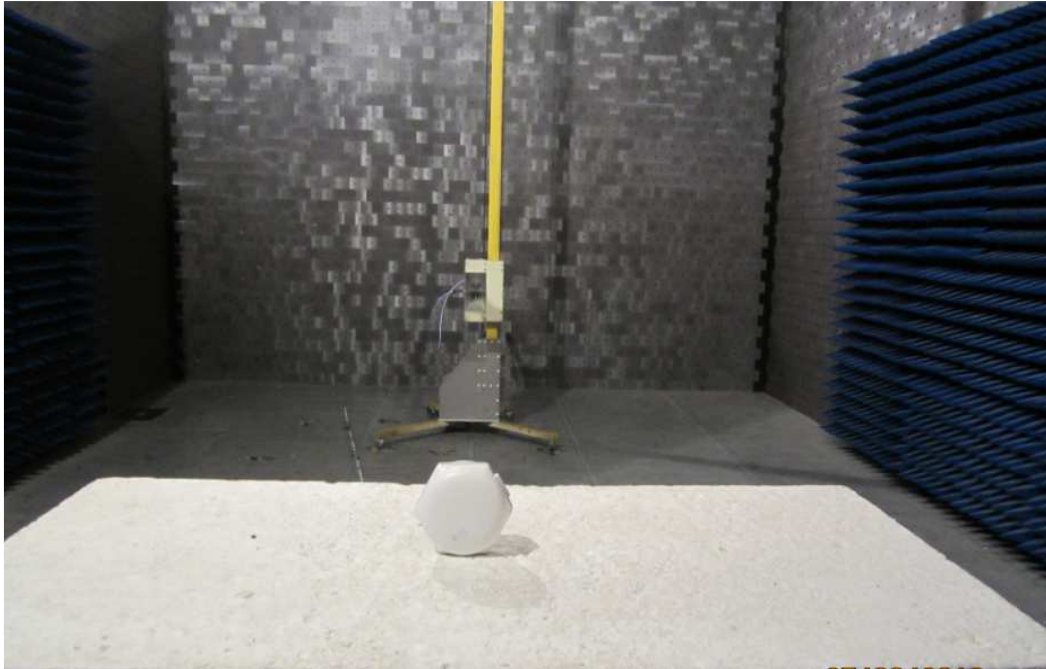
**Photograph 3: Set-up for Radiated Emission of Bluetooth, 1G-18GHz**

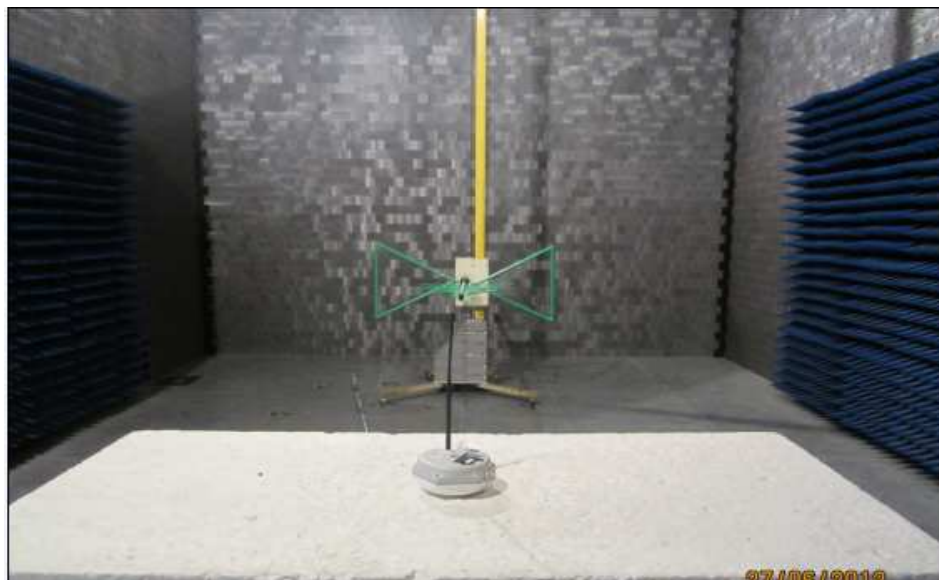
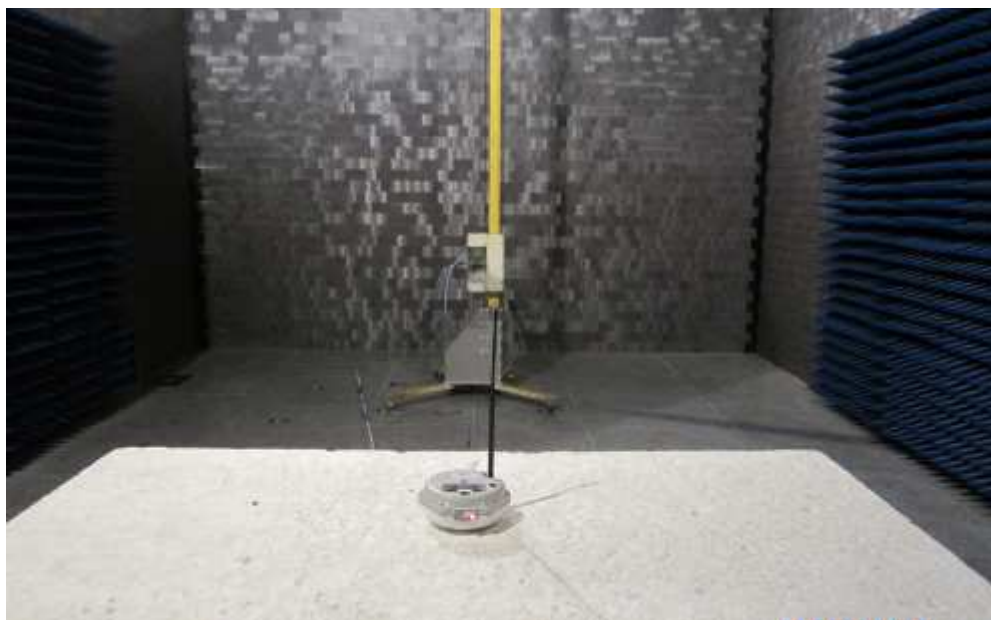
**Photograph 4: Set-up for Radiated Emission Land mobile Receiver,  
30MHZ~3GHZ;**

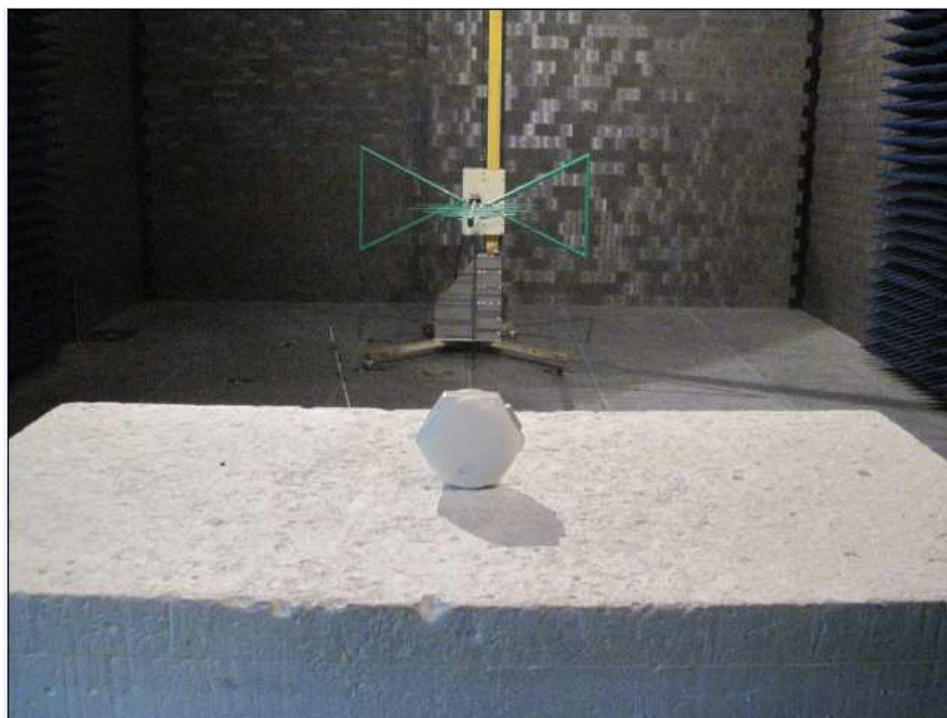
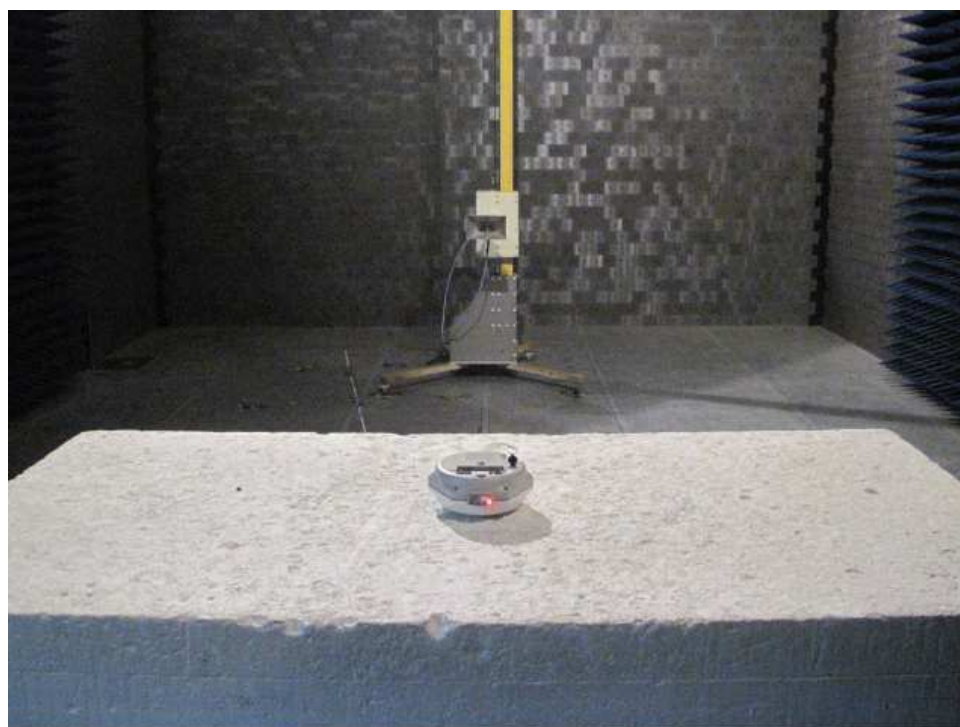
**Photograph 5: Set-up for Radiated Emission GPS Receiver, 30MHZ~8GHZ;**
