## DESCRIPTION OF SOUTHWEST MICROWAVE TEST SITE

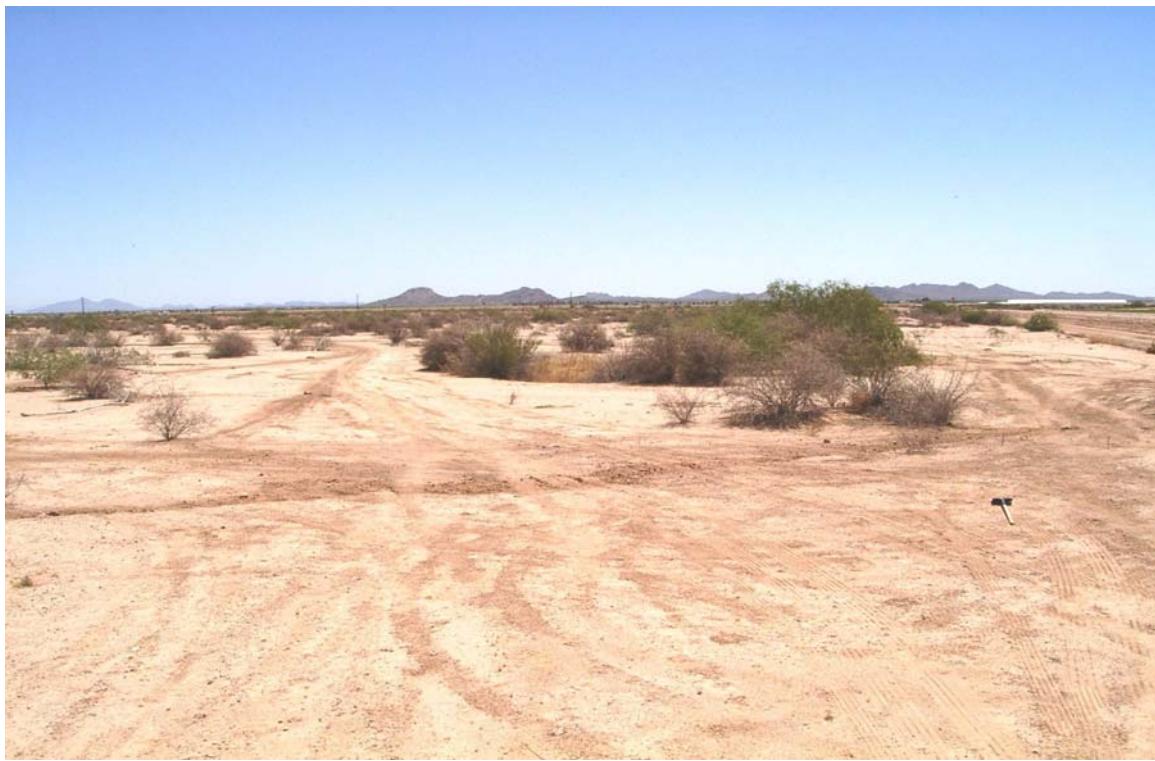
**Fig 2**

The site is level desert area with scattered low growing brush as shown in Fig 2. A 10 x 20 foot trailer for storing test equipment and providing a source of AC power is located in the southwest corner of the property. The only other buildings are a farmhouse and water tank over 500 meters west of Hartman Road. The soil is sandy and dry. Measured conductivity is .3 to .5 mS/meter when soaked with water and below .01mS/ meter when dry. Two pairs of leaky cables are buried in the locations as shown in Fig 1. The photo in Fig 3 is taken near the end of buried cable number 1. The tall trees and the water tank beyond Hartman Road are visible in the top of the picture.
