6160RF-2 PICTURES OF THE UNIT UNDER TEST

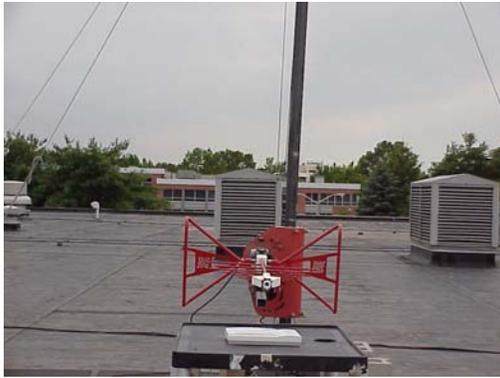
SENSE=HORZ UUT=HORZ

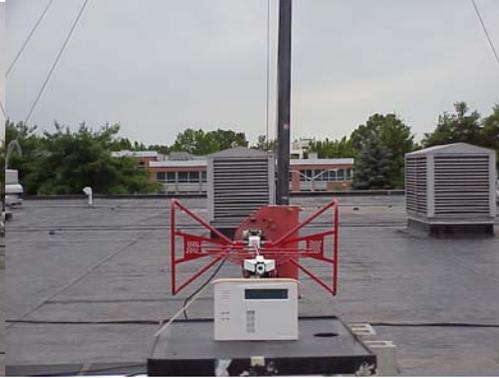
SENSE=HORZ UUT=VERT

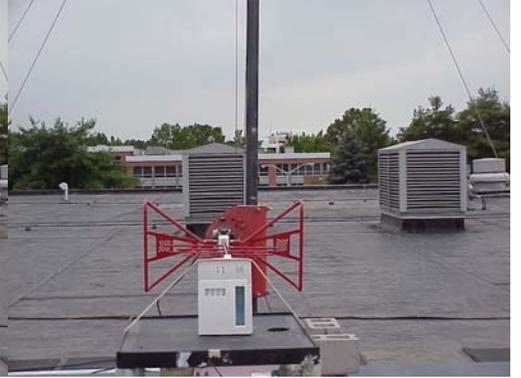
SENSE=HORZ UUT=OBLQ

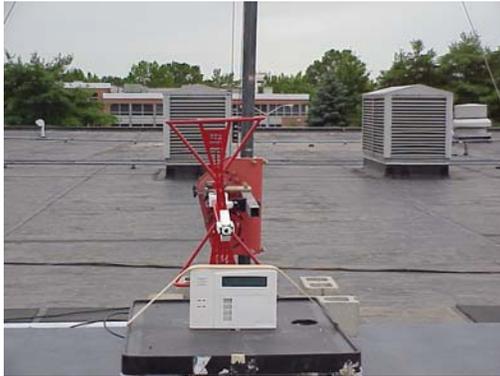
SENSE=VERT UUT=VERT

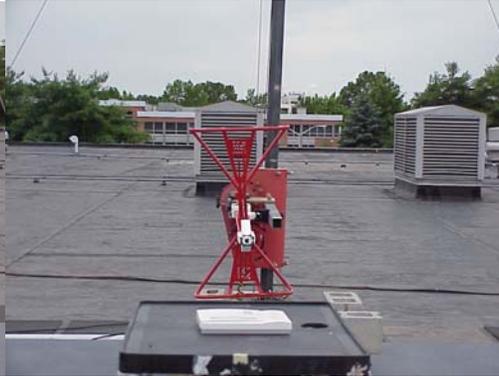
SENSE=VERT UUT=HORZ

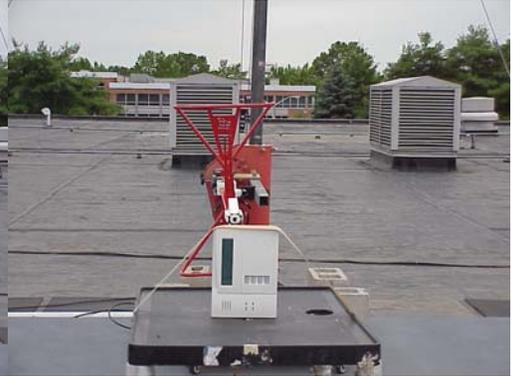
SENSE=VERT UUT=OBLQ

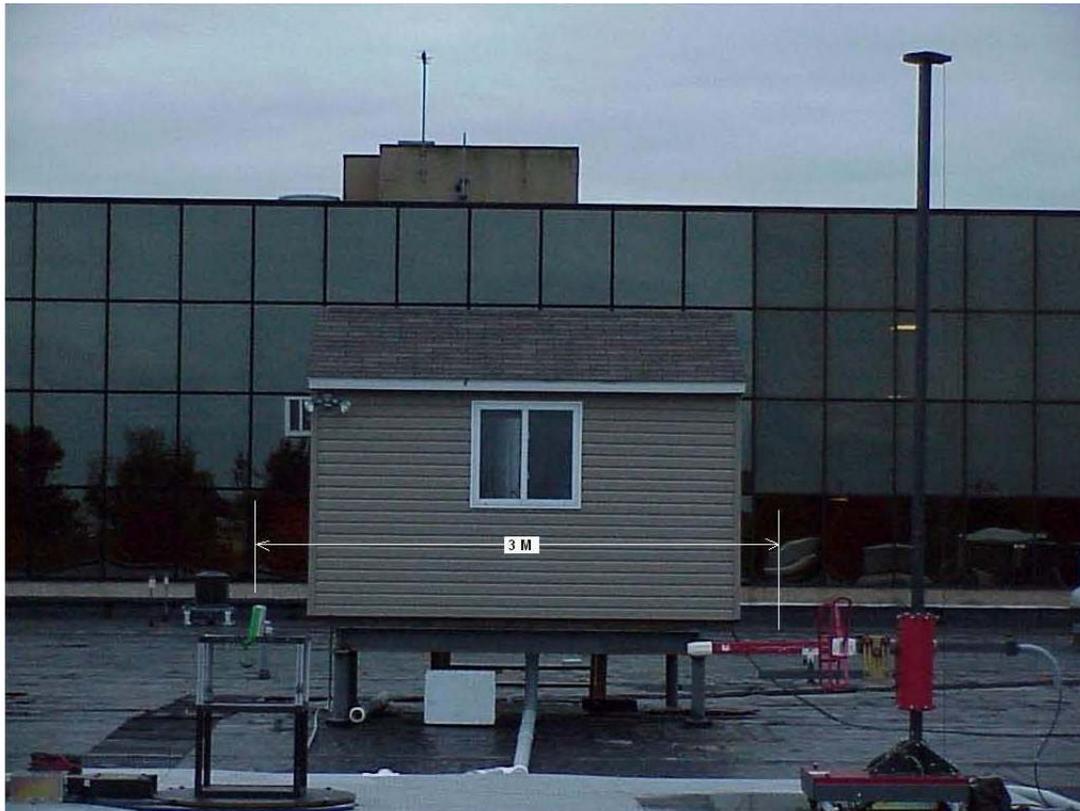
PICTURE OF THE OATS AT
2 CORPORATE CENTER DRIVE
MELVILLE, NY 11747

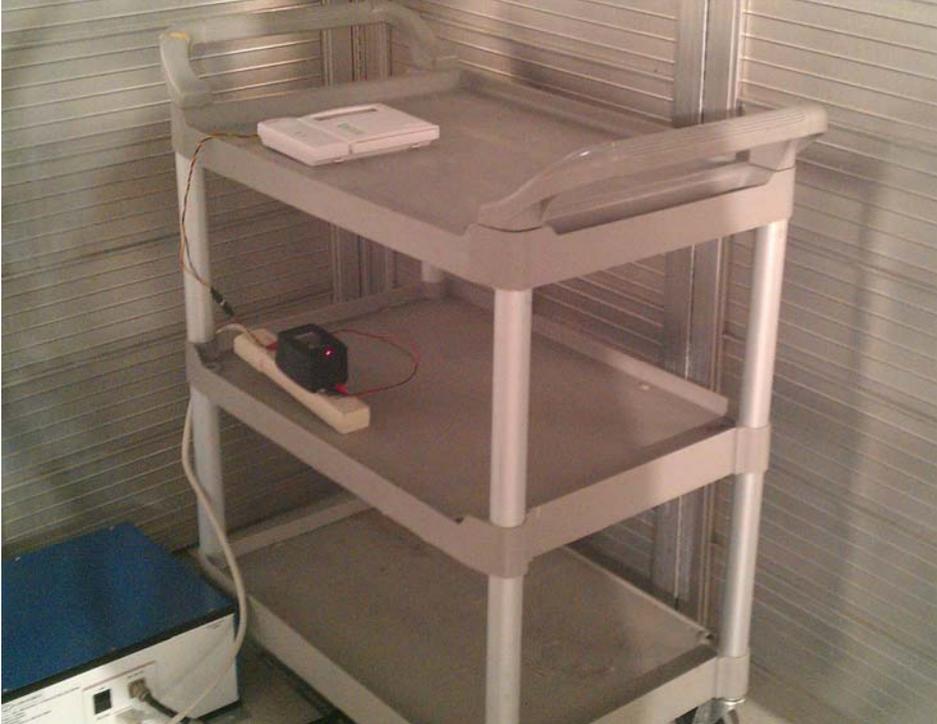
TEST SETUP PICTURES (CONT.)
