### **APPENDIX 3: Photographs of test setup**

#### **Radiated Spurious Emission**

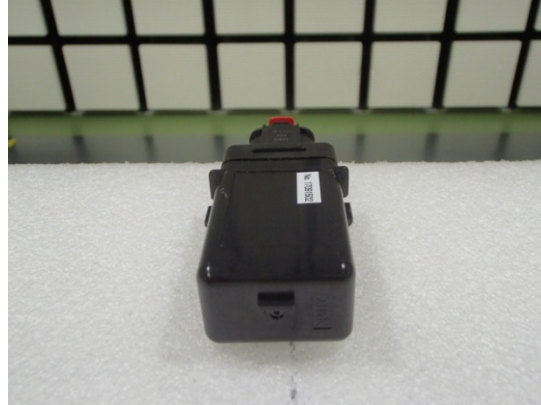
**X-axis**

### **Worst Case Position**

Below 1GHz : (Horizontal: X-axis/ Vertical:X-axis)

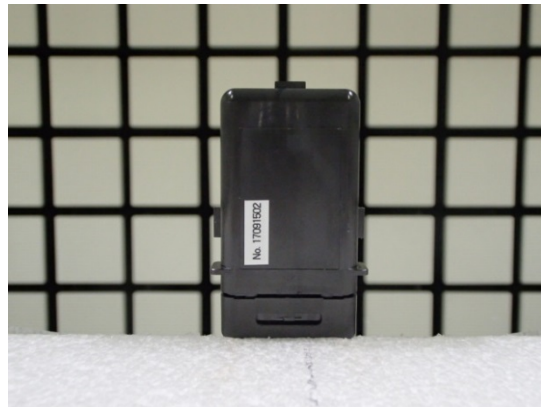
**Y-axis**

Above 1GHz : (Horizontal: Z-axis/ Vertical:Y-axis)
