## Emission tests to FCC and IC requirements of HA03

**Performed for Intermatic Inc.**

This exhibit is an extract of

DELTA Test Report E501839-1  
DANAK-197369  
5 March 2004

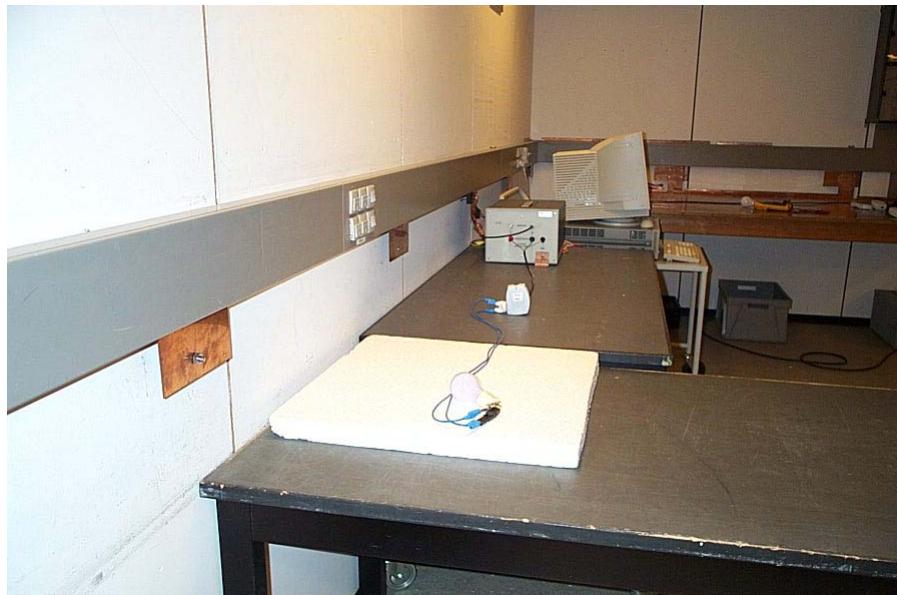
Photo 1      Set-up for conducted emission measurements.  
The LISN is bonded to the vertical ground plane (wall) of the screened room.

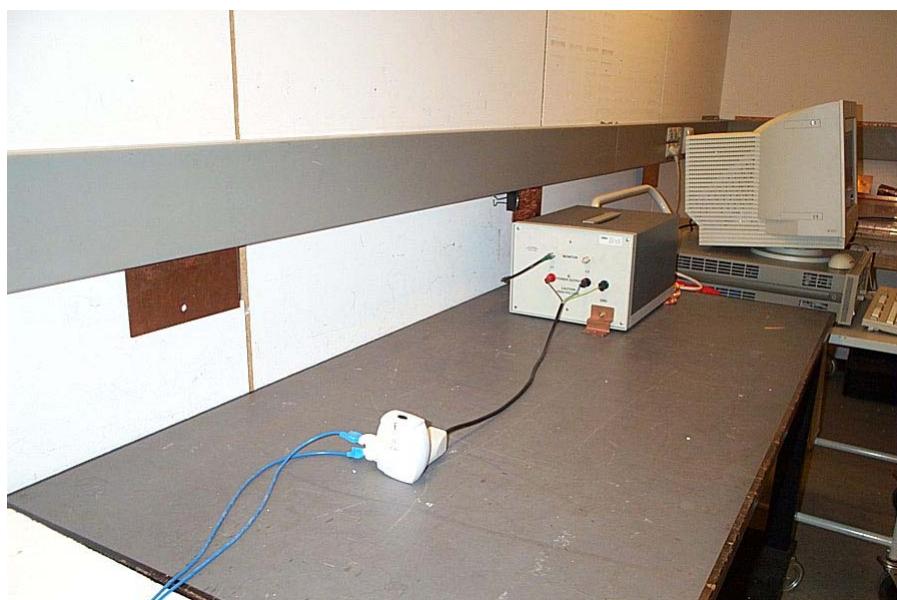
Photo 2      Set-up for conducted emission measurements.  
The LISN is bonded to the vertical ground plane (wall) of the screened room.

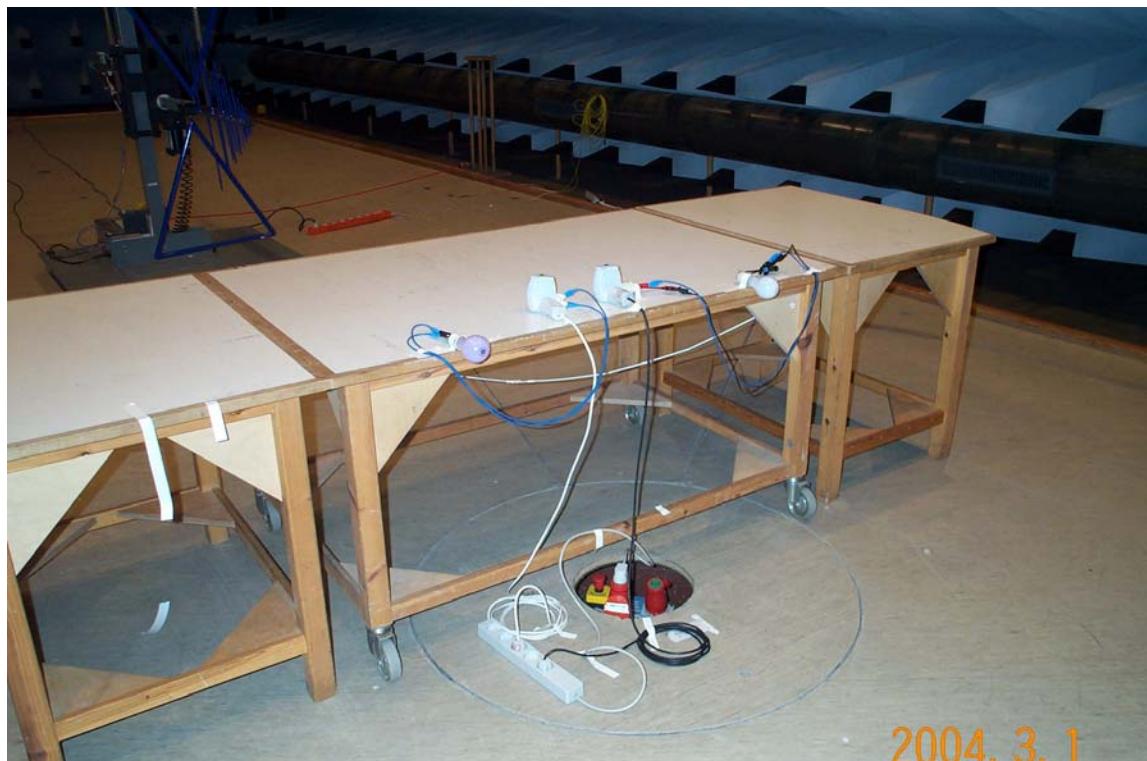
Photo 3      Set-up for measurements 30 – 1000 MHz. Date is 2004-02-12. Camera time is faulty.

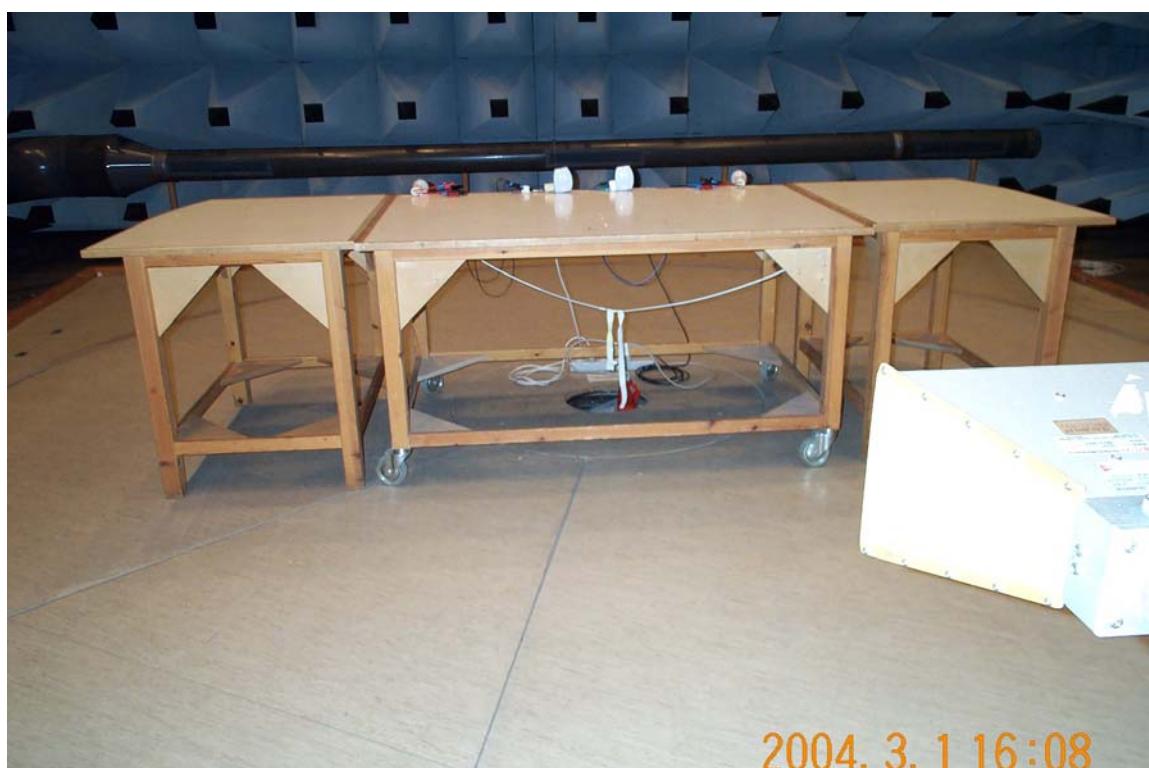
Photo 4      Measurement set-up > 1 GHz.
