### **APPENDIX 3: Photographs of test setup**

#### **Conducted Emission**

### **Radiated Spurious Emission**

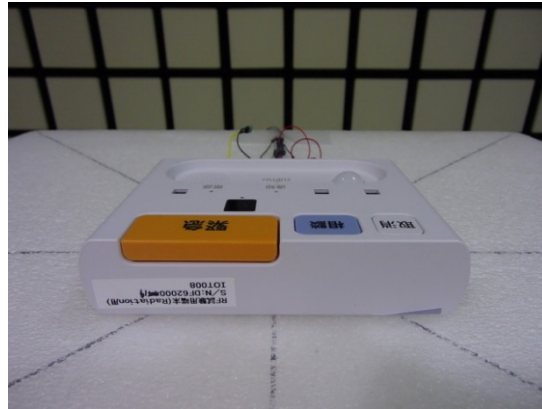
**X-axis**

### **Worst Case Position**

BT LE : Below 1GHz(Horizontal: X-axis/ Vertical:X-axis)

WLAN/BT LE : Above 1GHz(Horizontal: X-axis/ Vertical:Y-axis)

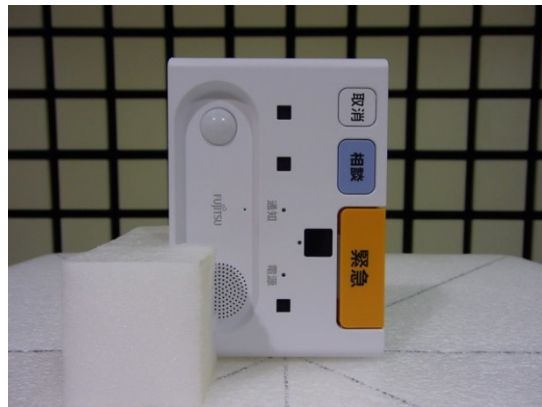
**Z-axis**

WLAN : Below 1GHz(Horizontal: Z-axis/ Vertical:Z-axis)
