EMC Technologies Report Number: M070237_Cert_EYTF3CSFT_WLAN

APPENDIX B2

Test Setup Photograph

FCC Part 15 class B test set up photos

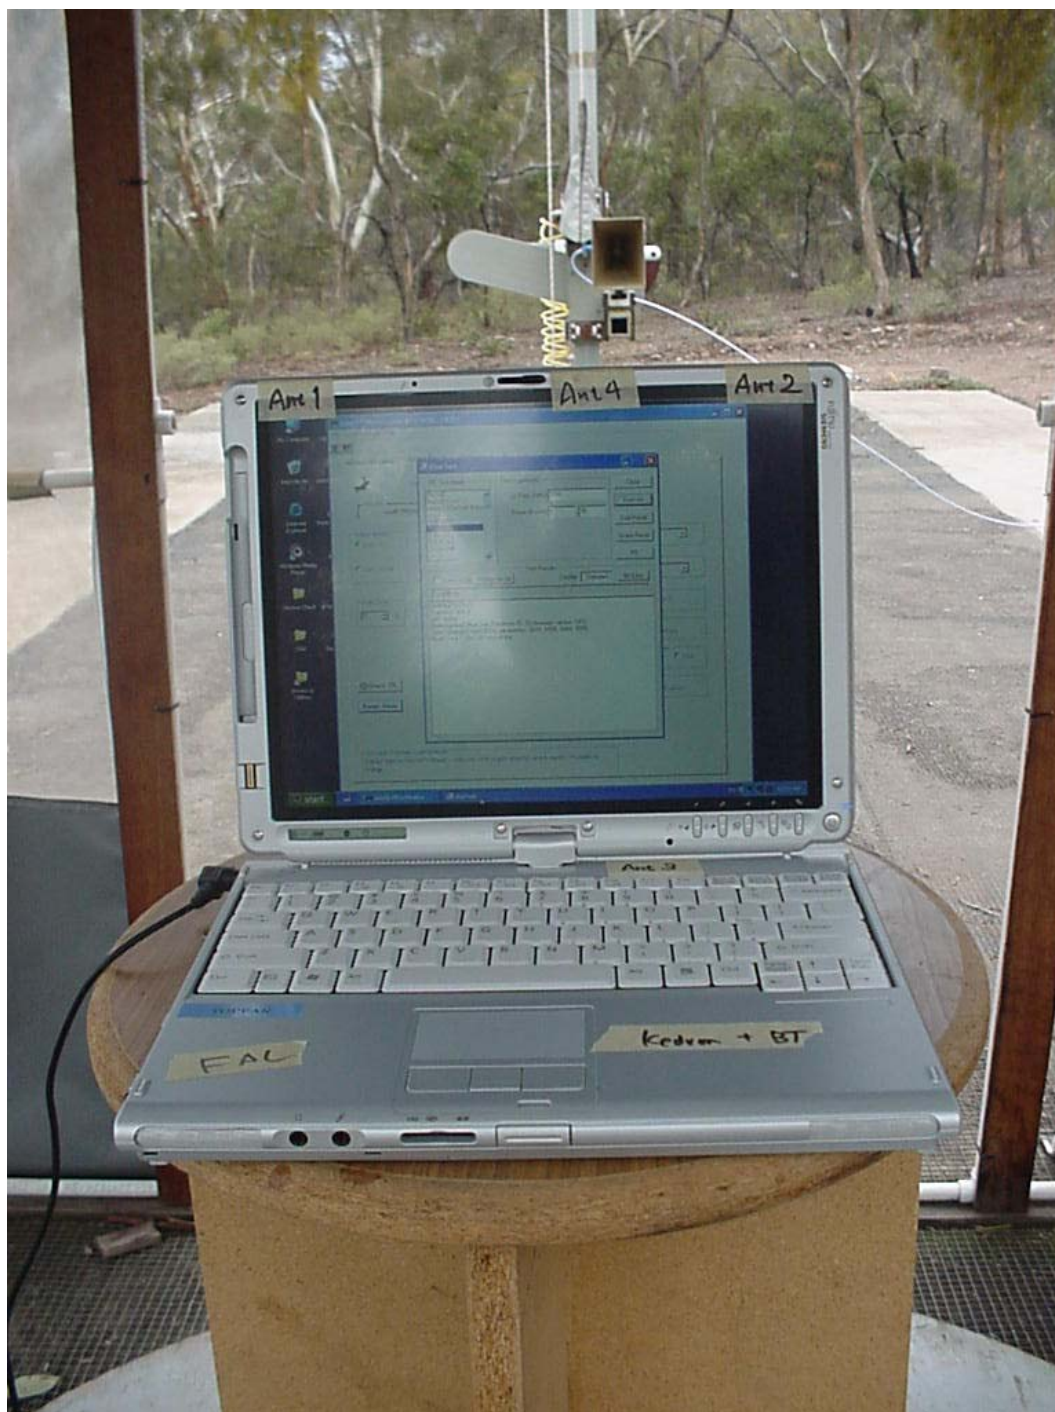
Radiated Spurious Emissions Test Setup

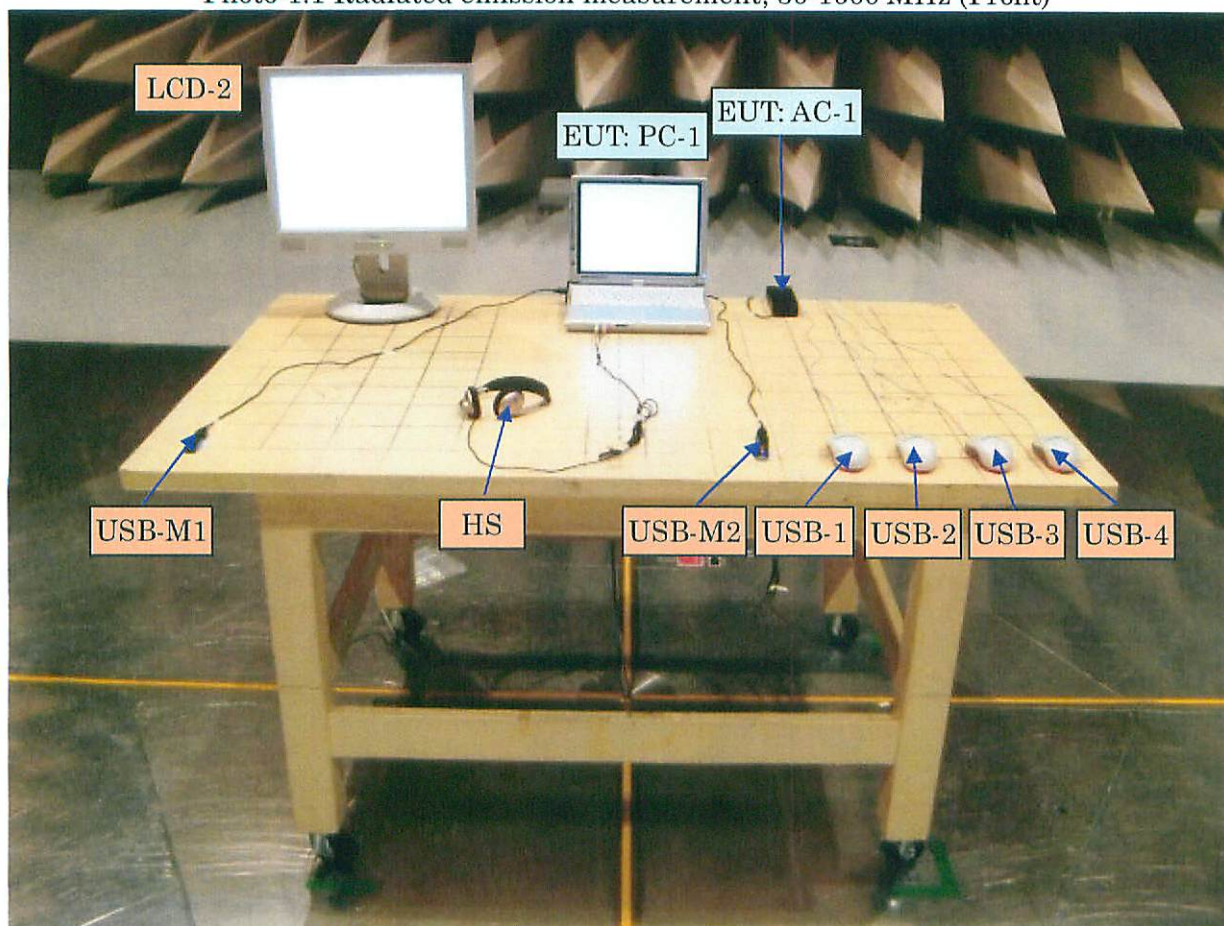
Photo-1.1 Radiated emission measurement; 30-1000 MHz (Front)

- PC-2, HUB and TEL were set at outside of the chamber.

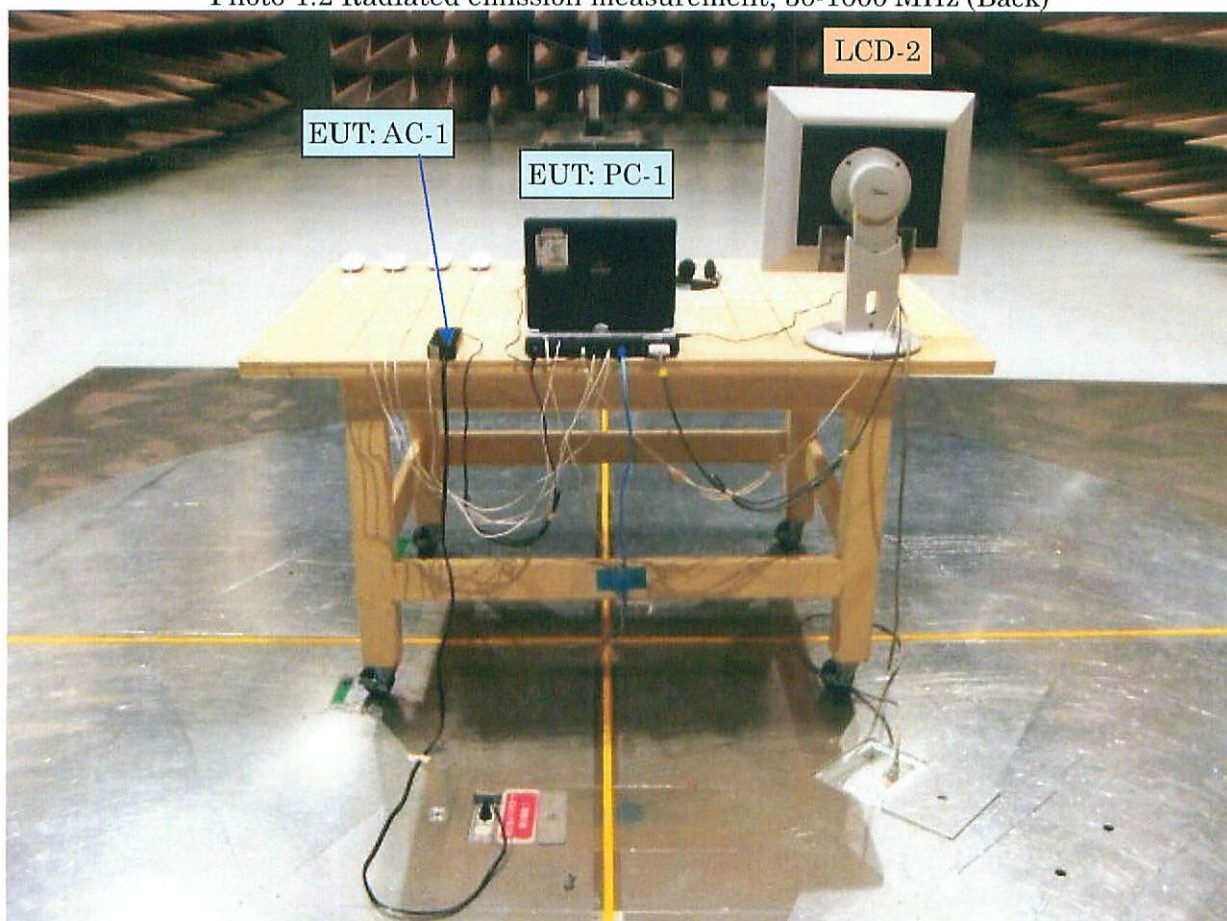
Photo-1.2 Radiated emission measurement; 30-1000 MHz (Back)

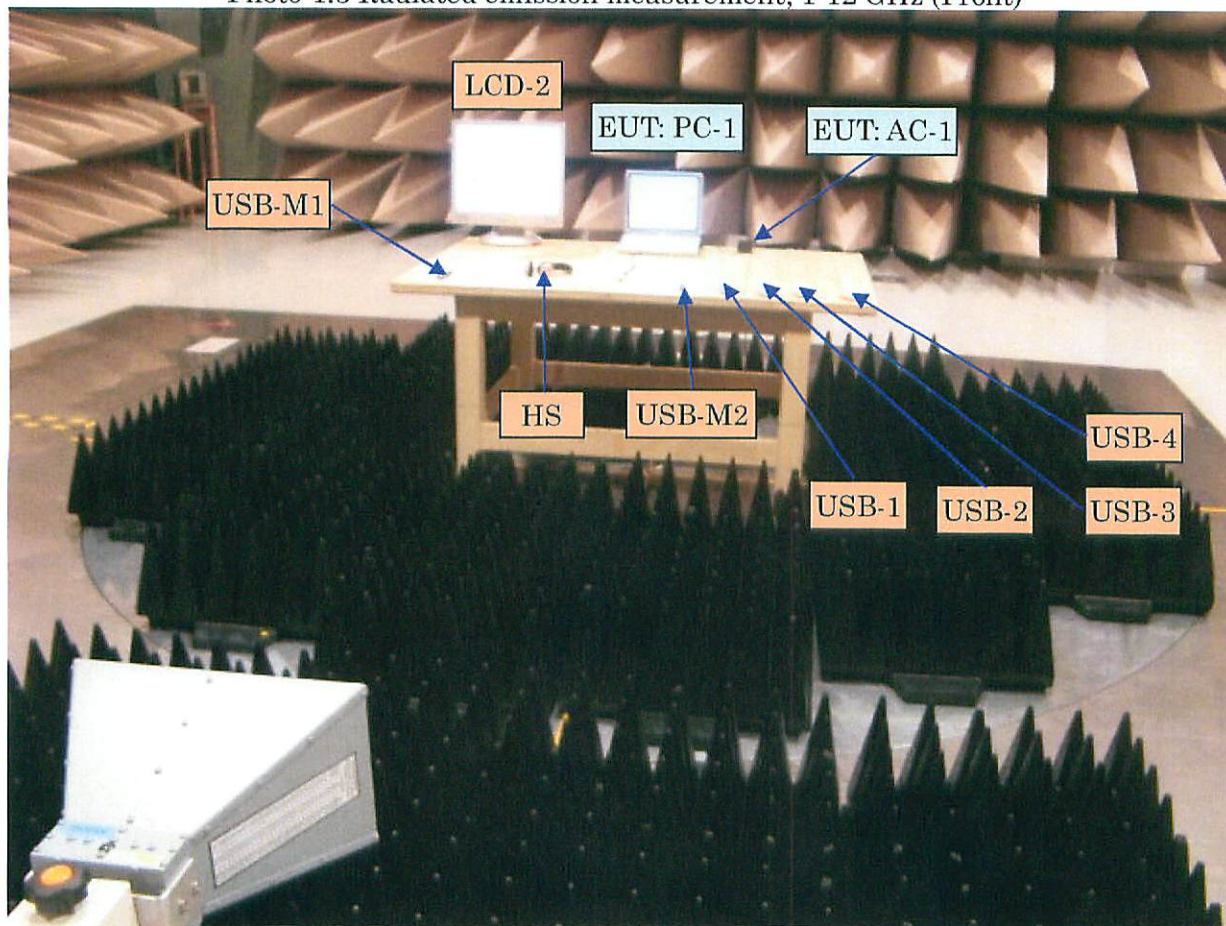
Photo-1.3 Radiated emission measurement; 1-12 GHz (Front)

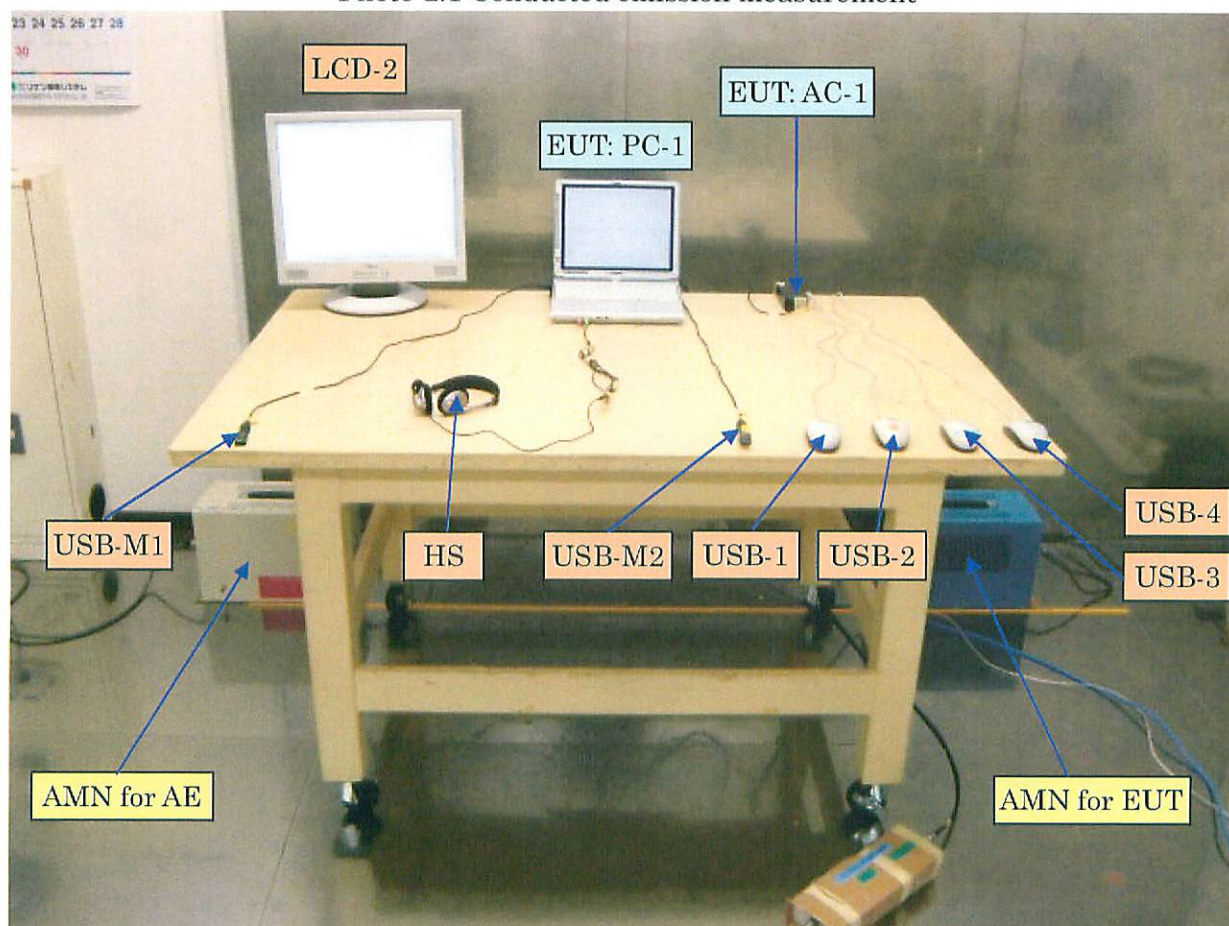
Photo-2.1 Conducted emission measurement
