**EMC Technologies Report Number: M071118\_Cert\_4965AGN\_DTS\_BT**

## **APPENDIX B2**

### **Test Setup Photograph**

**FCC Part 15 class B test set up photos**

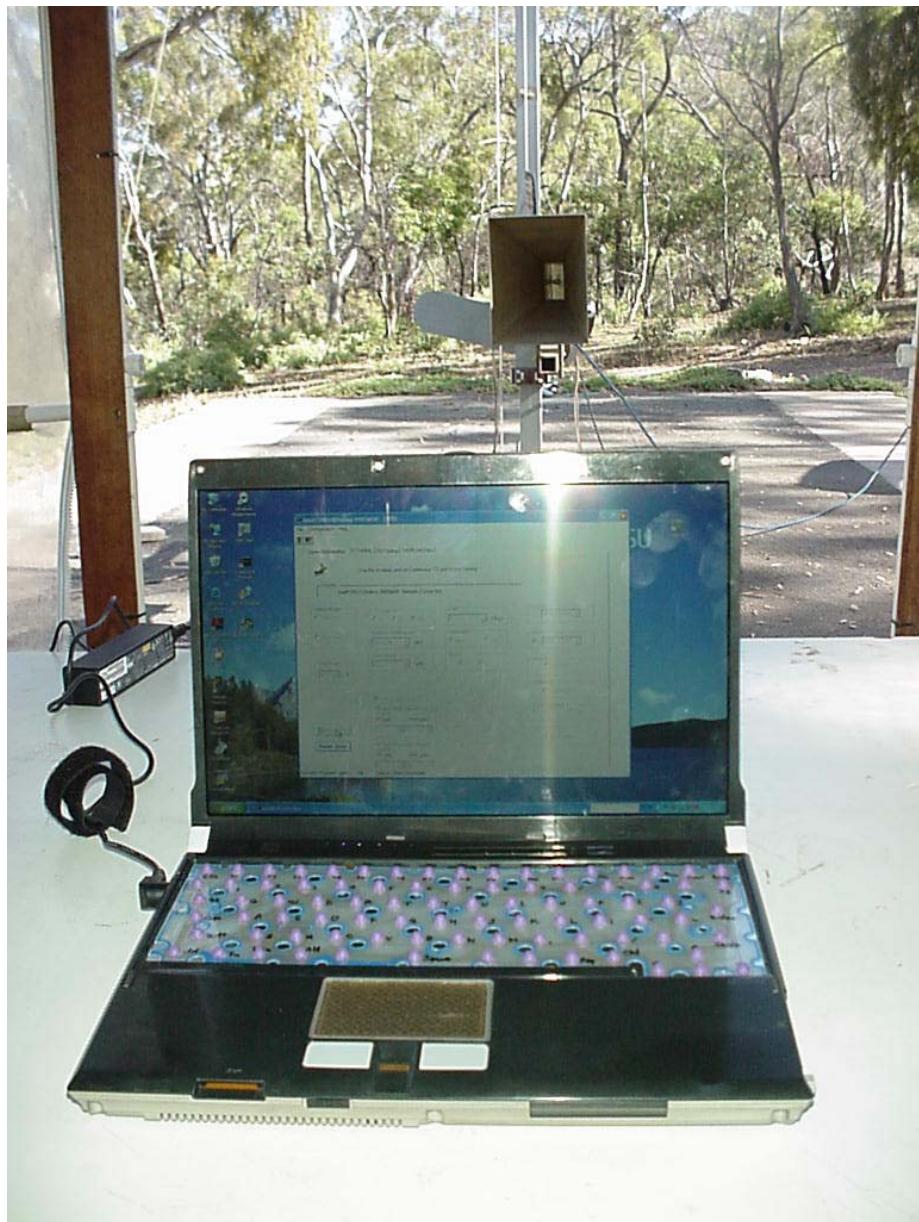
**Radiated Spurious Emissions Test Setup**

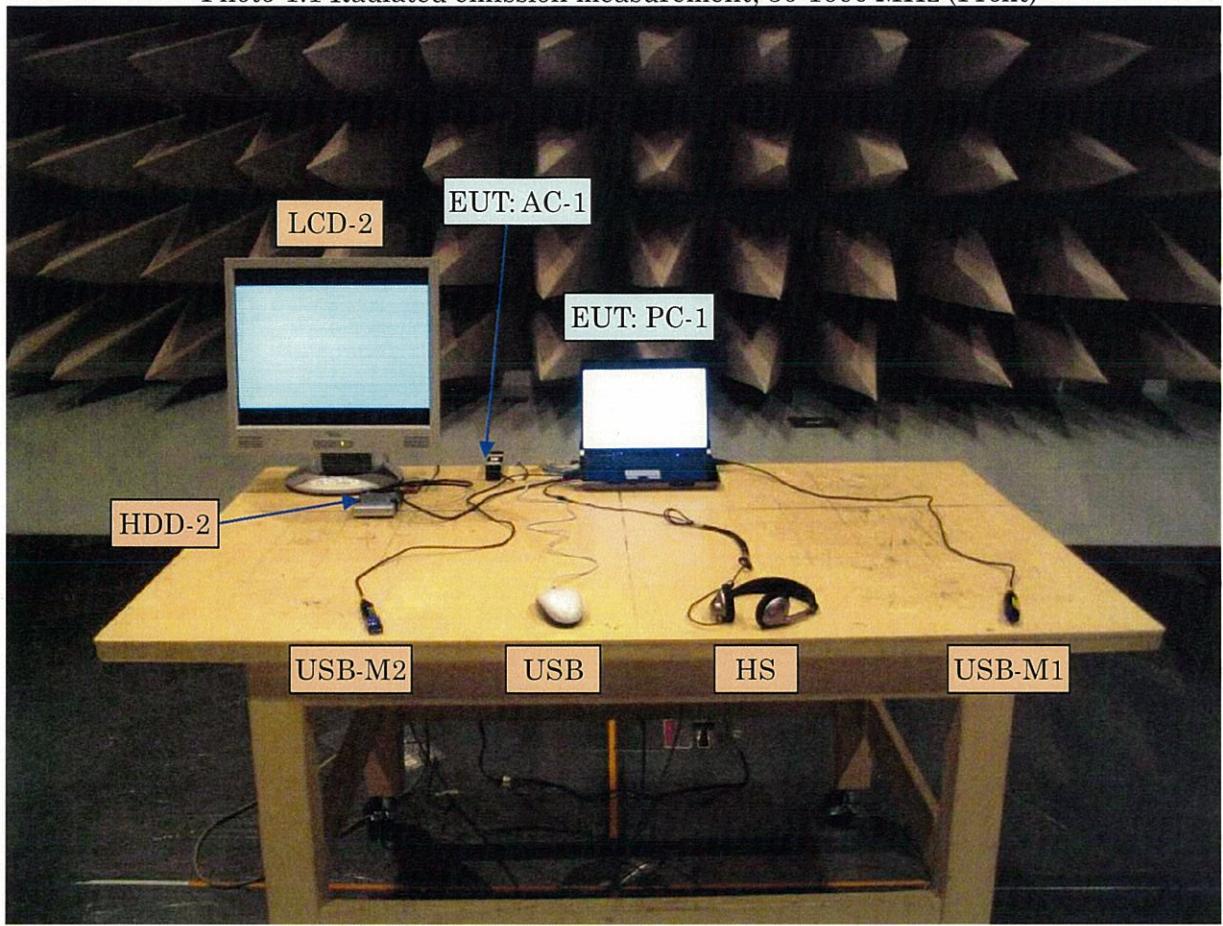
Photo-1.1 Radiated emission measurement; 30-1000 MHz (Front)

- PC-2, PC-3, HUB and TEL were set at outside of the chamber.

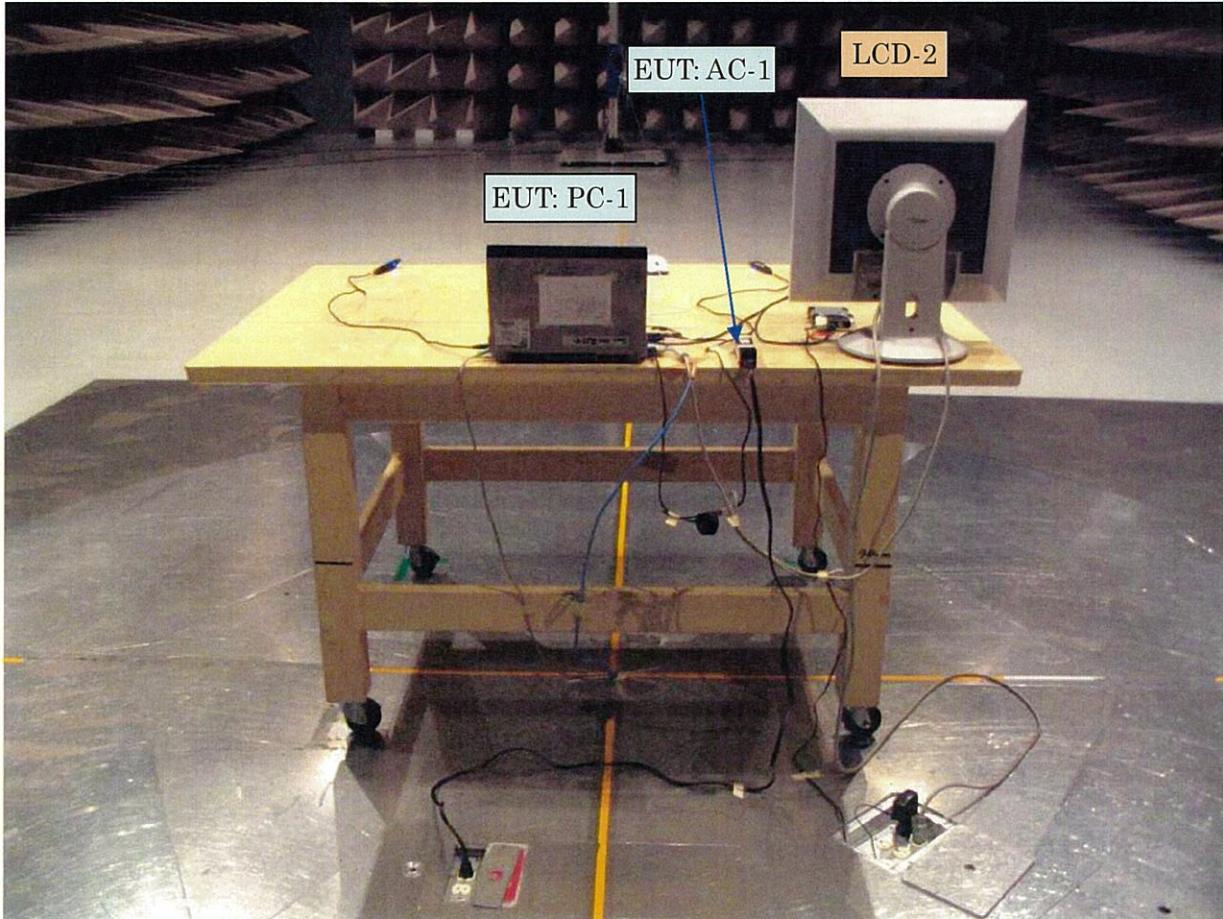
Photo-1.2 Radiated emission measurement; 30-1000 MHz (Back)

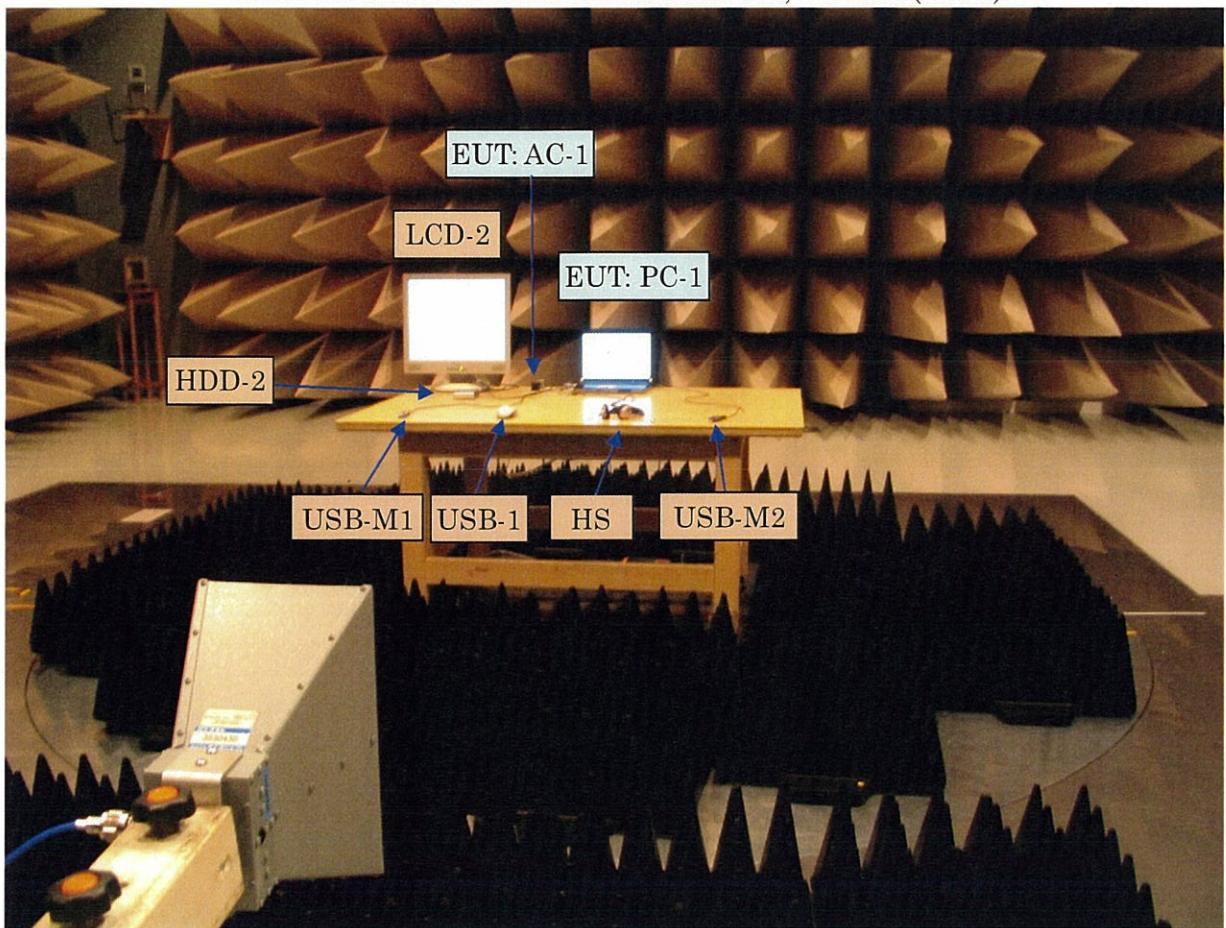
Photo-1.3 Radiated emission measurement; 1-6 GHz (Front)

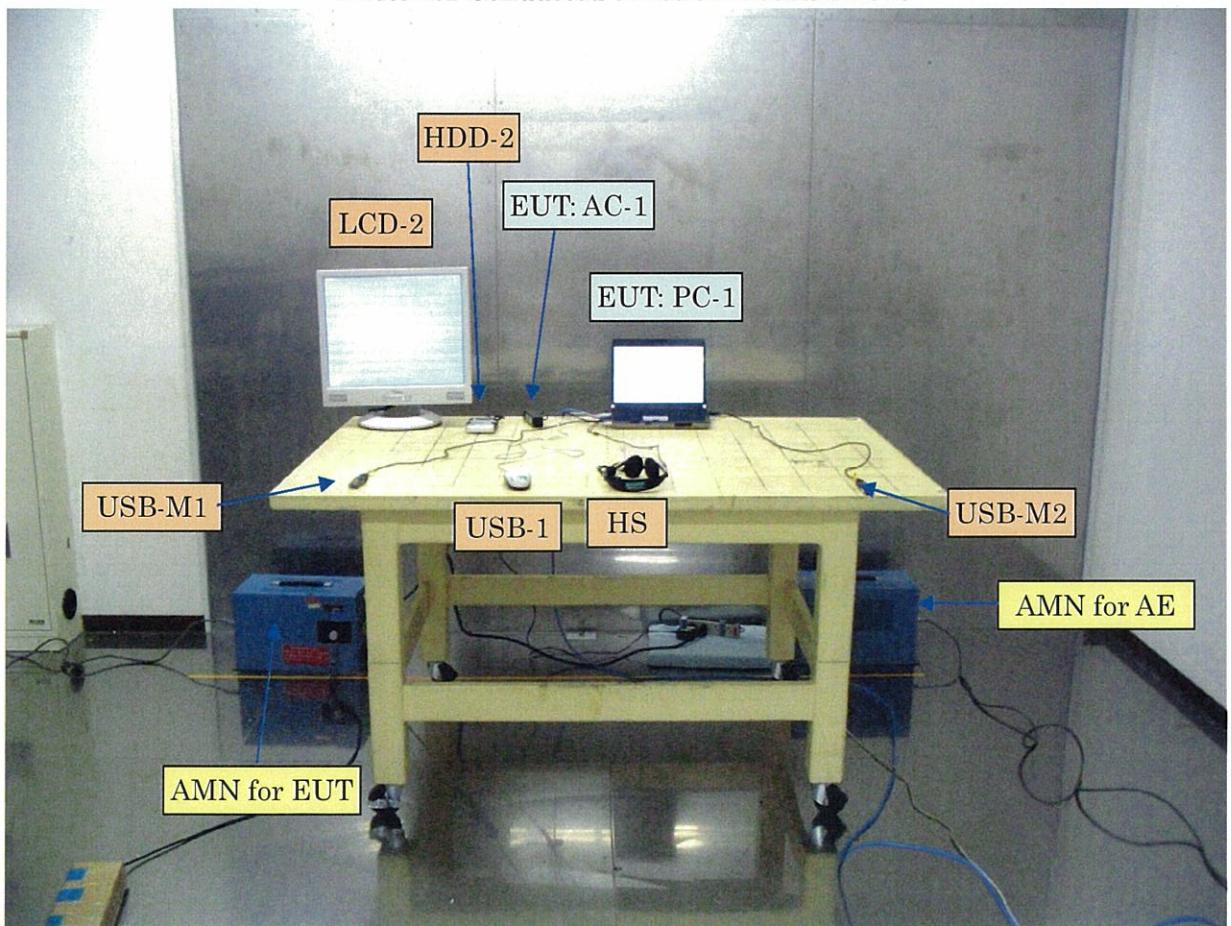
Photo-2.1 Conducted emission measurement

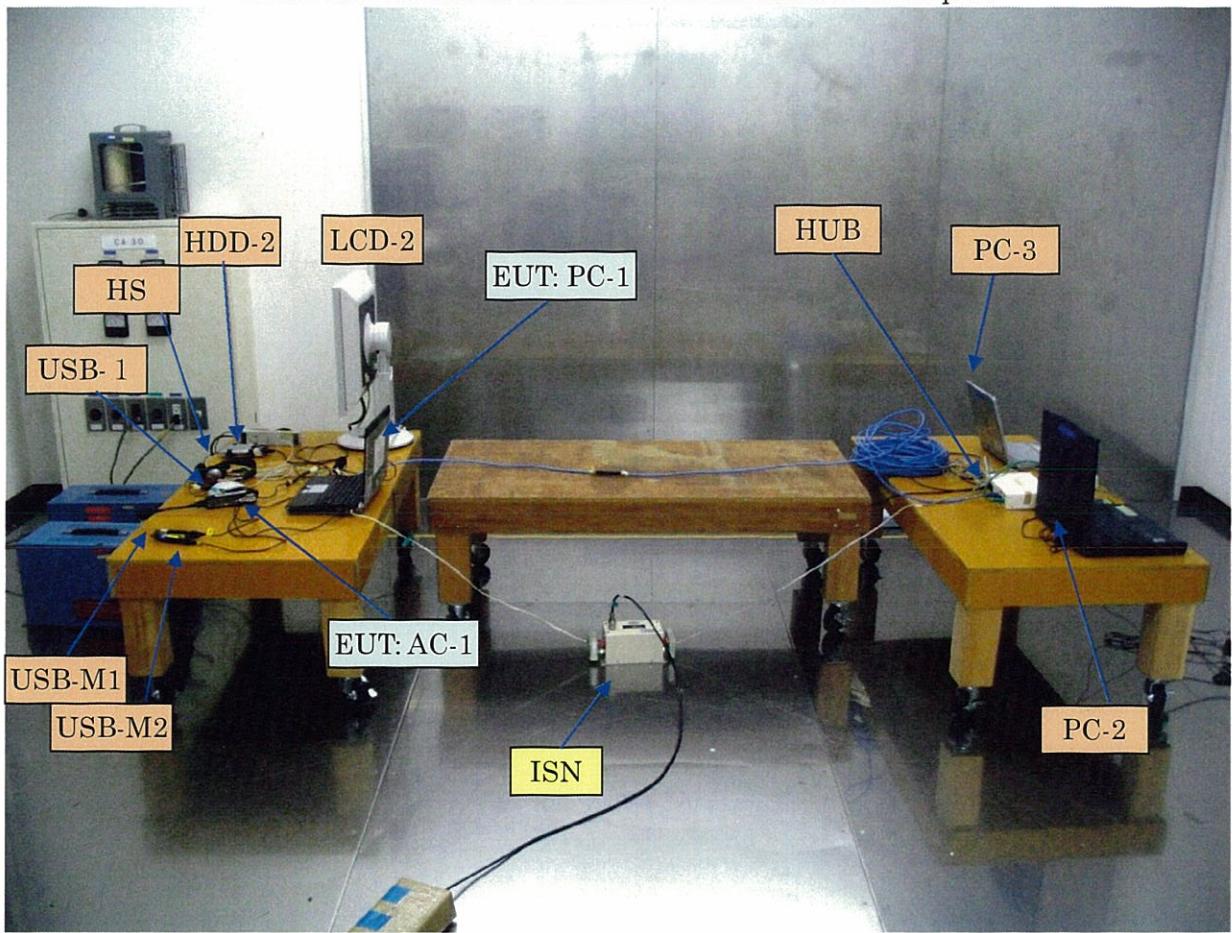
## Photo-2.2 Conducted emission measurement: Telecom port

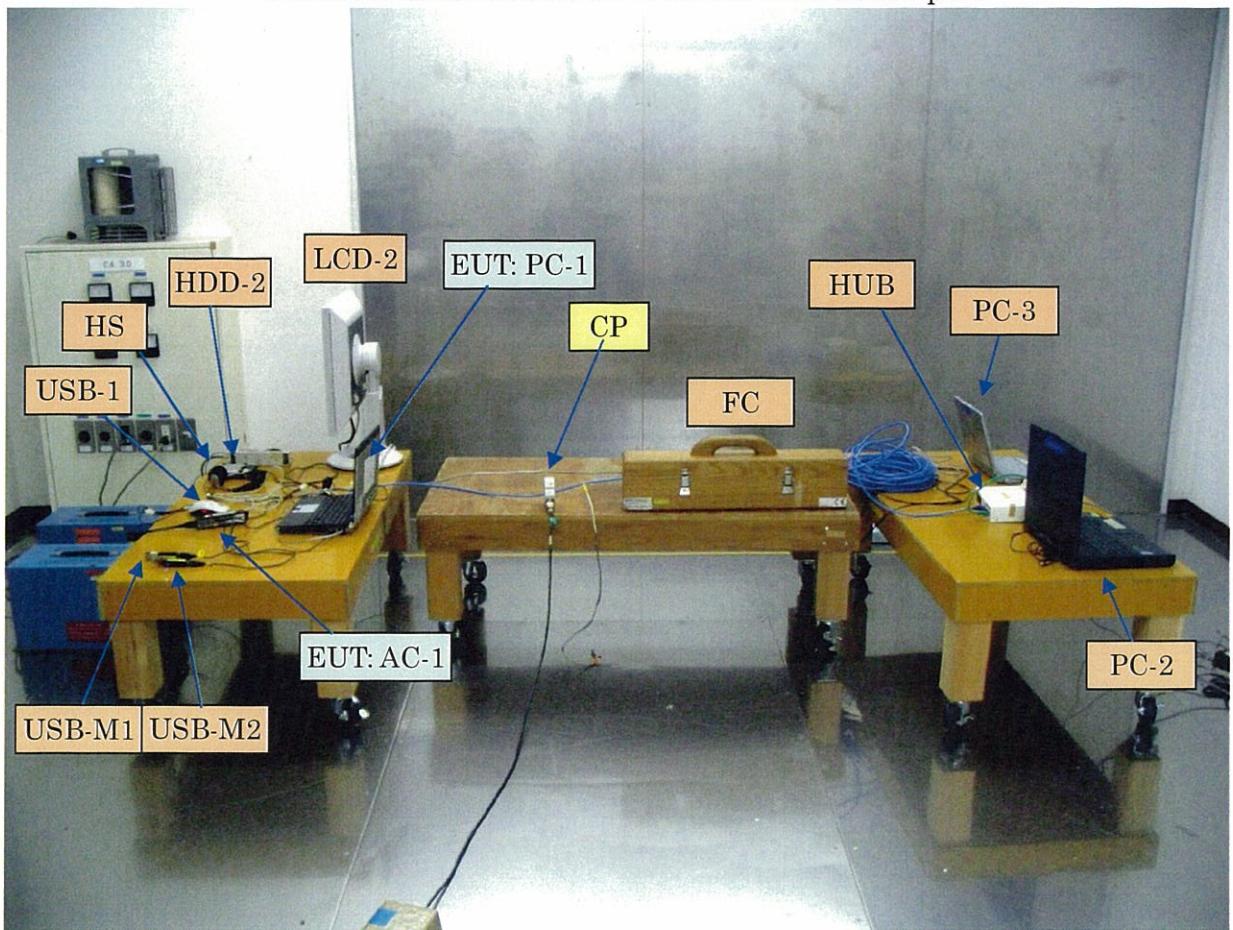
### Photo-2.3 Conducted emission measurement: LAN port

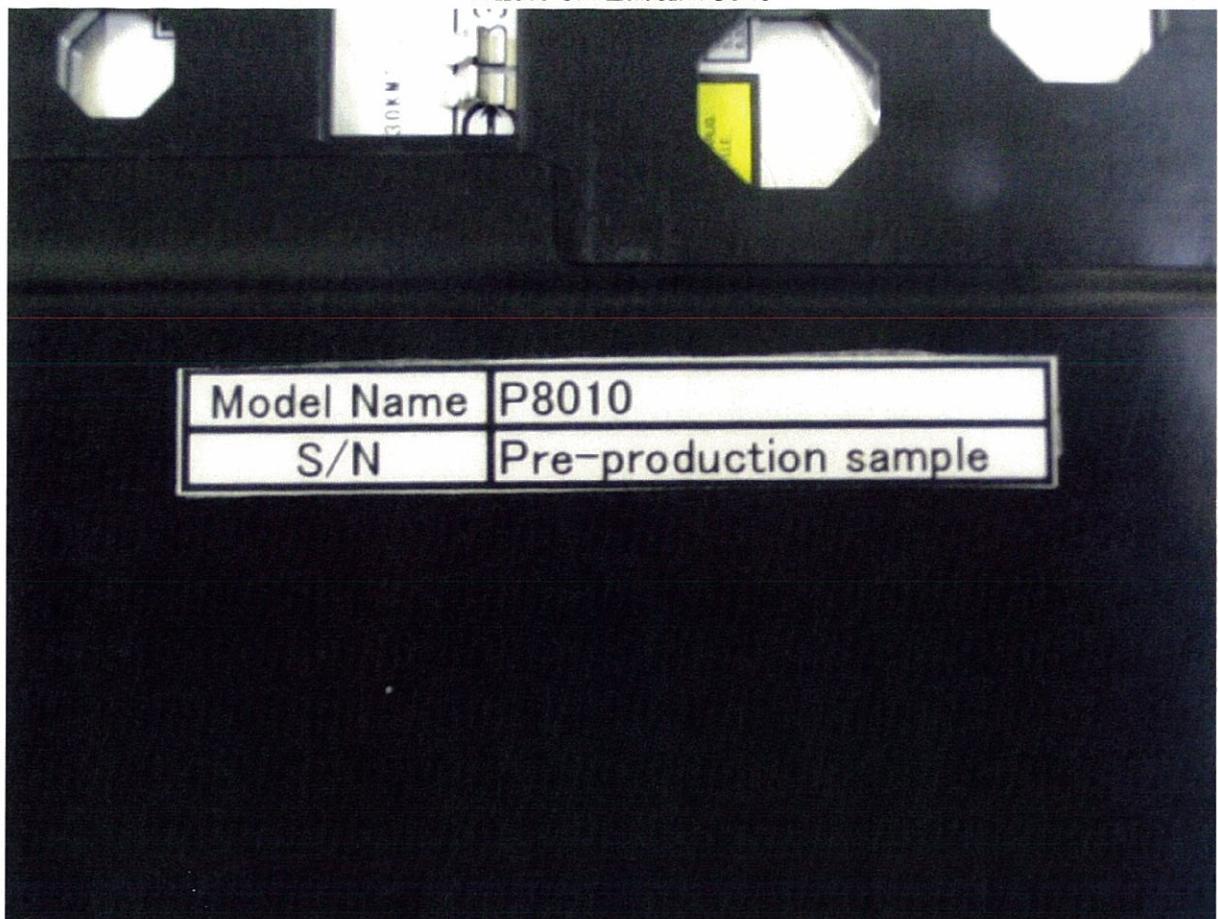
Photo-3.1 Label: P8010

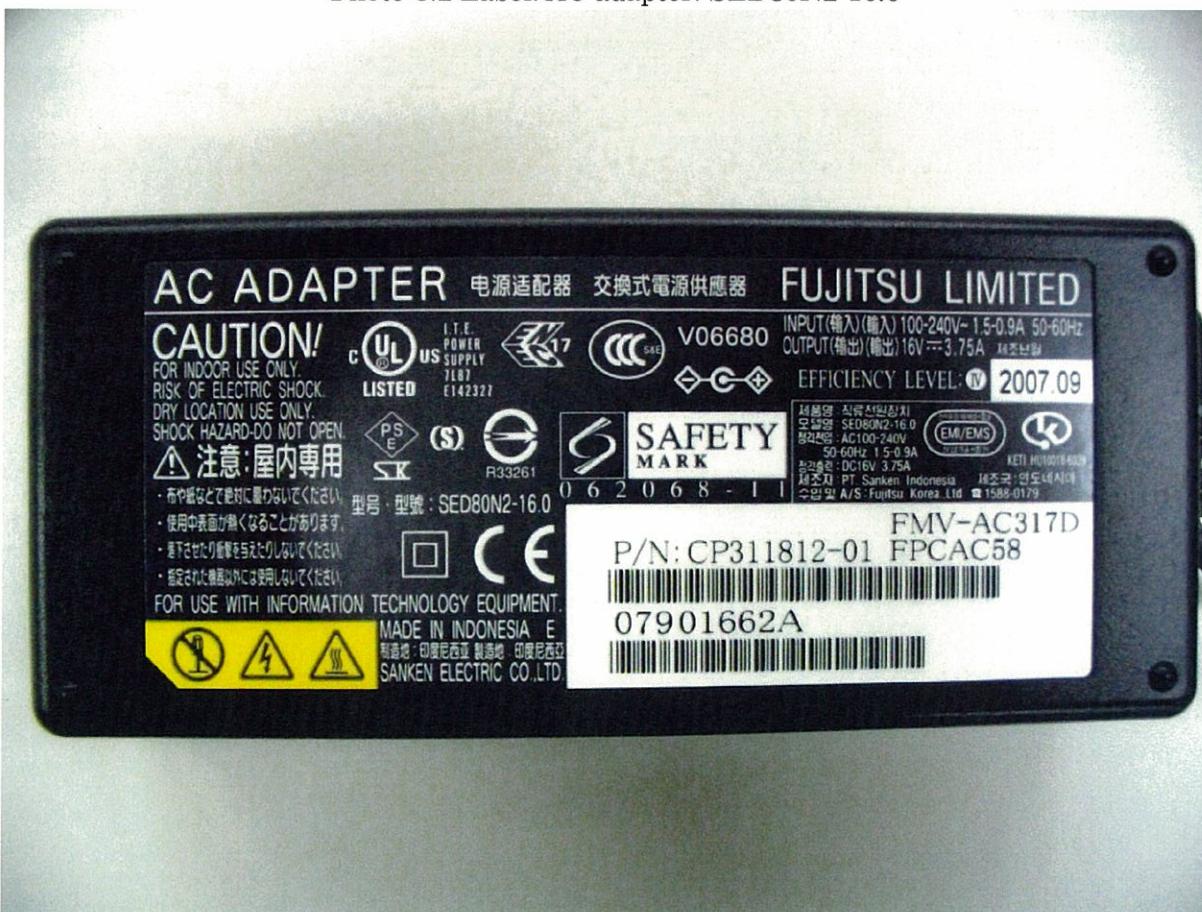
Photo-3.2 Label: AC adapter: SED80N2-16.0

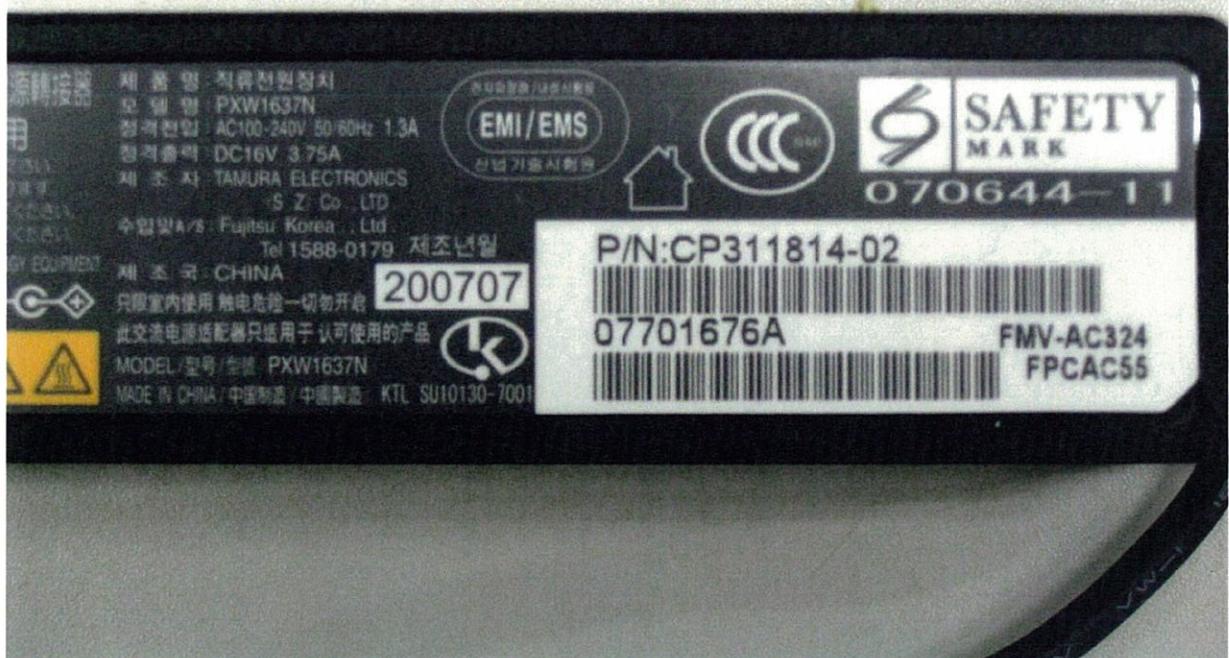
Photo-3.3 Label: AC adapter: PWX1637N

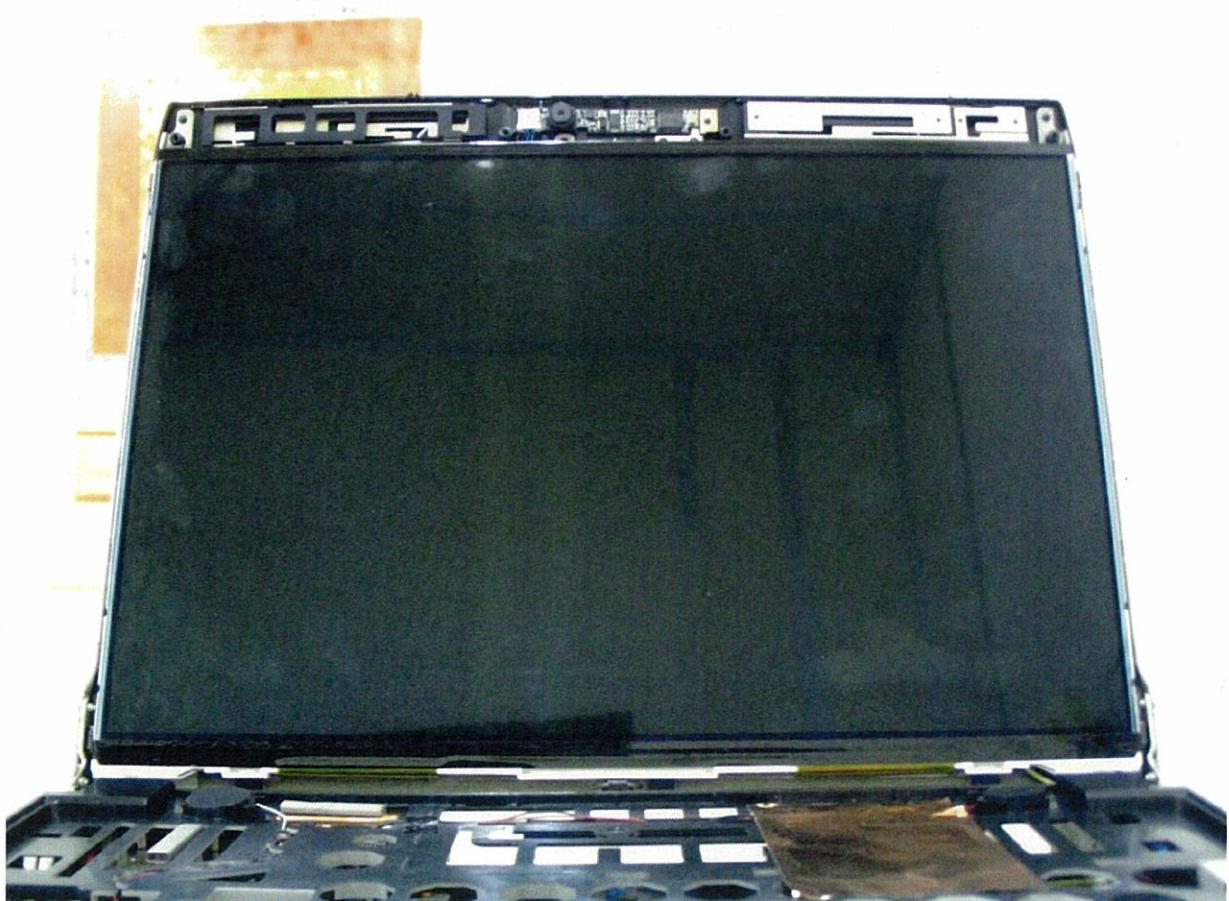
Photo-4.1 Internal view for LCD
