EMC TEST SETUP PHOTOS

MOTOROLA, INC. Portable Cellular Phone SAR Test Report Number: **20669-1F** FCC ID: **IHDT56HS1**

Appendix 7

Photographs of the device under test

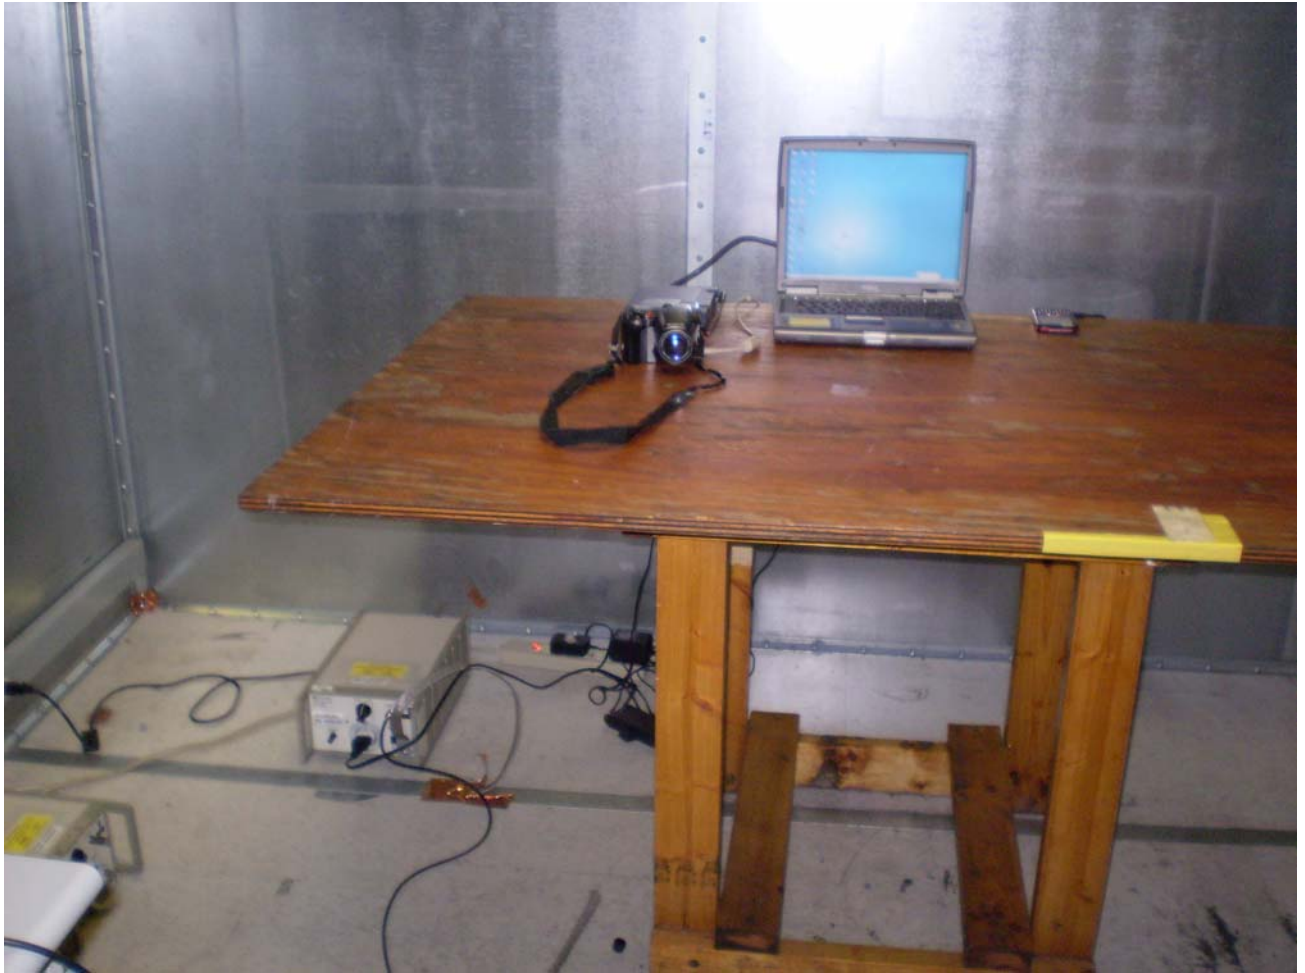
EMC Report #20700-1, AC Line - Part 15

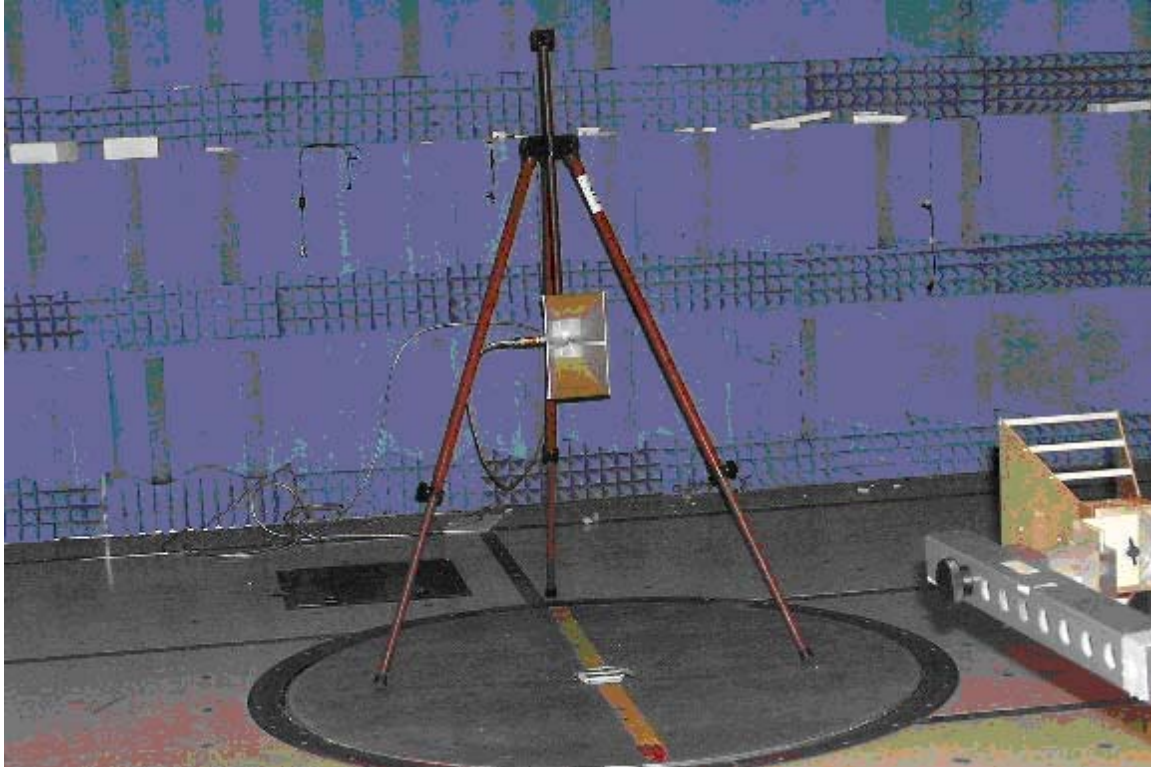
EMC Report #20700-1, Antenna - Substitution

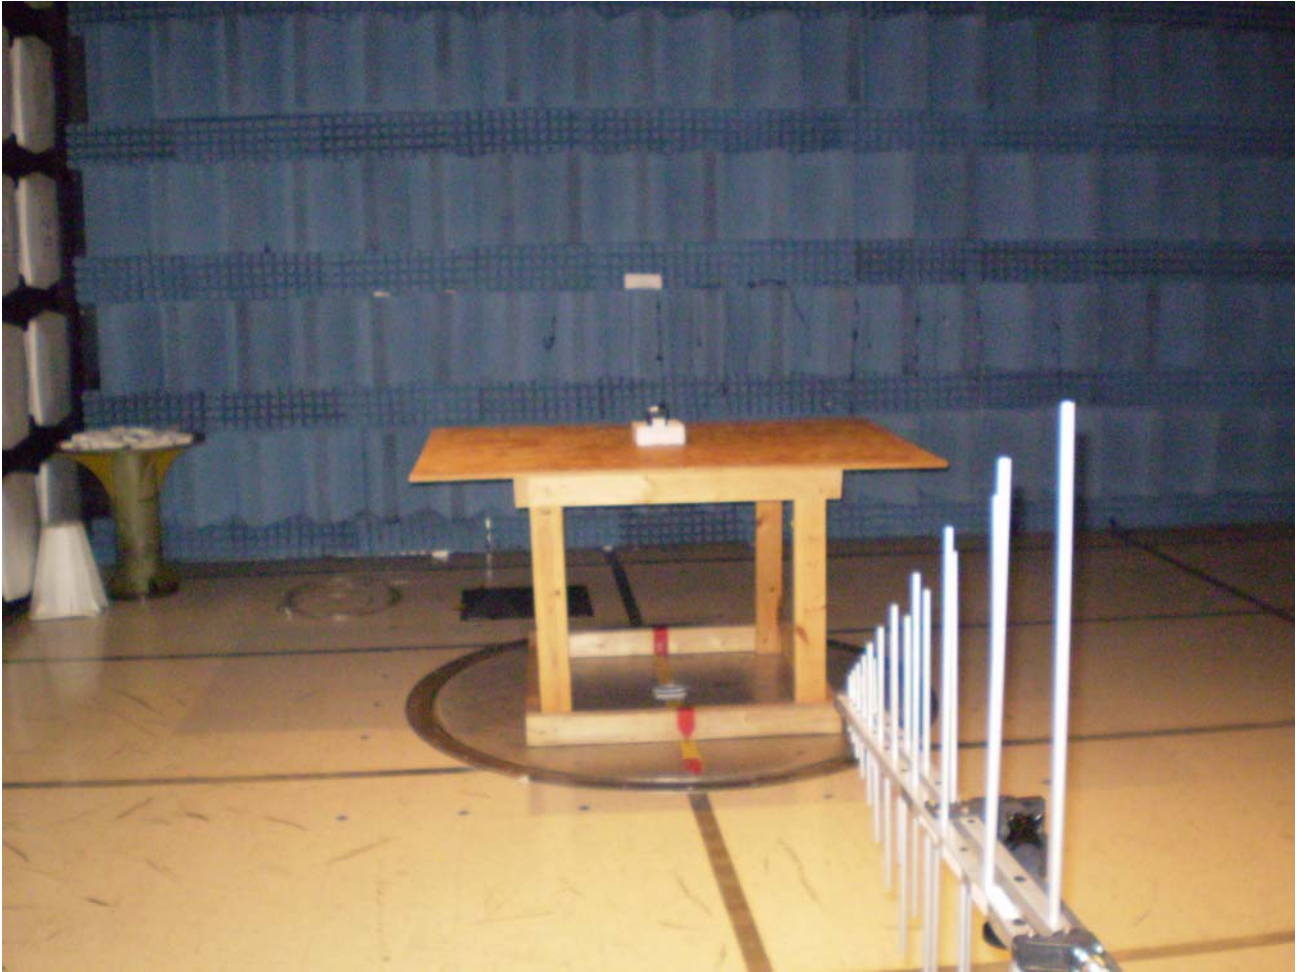
EMC Report #20700-1, Tx Radiated

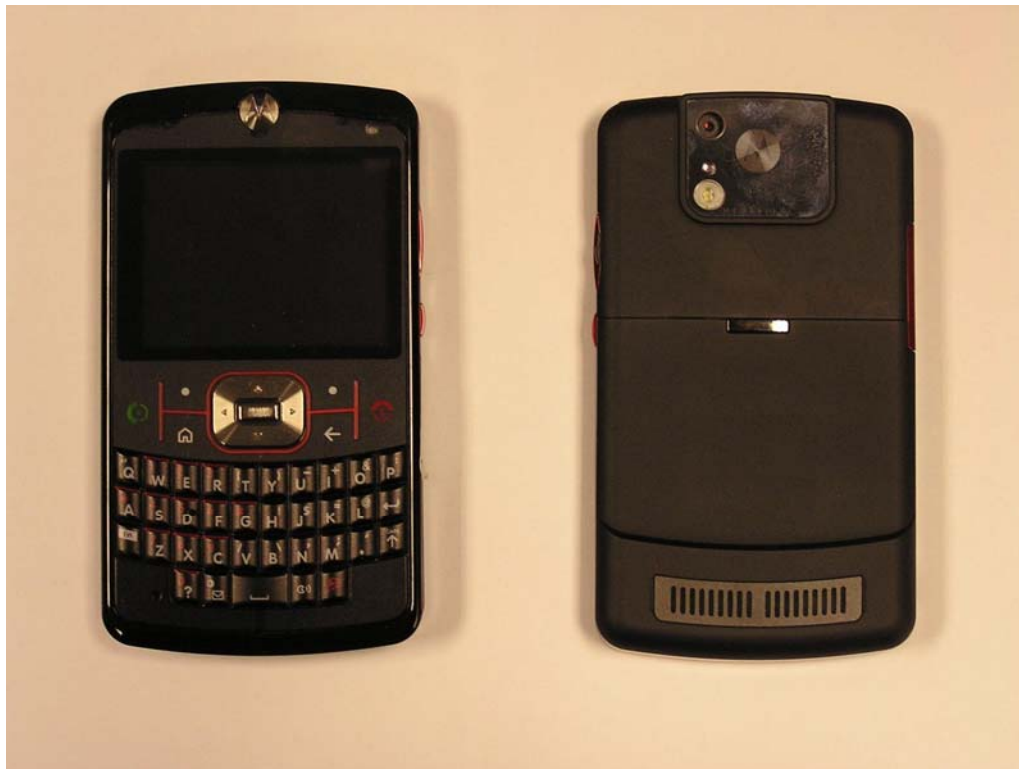
Figure 1 – Front and Back of Transceiver

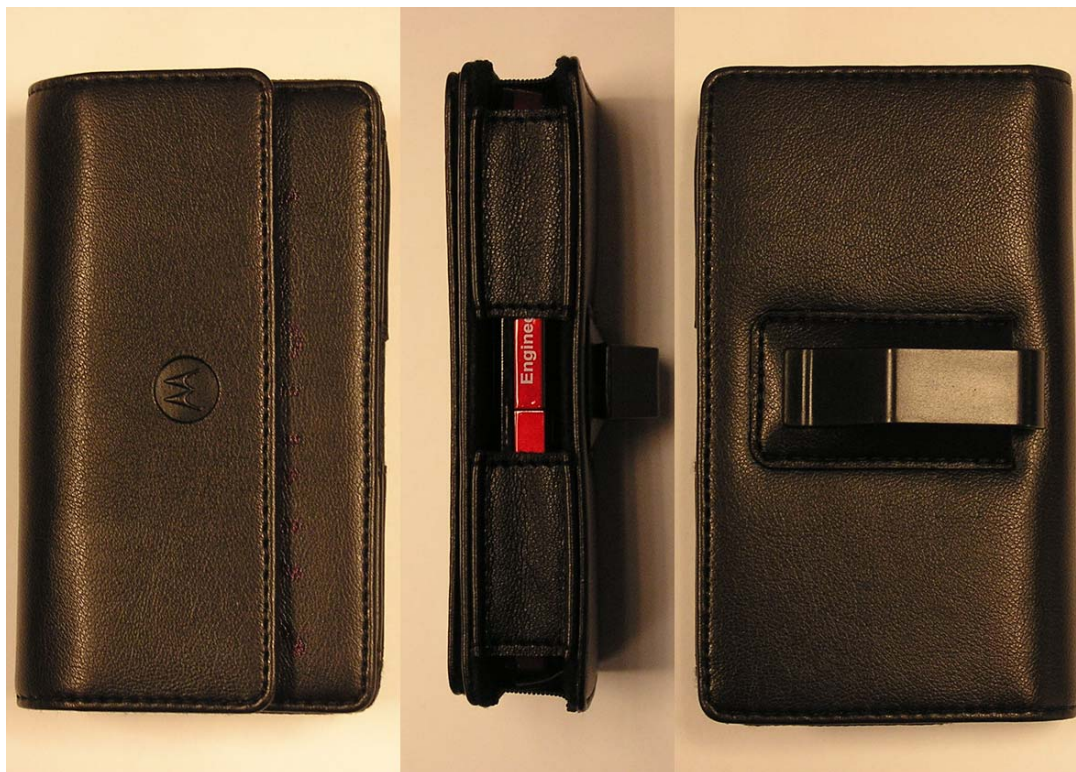
Figure 2 – Transceiver with Leather Pouch SYN1985A

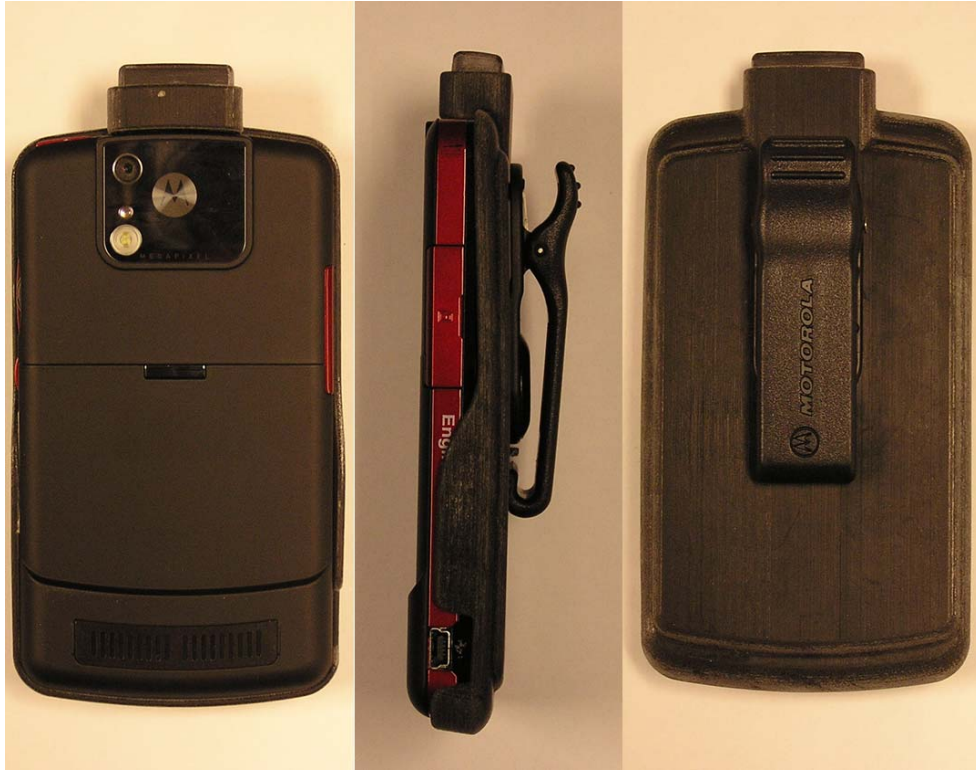
Figure 3 – Transceiver with Plastic Clip SYN2087A

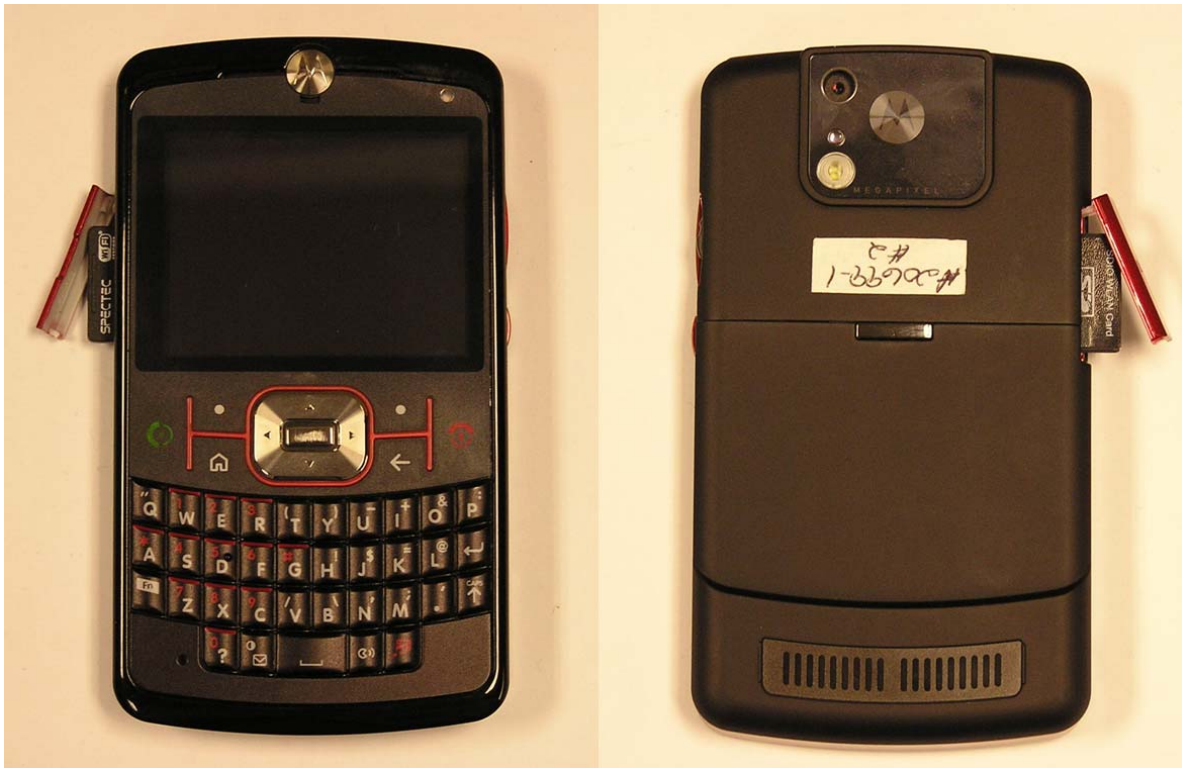
Figure 4 – Transceiver with SDIO Wi-Fi Card

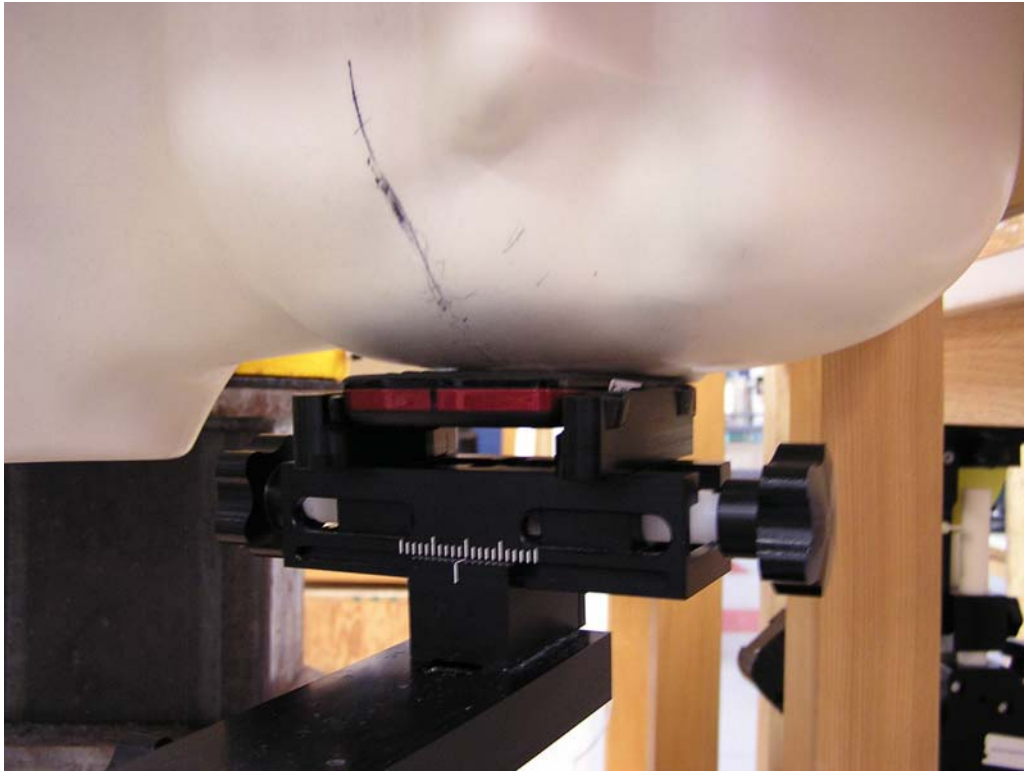
Figure 5 – Transceiver against head, Cheek Touch position

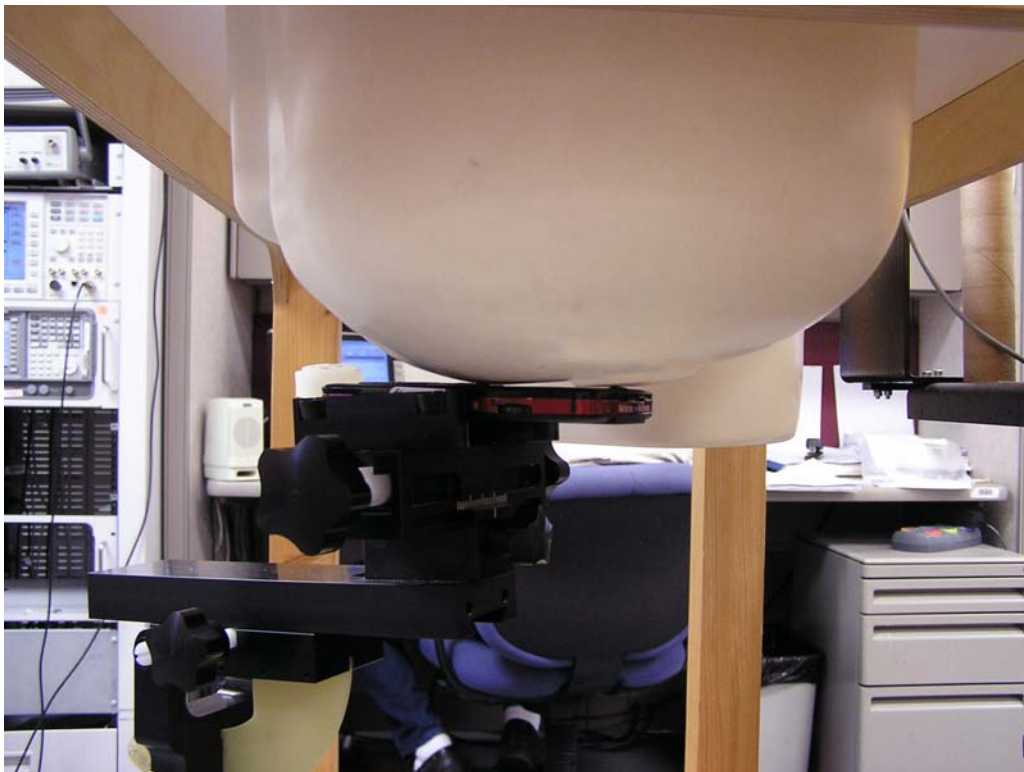
Figure 6 – Transceiver against head, Cheek Touch position

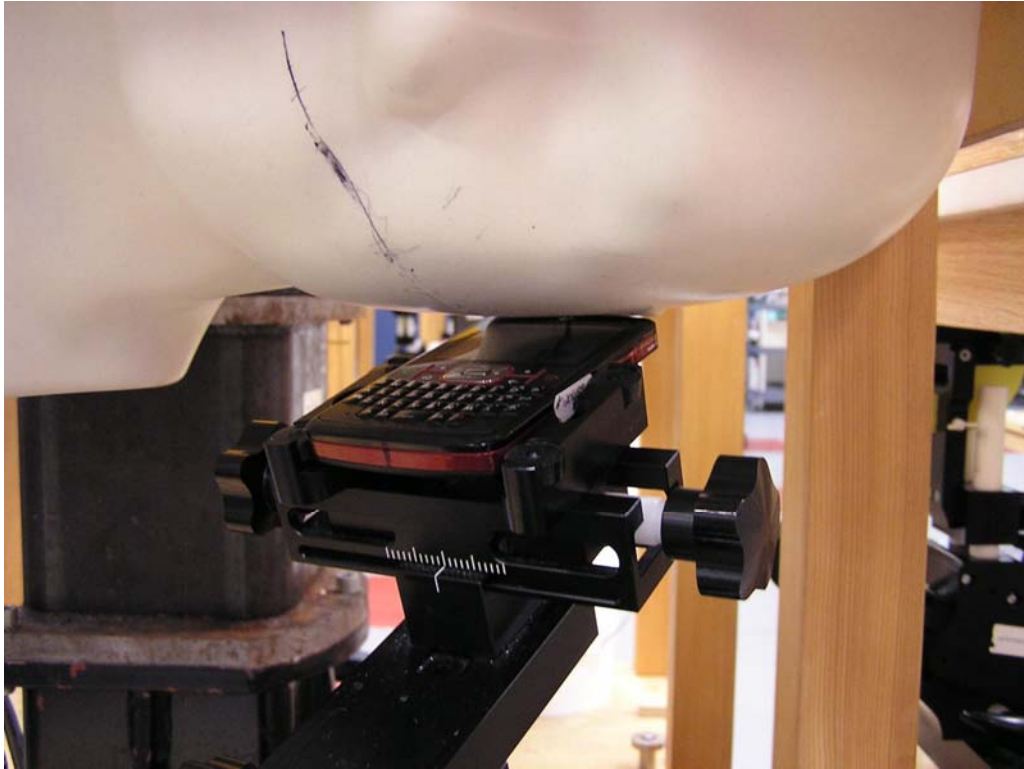
Figure 7 – Transceiver against head, 15° Tilt position

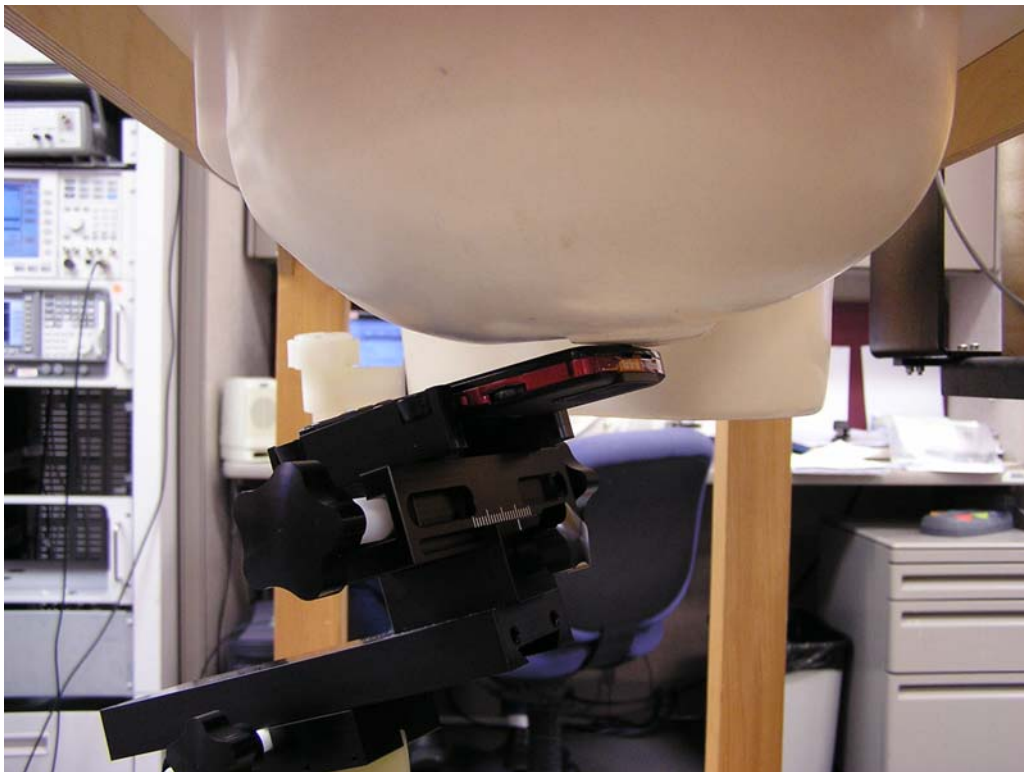
Figure 8 – Transceiver against head, 15° Tilt position

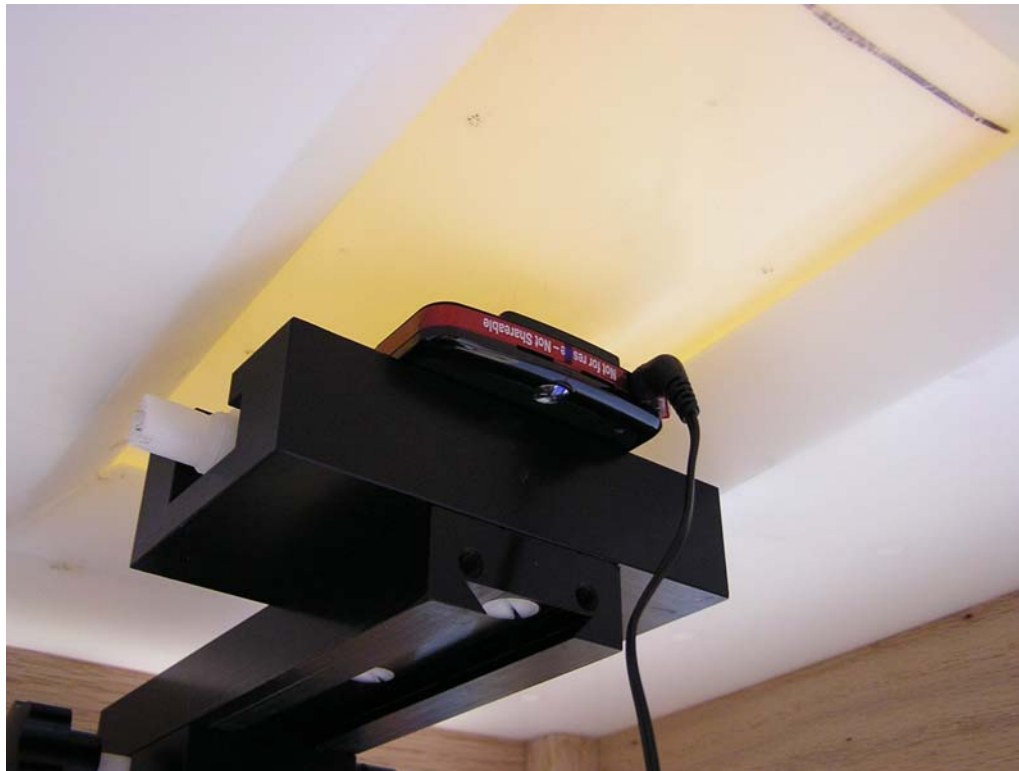
Figure 9 – Transceiver against body, Back of Phone 15 mm from Phantom position

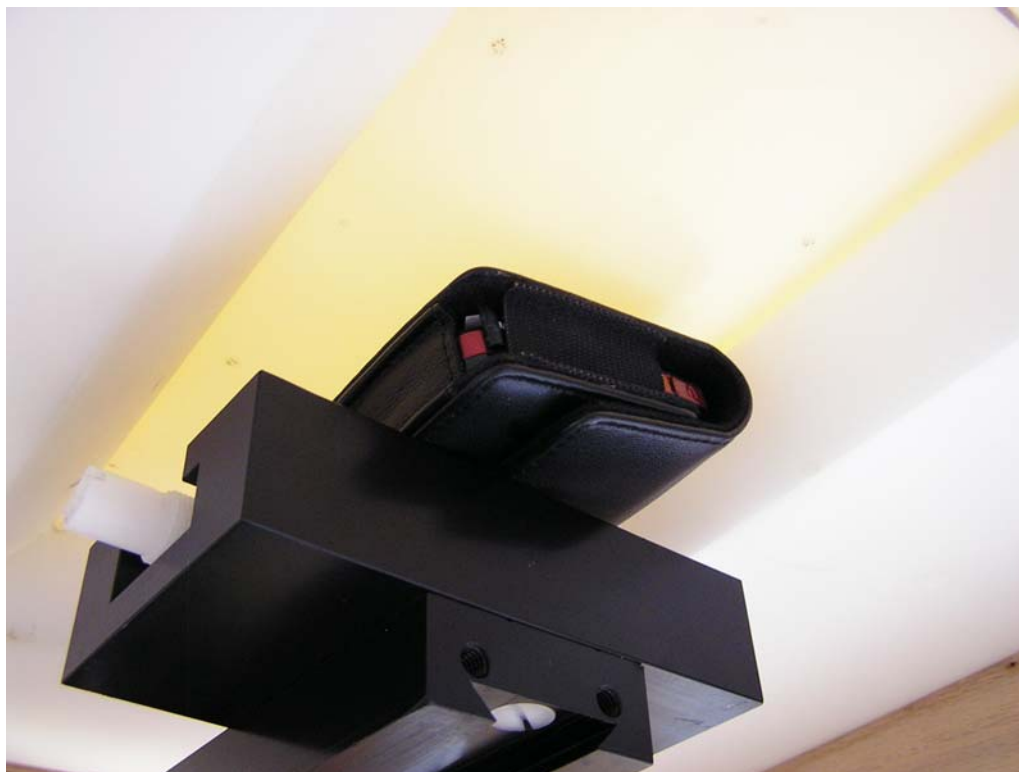
Figure 10 – Transceiver against body with Leather Pouch SYN1985A

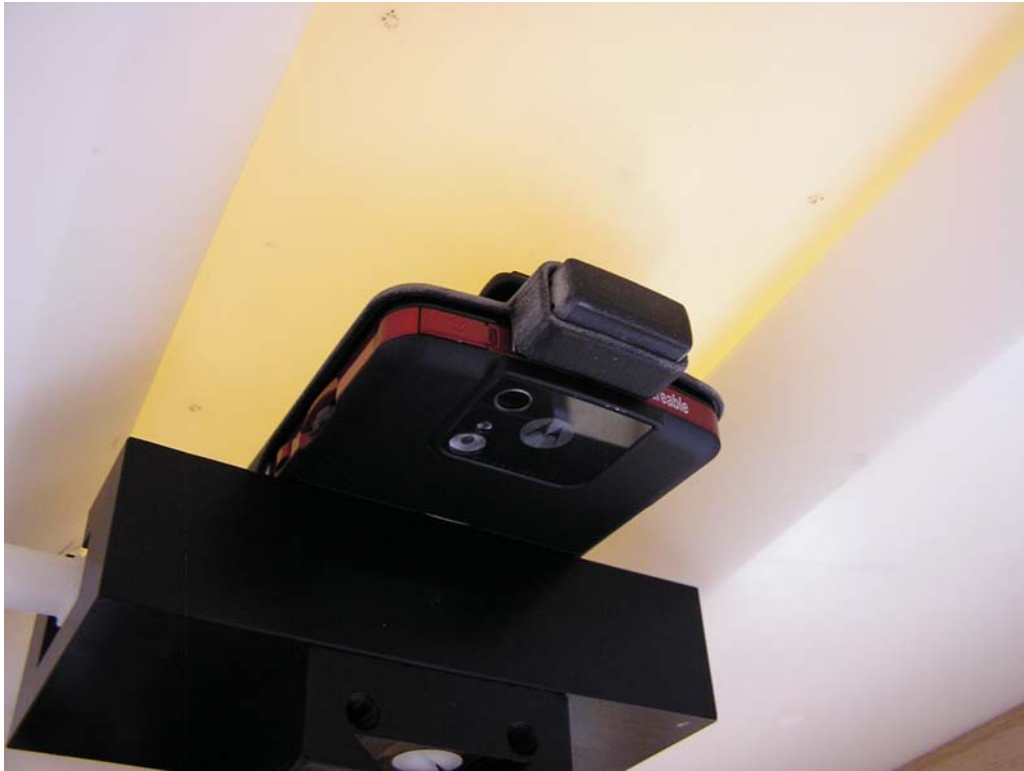
Figure 11 – Transceiver against body with Plastic Clip SYN2087A

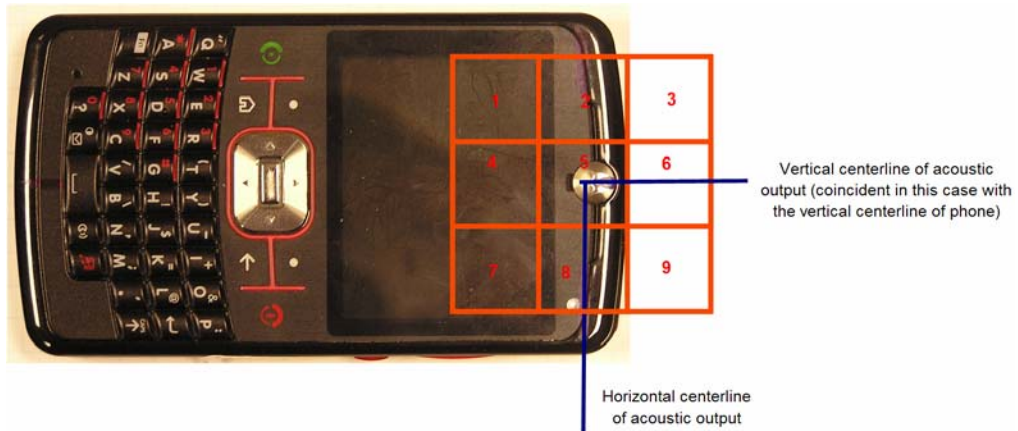
Figure A5-1. Phone Open - Orientation of Wireless Device and Measurement Plane

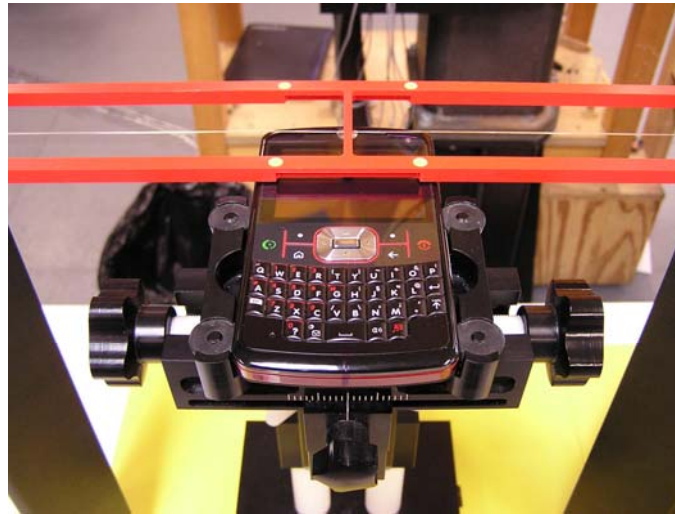
Figure A5-2. Views from the front

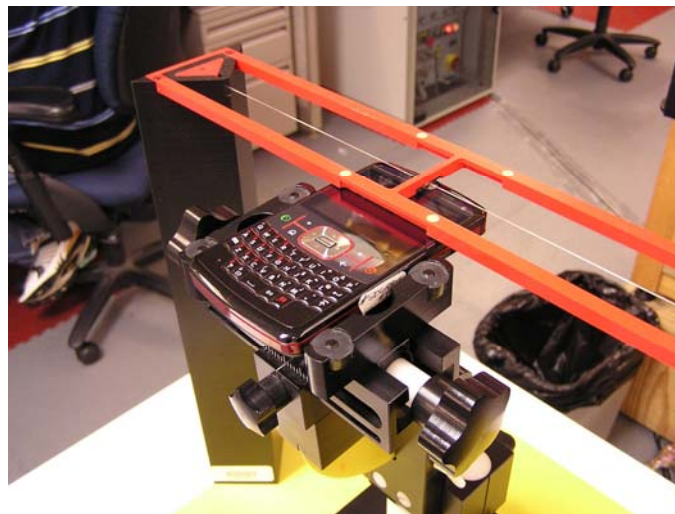
Figure A5-3. Views from the side
