Radio Approval Testing of the  
McMurdo Limited  
SmartFind S5 AIS SART  
In accordance with IEC 61097-14 and IEC 60945

Document 75907213 Report 02 Issue 3

May 2010

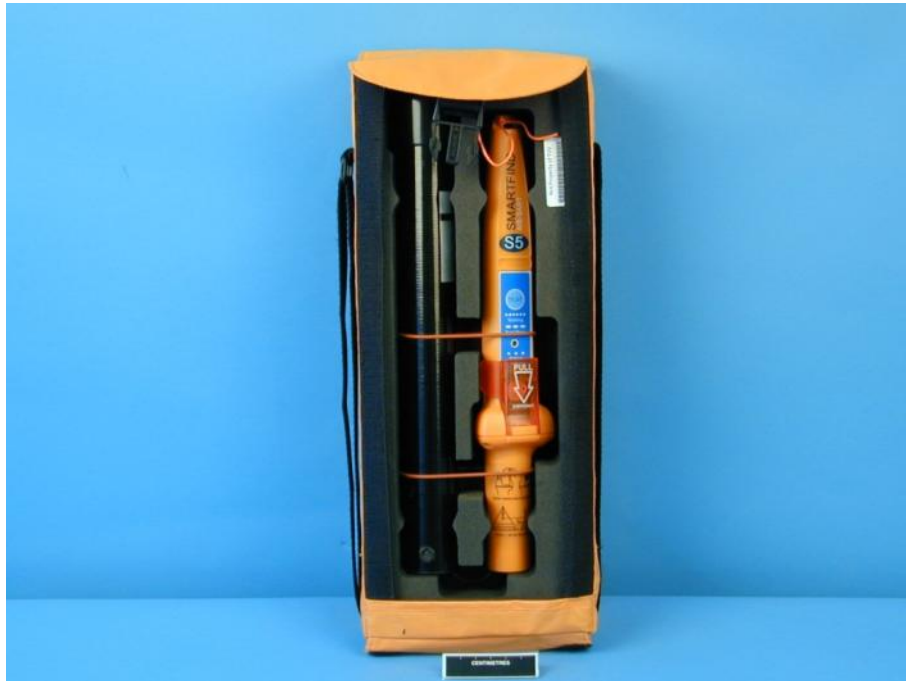
The Equipment Under Test (EUT) was a McMurdo Limited SmartFind S5 AIS SART as shown in the photograph below. A full technical description can be found in the manufacturer's documentation.

Equipment Under Test

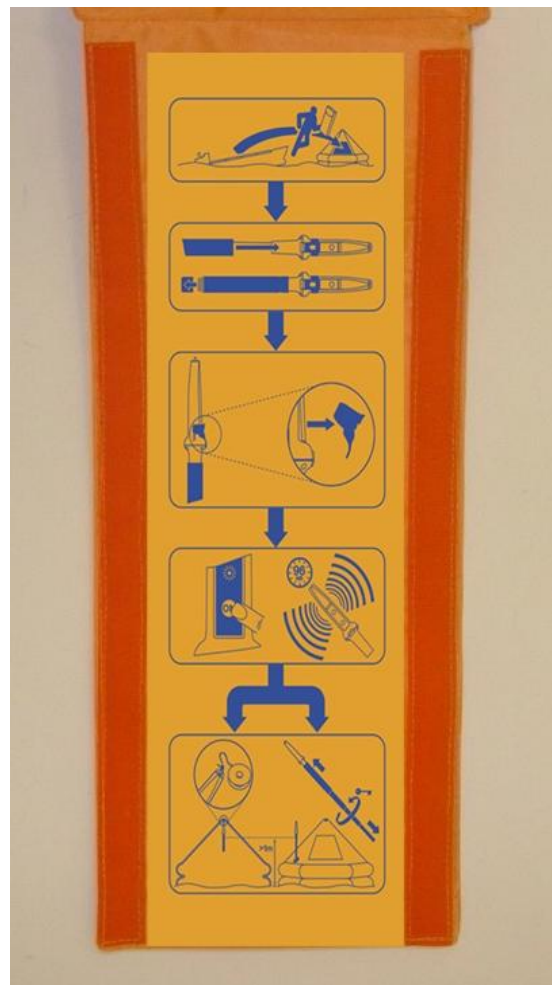
The SmartFind S5 AIS SART is equipped with a blue label which indicates the position of the ON button: this switch is set behind the tamperproof device which provides a means to prevent inadvertent activation. There are additional diagram labels which are located on the lower section of the AIS-SART which depict the removal of the tamper proof device and the pressing of the ON button. Additional diagrams are provided for the installation of the mounting pole; along with installation instructions printed on the inside of the carry bag. Additional instructions are provided in the operator's manual supplied with the product.

SmartFind S5 AIS SART labels depicting activation and installation

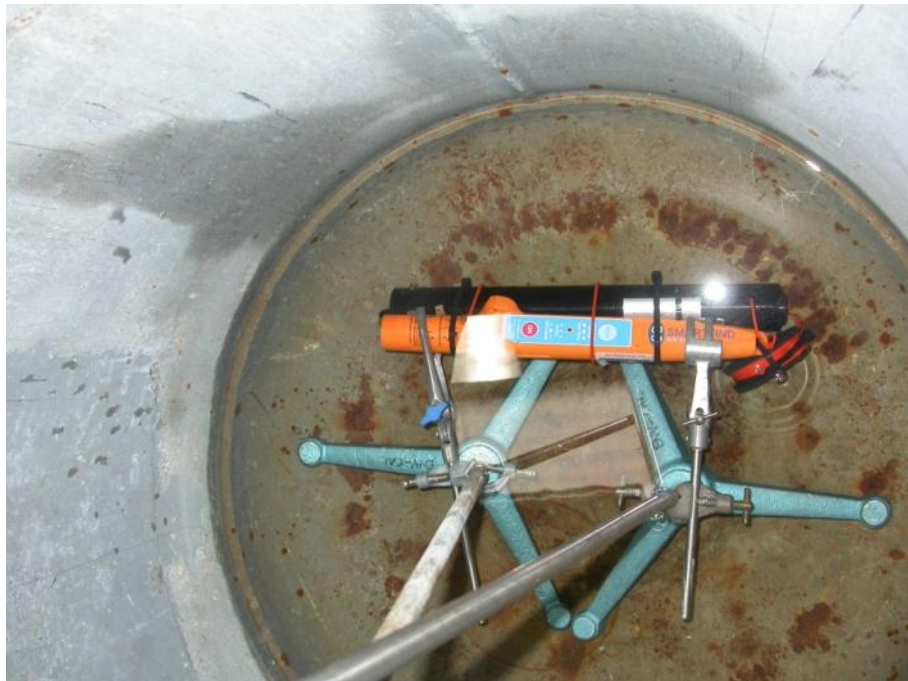
The test was performed with the EUT in the following mode(s): Idle. The EUT was tested stand alone i.e. not enclosed in the storage bag as supplied by the manufacturer.

Test Set-up – Water Immersion

With the EUT in the idle state the pressure of the vessel was raised to 1.0 bar (g); this condition was maintained for 5 minutes, after which the pressure vessel was returned to laboratory ambient.

The EUT was subject to a visual inspection: no signs of water ingress were noted.

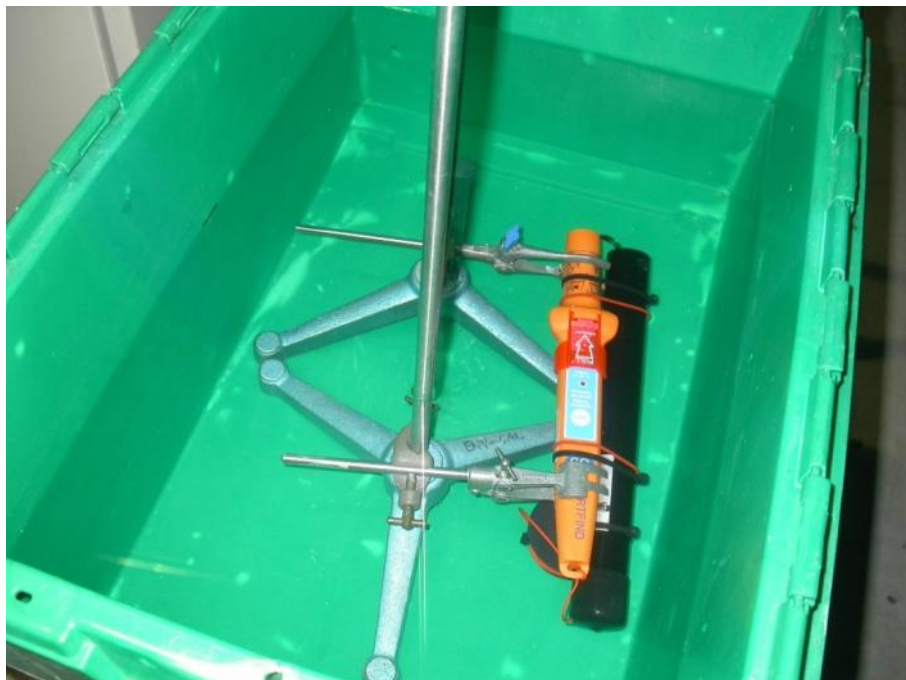
The test was performed with the EUT in the following mode(s): Idle. The EUT was tested stand alone i.e. not enclosed in the storage bag as supplied by the manufacturer.

Test Set-up

The chamber conditions were maintained for 1 hour after which time the EUT was immersed in water at 24.9°C to a depth of 100mm from the highest point of the EUT to the surface of the water.

The EUT was subject to a visual inspection: no signs of water ingress were noted.

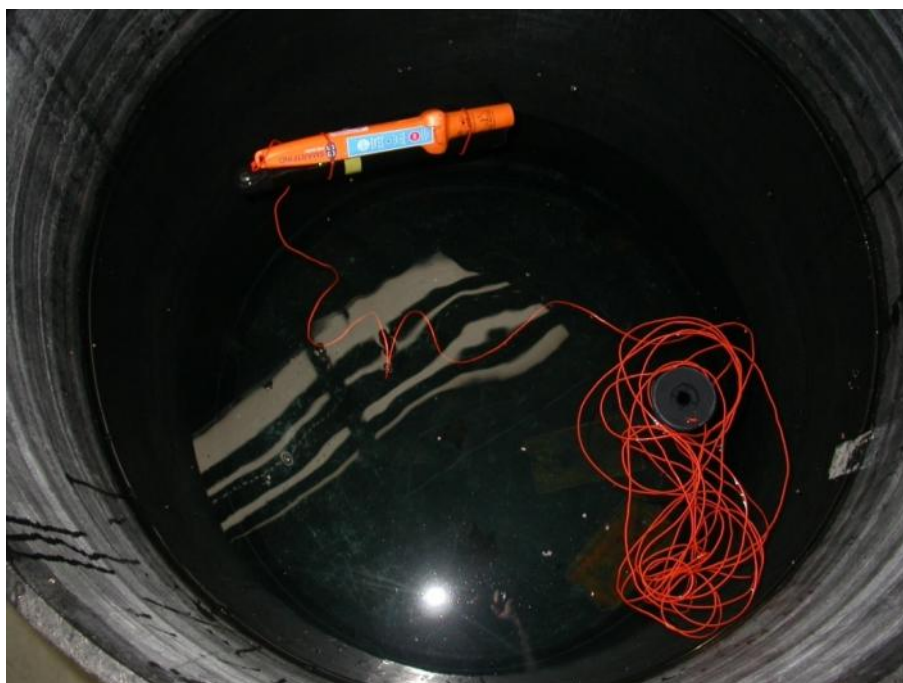
The test was performed with the EUT in the following mode(s): Idle. The EUT was tested with the mounting pole attached but not installed. The EUT was not enclosed in the storage bag as supplied by the manufacturer.

Test Set-up

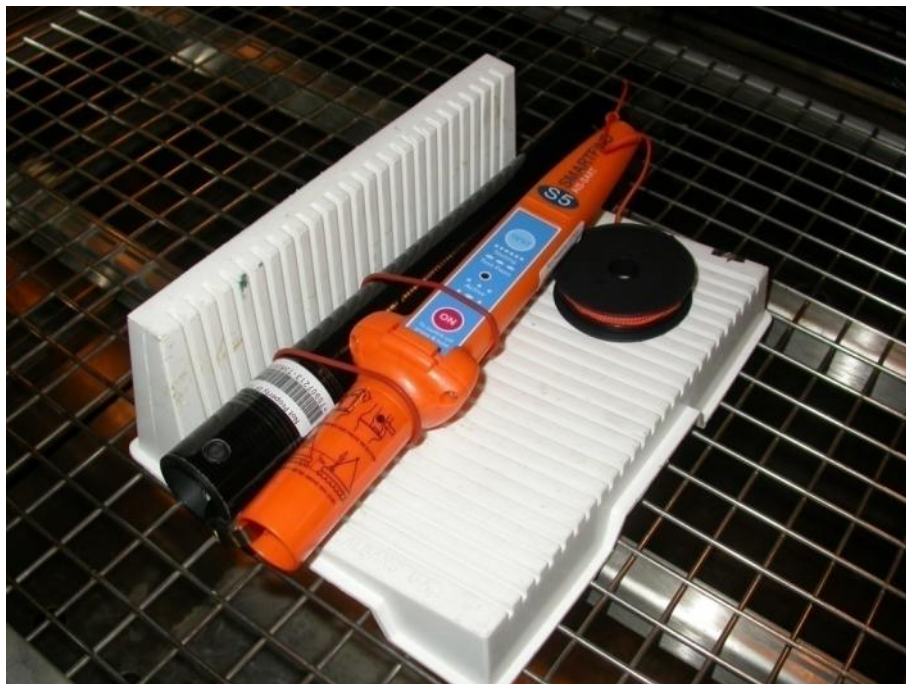
The test was performed with the EUT in the following mode(s): Idle. The EUT was tested stand alone i.e. not enclosed in the storage bag as supplied by the manufacturer.

Test Set-up – Dry Heat

The EUT was placed in the environmental chamber at laboratory ambient conditions. The temperature was then raised and maintained at +70°C for a period of approximately 13.5 hours after which time a performance check was carried out. The temperature of the chamber was then returned to laboratory ambient conditions after which time another performance check was carried out.

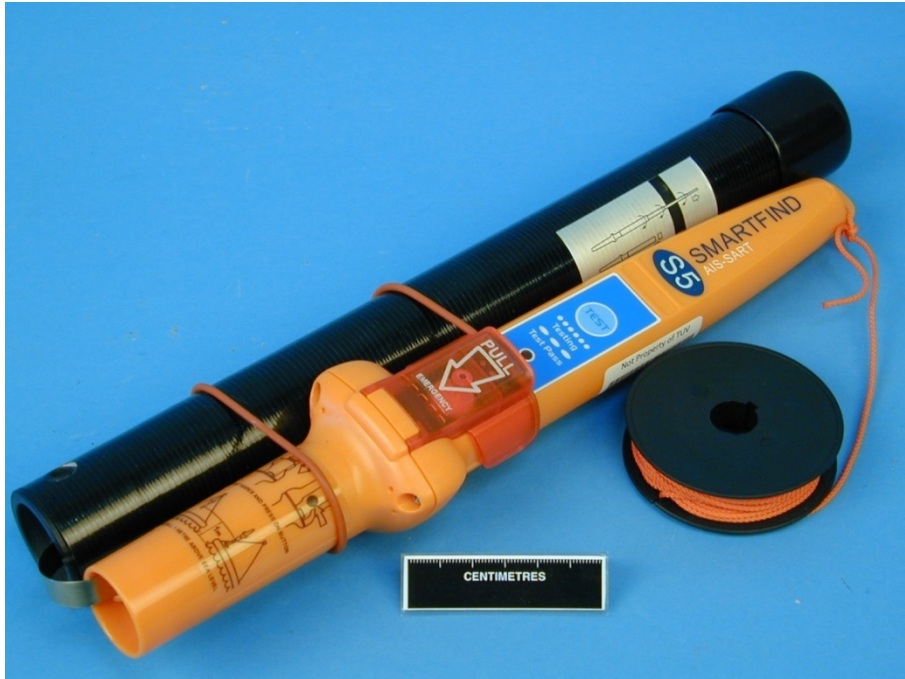
SmartFind S5 AIS SART
