FCC ID: L64A00105

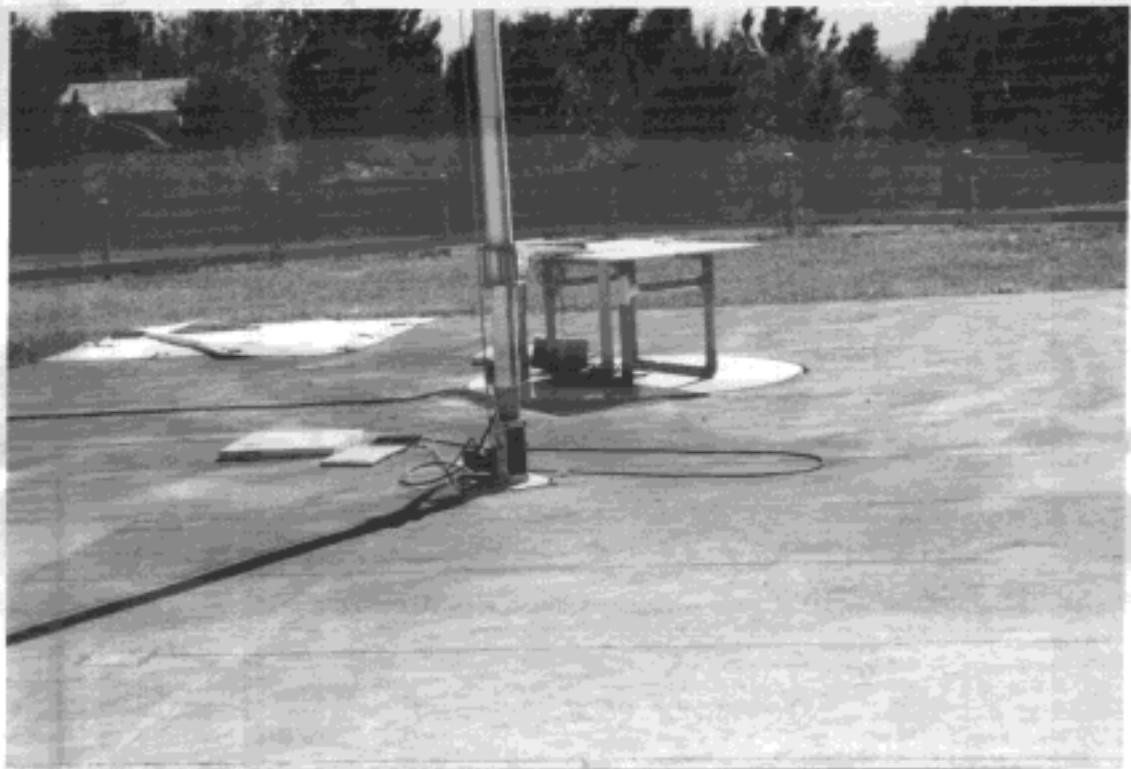
Photo 1
Radiated Emissions Overall Front View

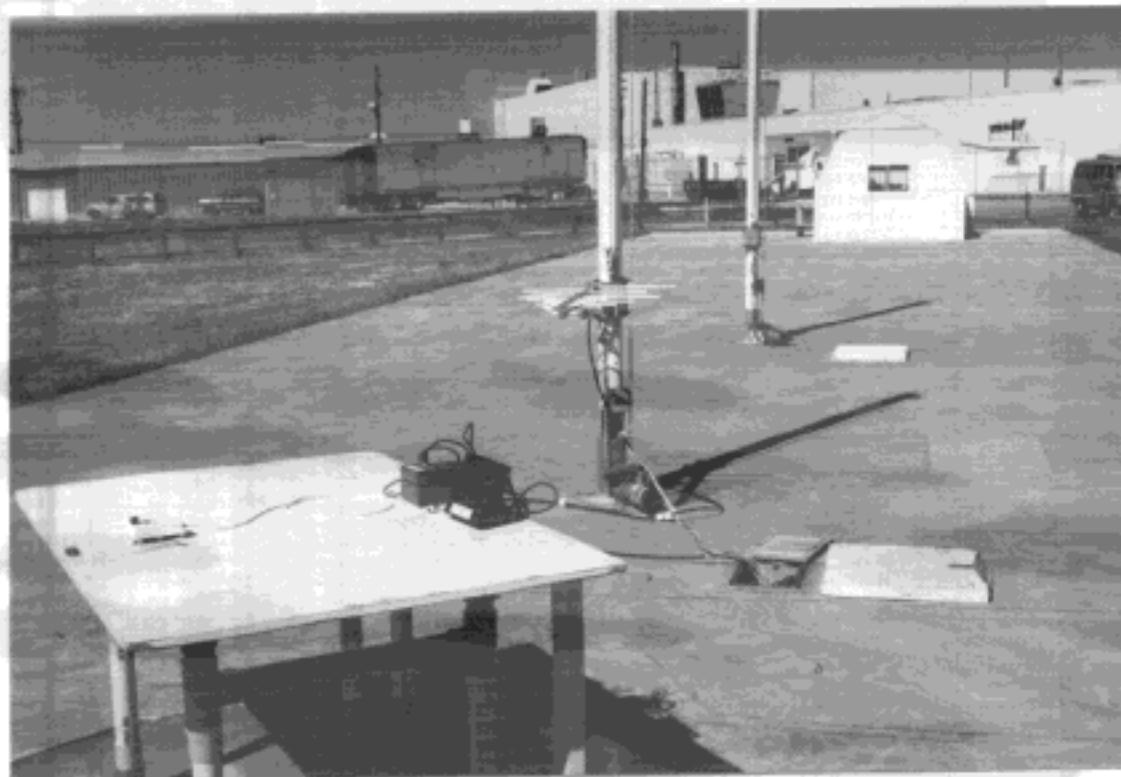
Photo 2
Radiated Emissions Overall Rear View

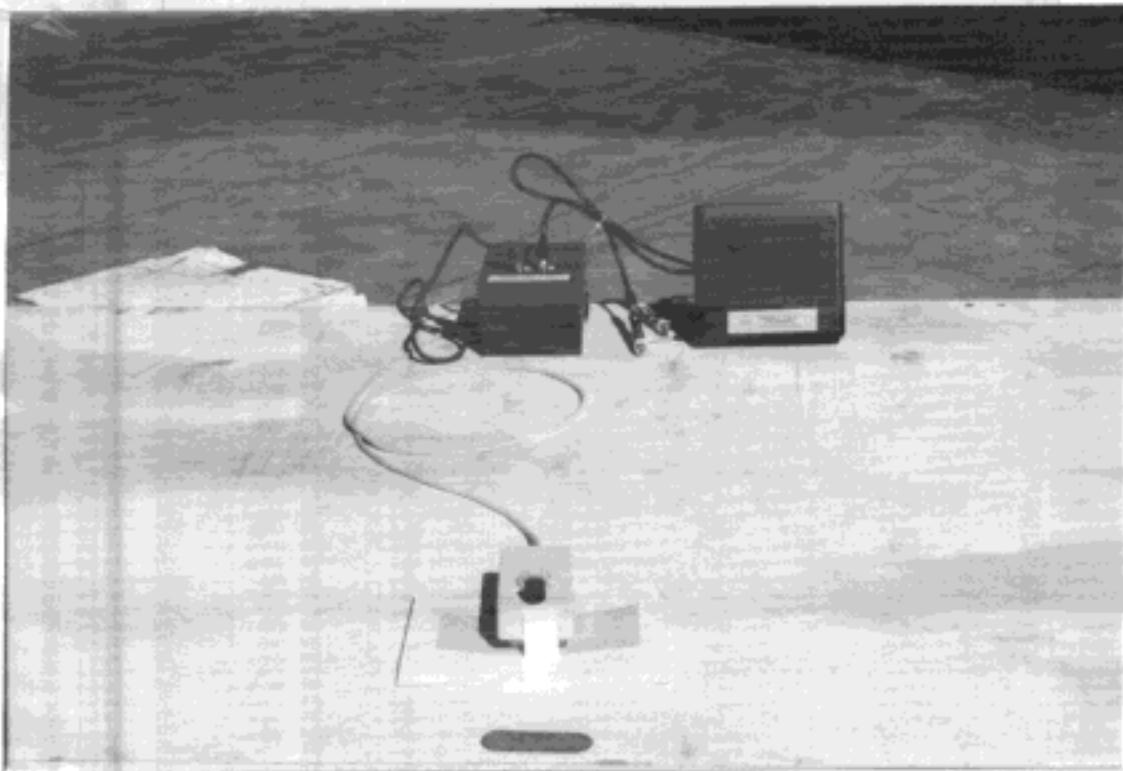
Photograph 3
Front View Close-up of Radiated Emissions Test Setup

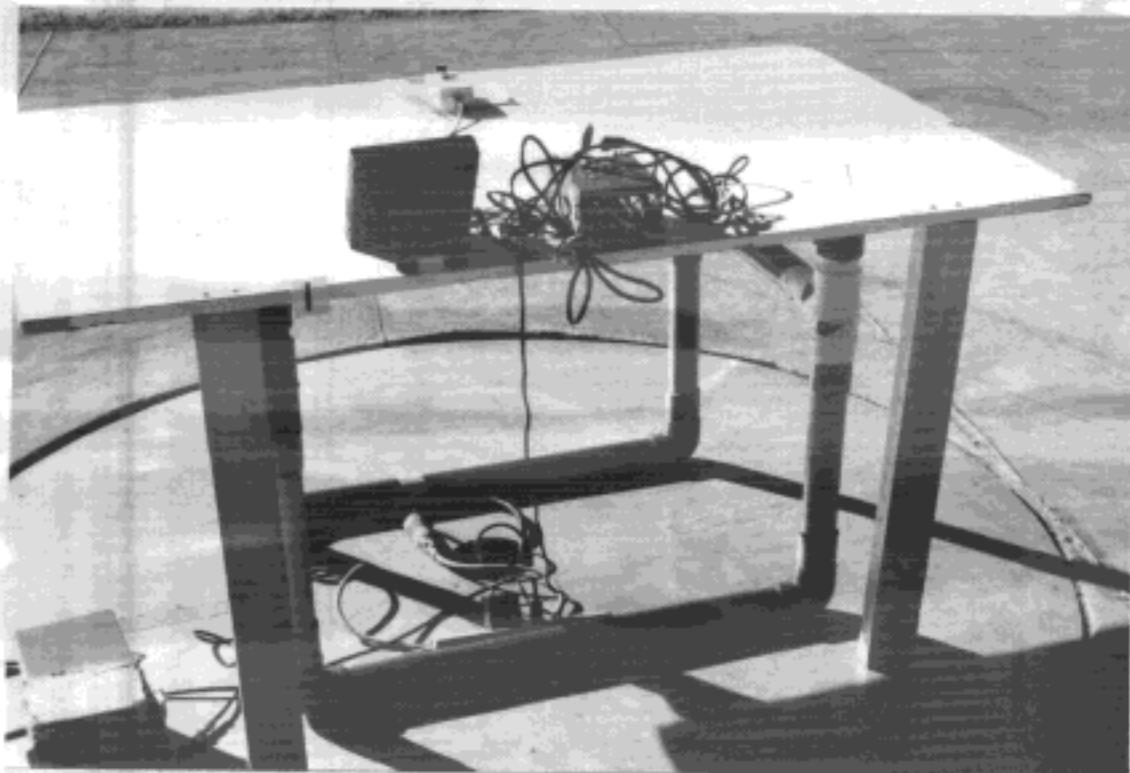
Photo 4
Radiated Emissions
143.03 Horizontal Polarization Cable Position
Color Enhanced, Camera Input

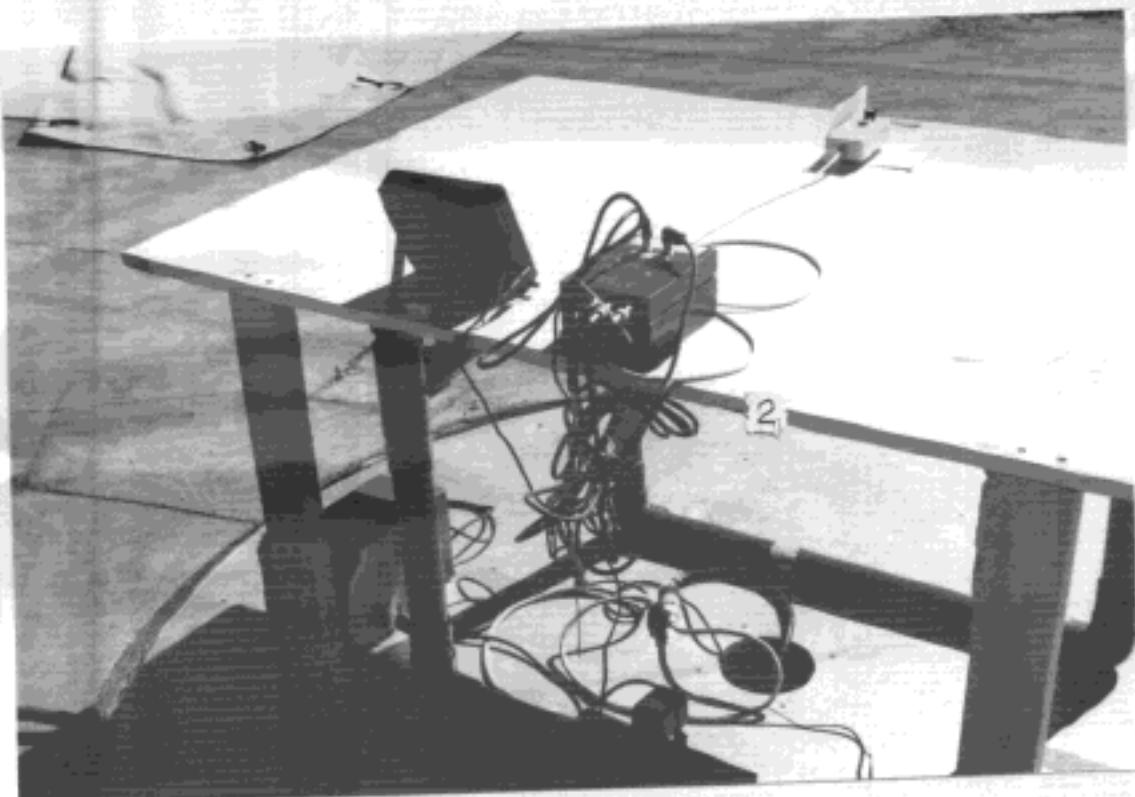
Photo 5
Radiated Emissions
190.7 MHz, Vertical Polarization Cable Position
Color Enhanced, Camera Input

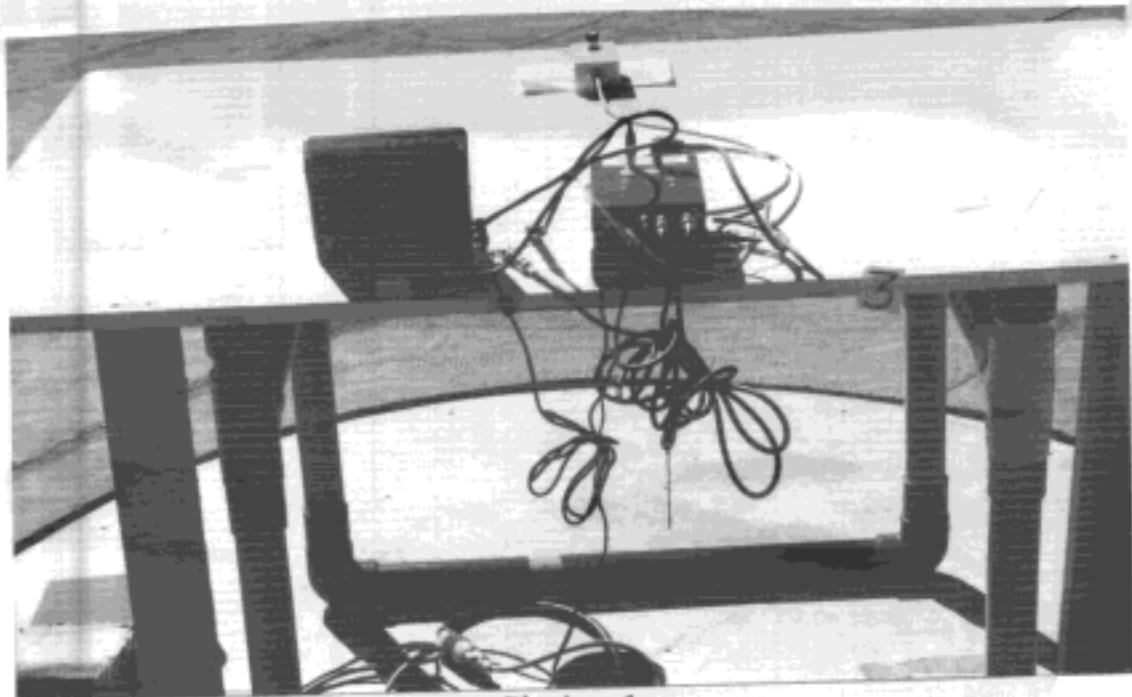
Photo 6
Radiated Emissions
286 MHz, Horizontal Polarization Cable Position
Color Enhanced, Camera Input

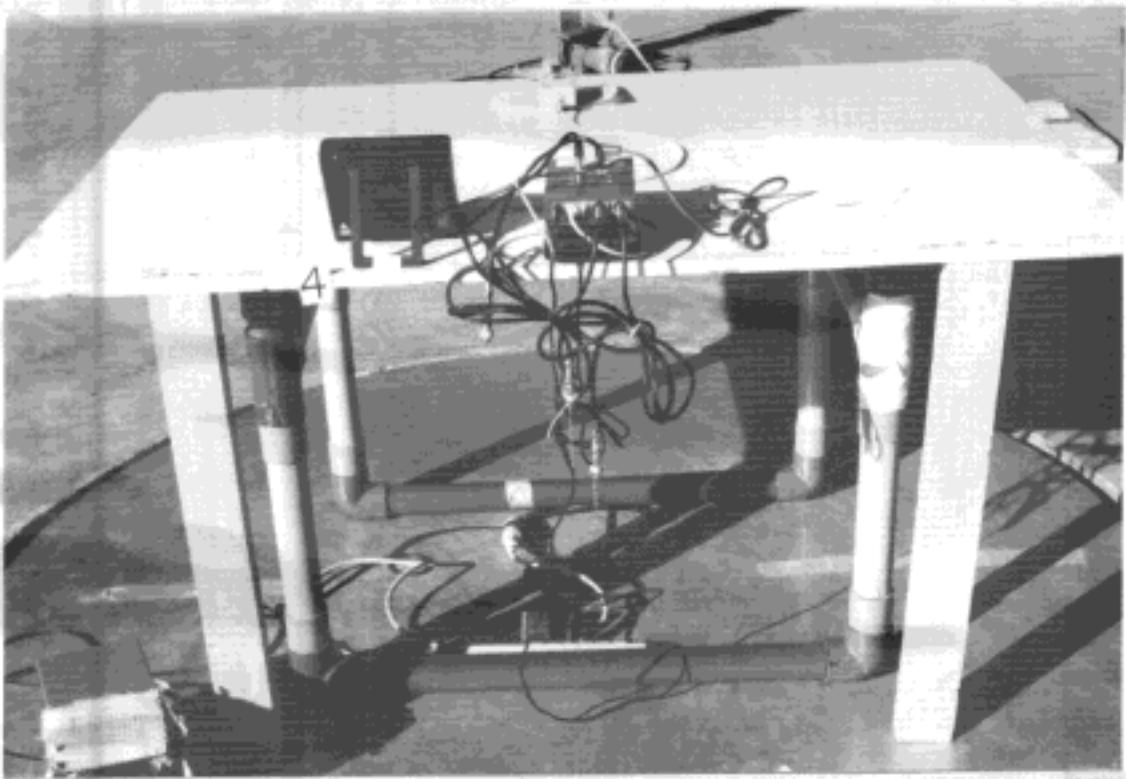
Photo 7
Radiated Emissions
286 MHz, Vertical Polarization Cable Position
Color Enhanced, Camera Input

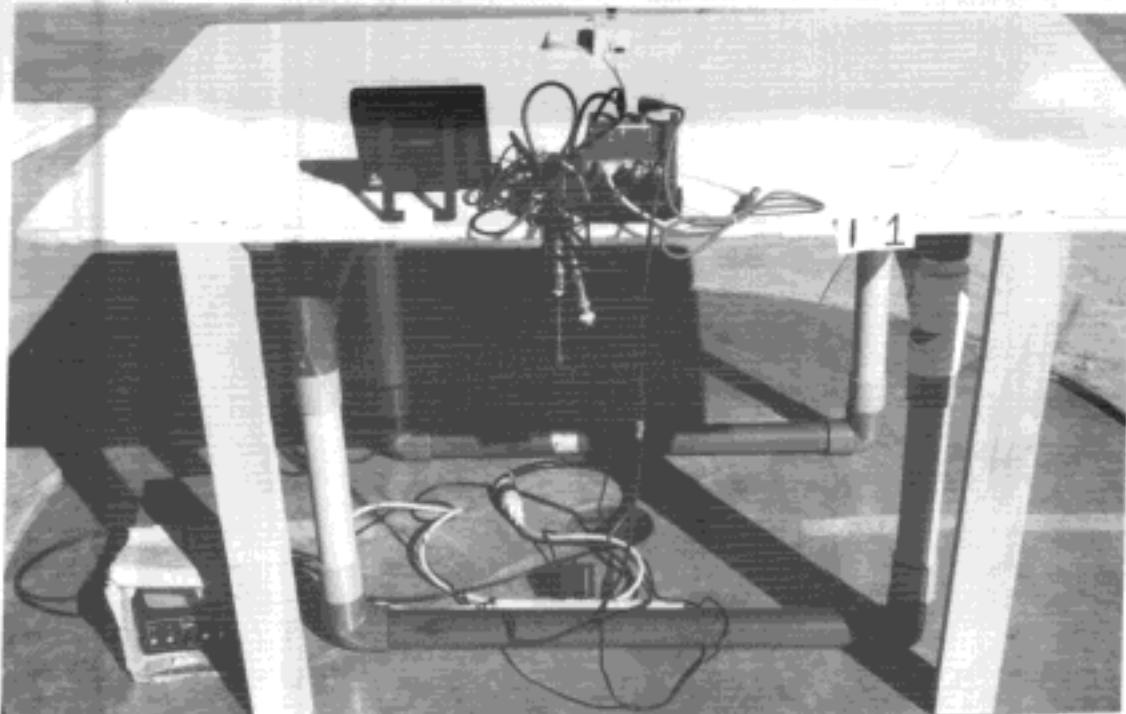
Photo 8
Radiated Emissions
85.9 MHz, Horizontal Polarization
VITS 5 Volt Input

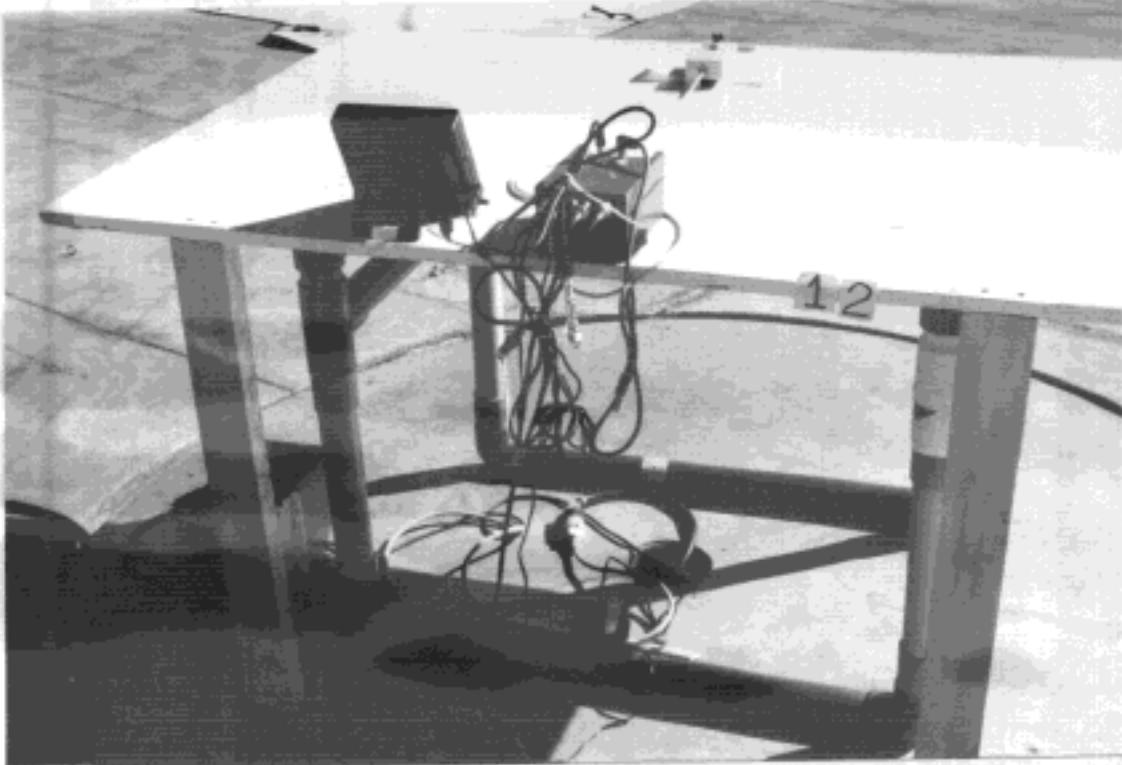
Photograph 9
85.9 MHz, Vertical Polarization
VITS 5 Volt Input

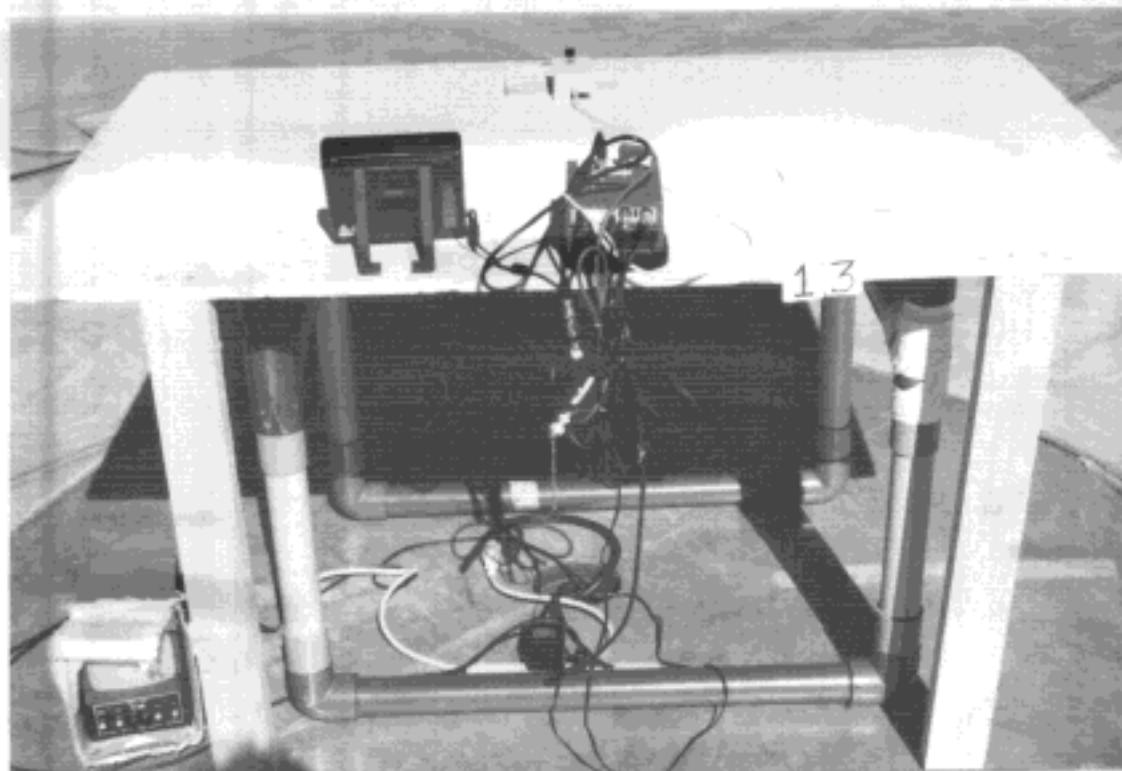
Photograph 10
267 MHz, Horizontal Polarization
VITS 5 Volt Input

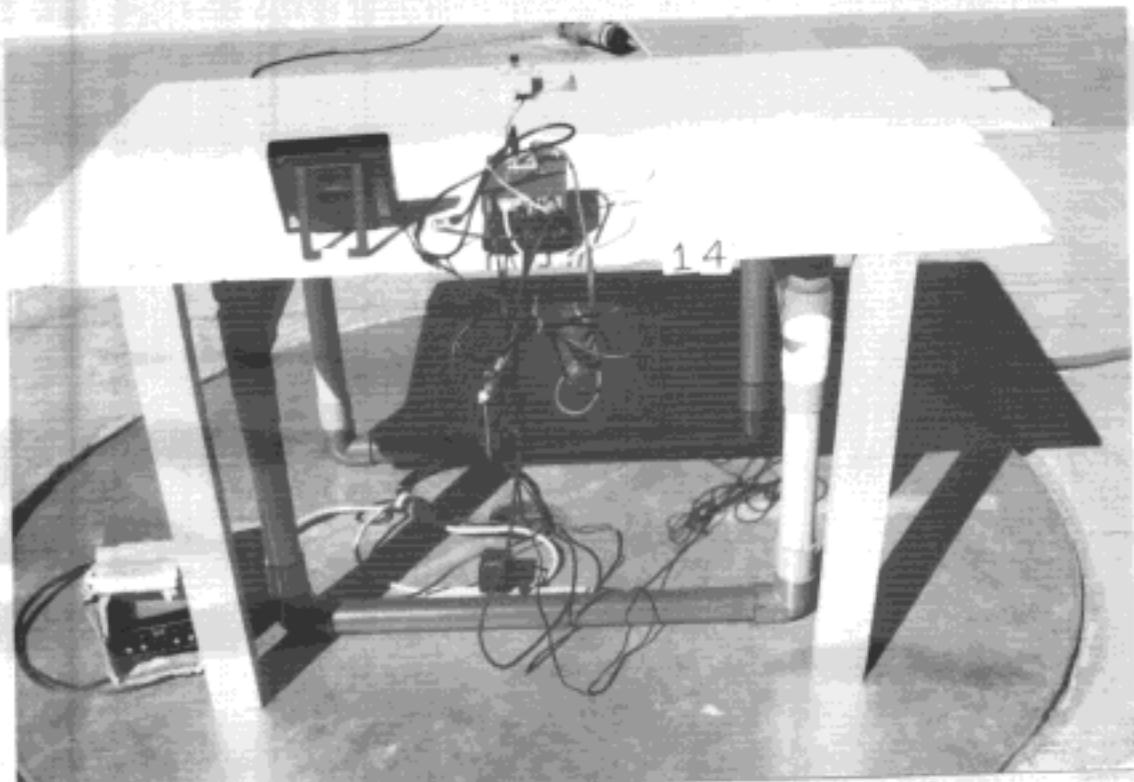
Photograph 11
267 MHz, Vertical Polarization
VITS 5 Volt Input

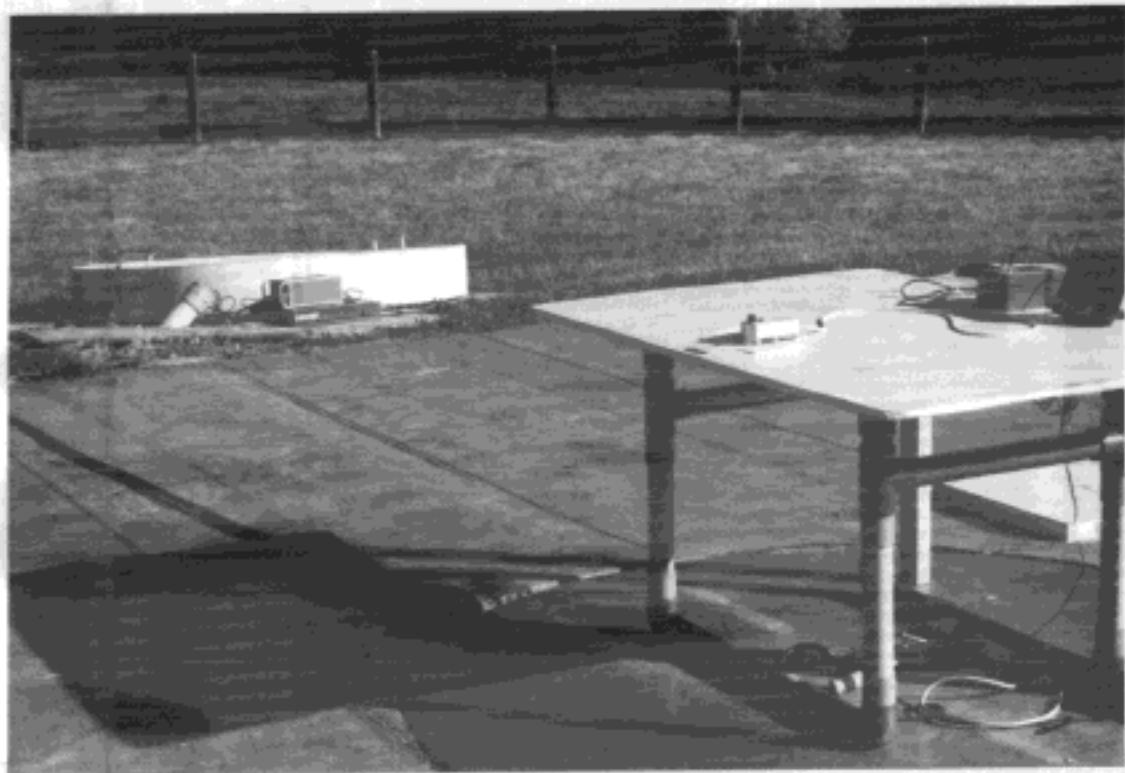
Photograph 12
VITS Generator and Video Amp placed on the Side of the OATS

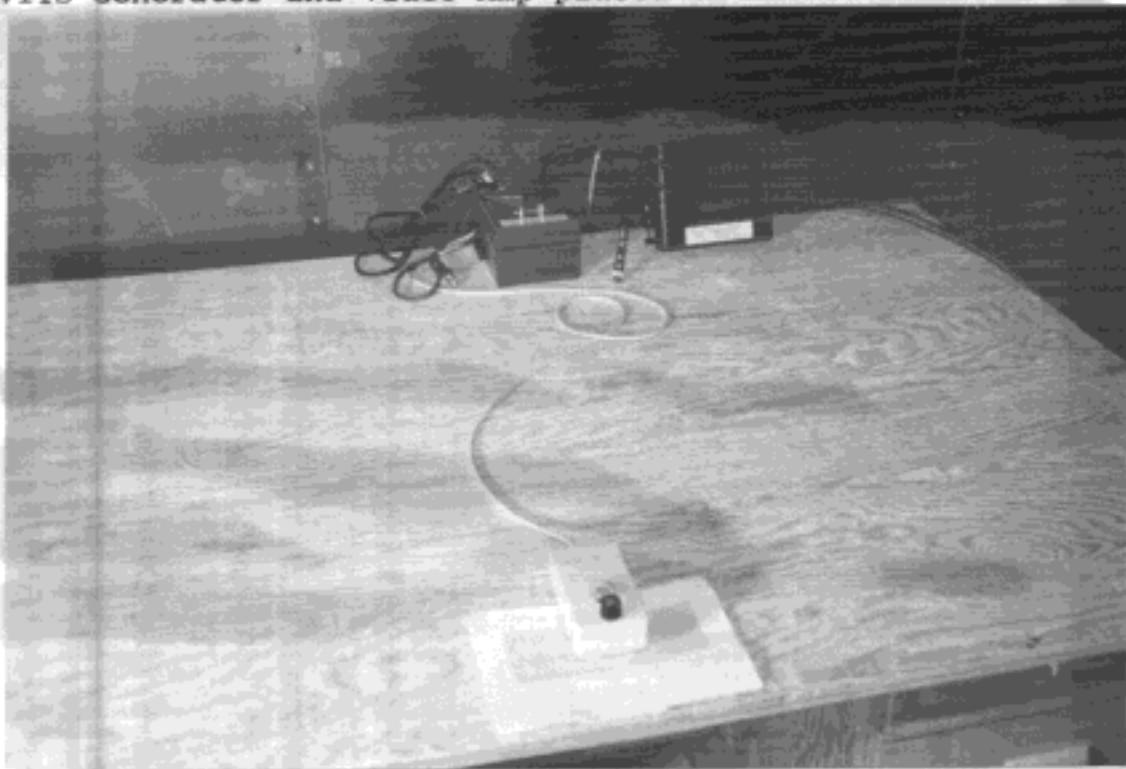
Photograph 13
Power Line Conducted - Front View

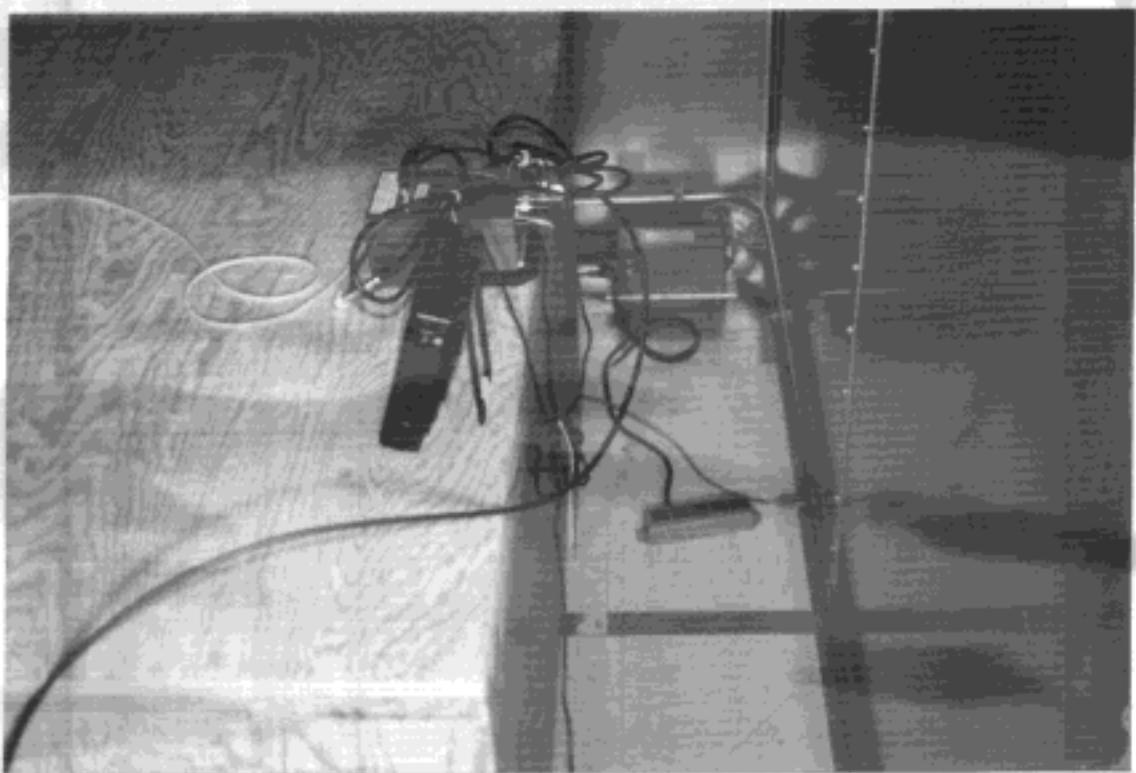
Photograph 14
Power Line Conducted - Rear View

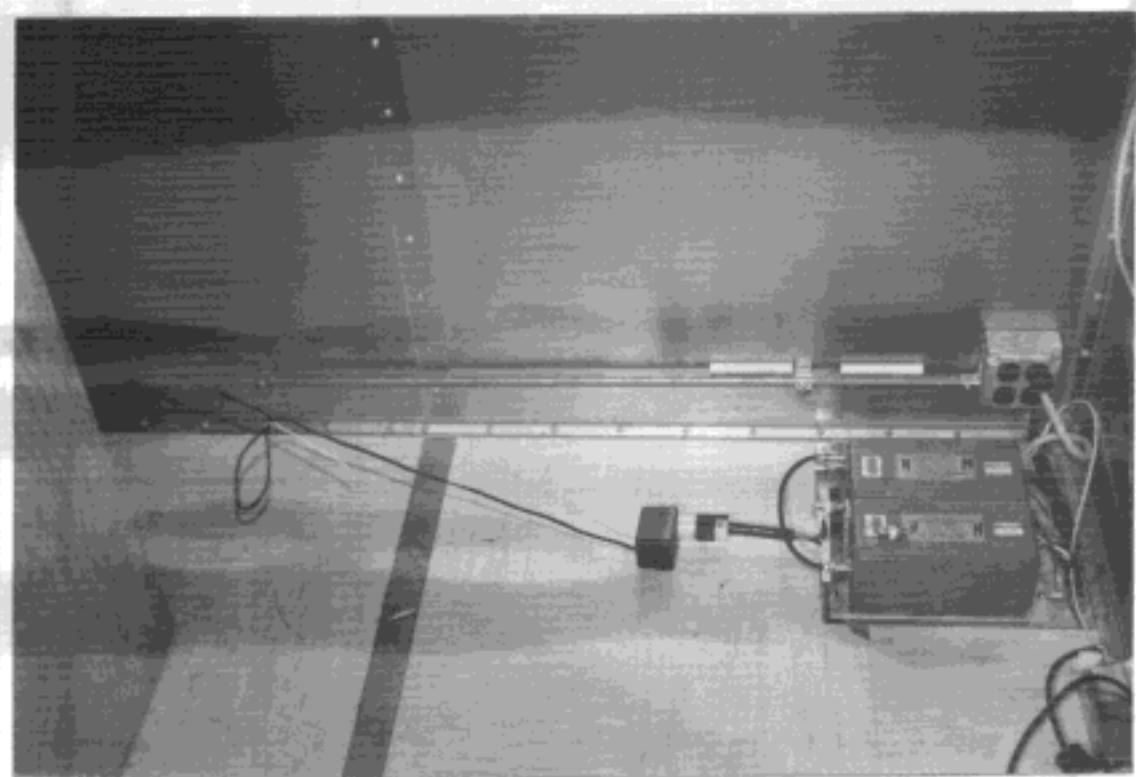
Photograph 15
UUT LISNs - 120 VAC/60 Hz Input

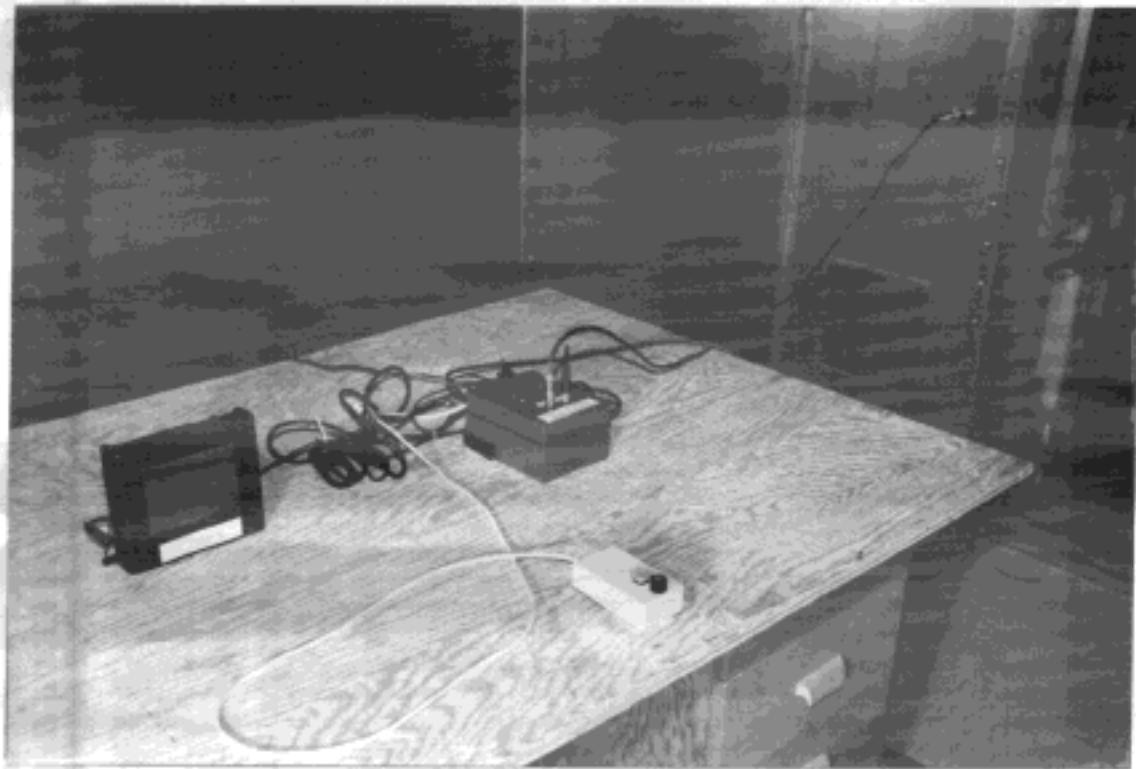
Photo 16
Output & Spurious Conducted Test Setup
Inside Shielded Room

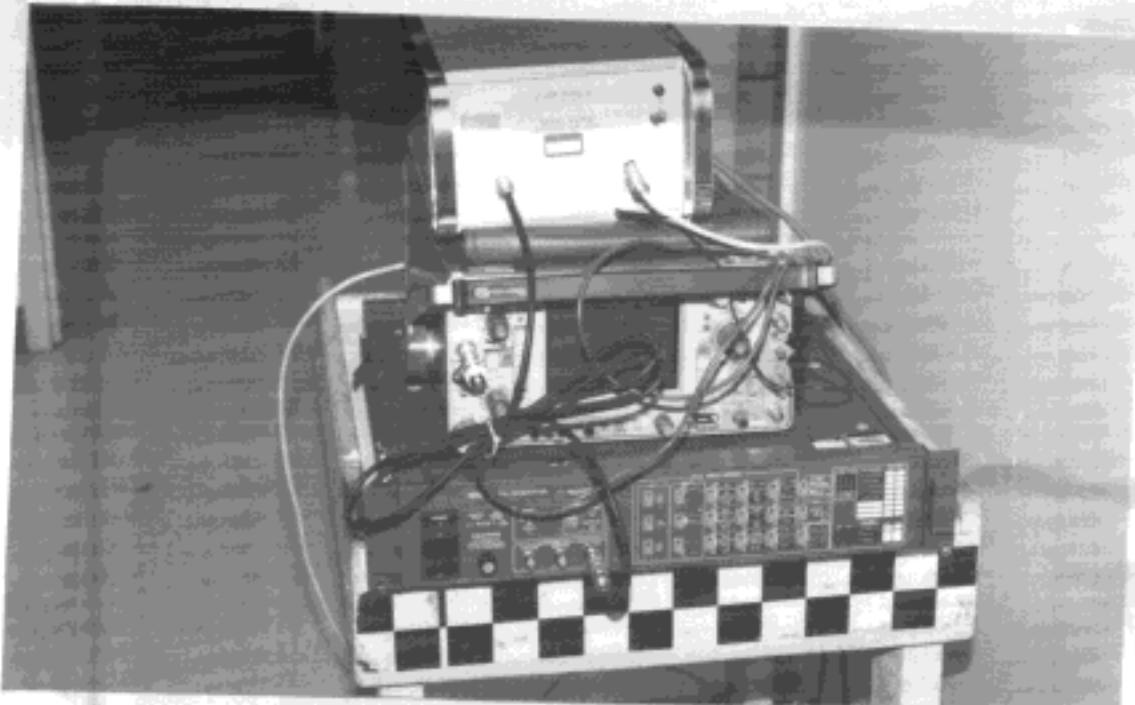
Photo 17
Tektronix 1910 Generator and Video Amp
Outside Shielded Room

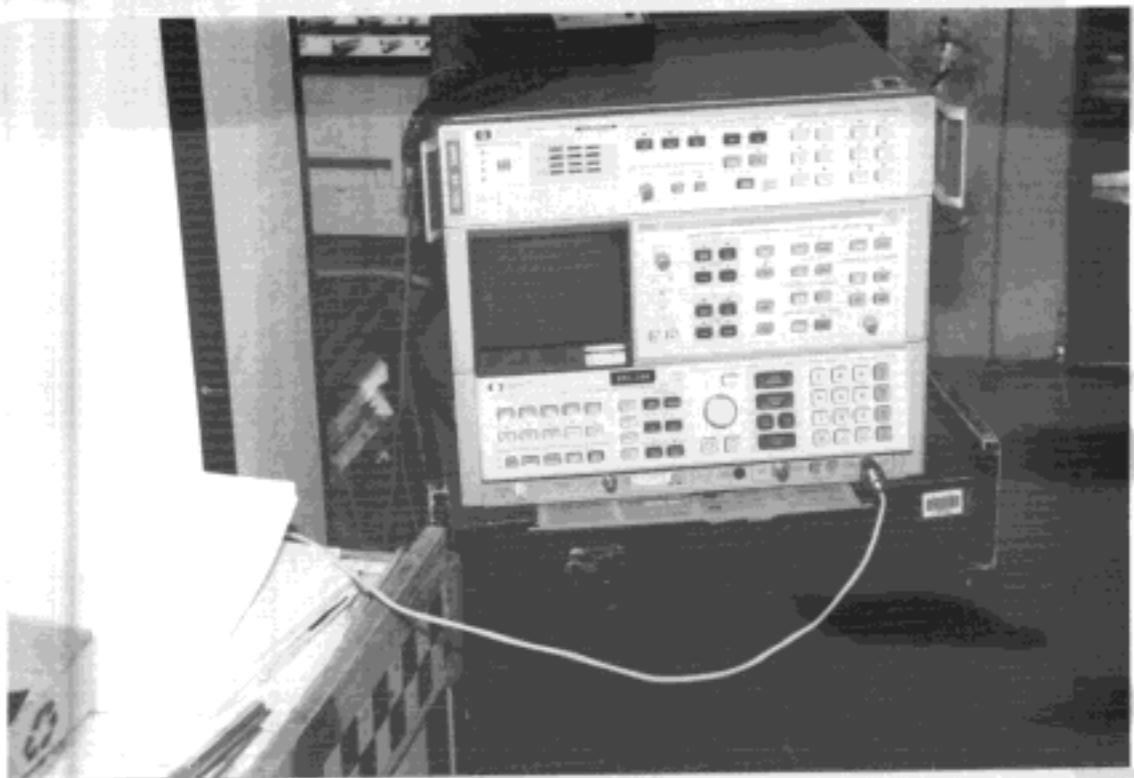
Photograph 18
Power Line Conducted/Output & Spurious Conducted
8568B Analyzer Outside Shielded Room

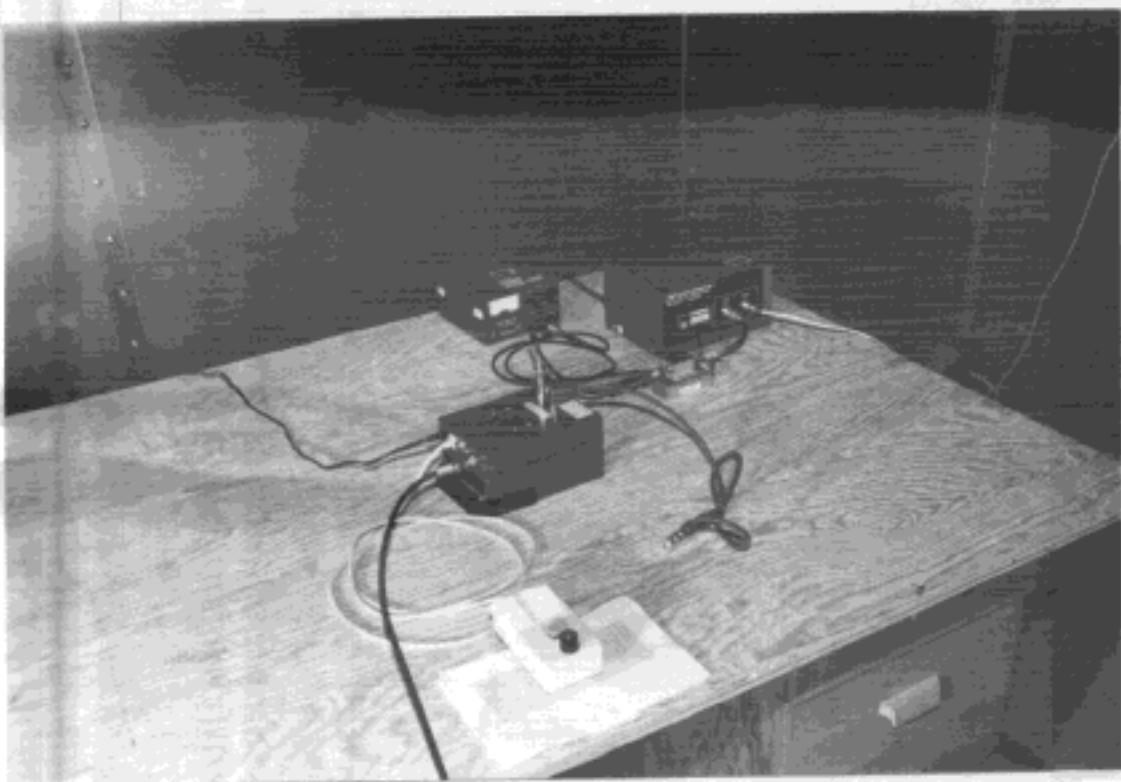
Photograph 19
Transfer Switch Isolation Test Setup - Front View
Inside Shielded Room

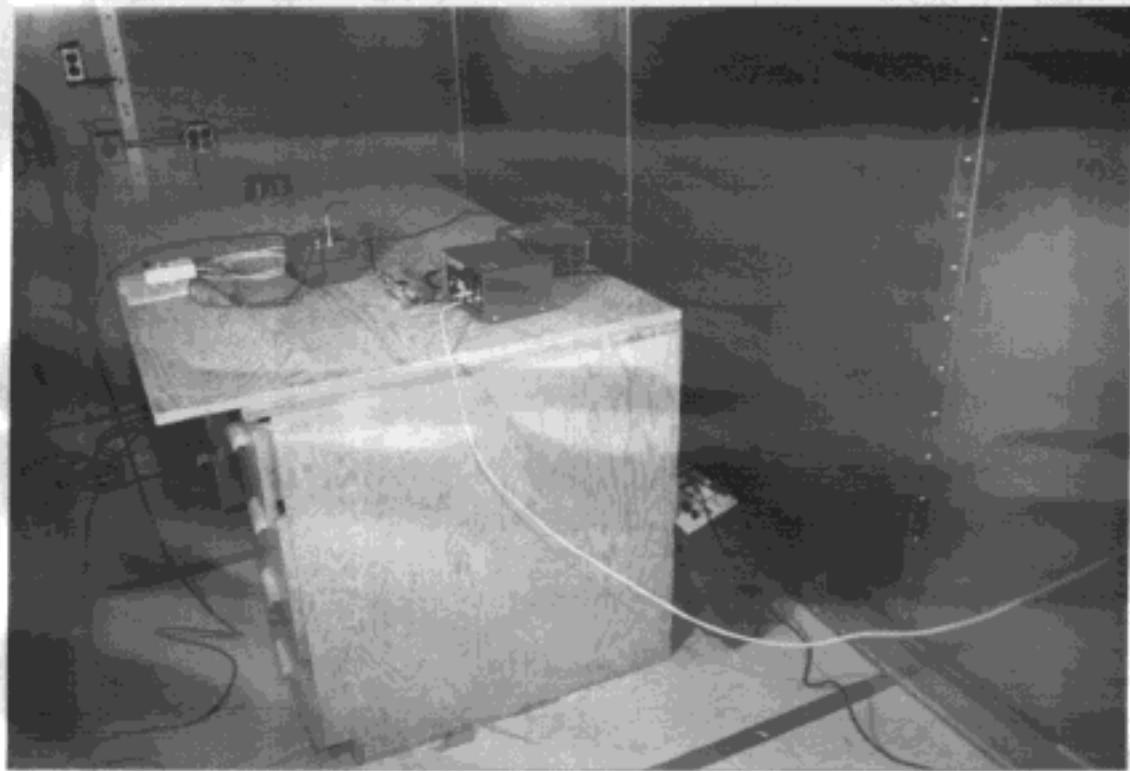
Photograph 20
Transfer Switch Isolation Test
Right Side View Inside Shielded Room
