INTERTEK TESTING SERVICES

3.7 Line Conducted Configuration Photograph (cont.) - Base Unit

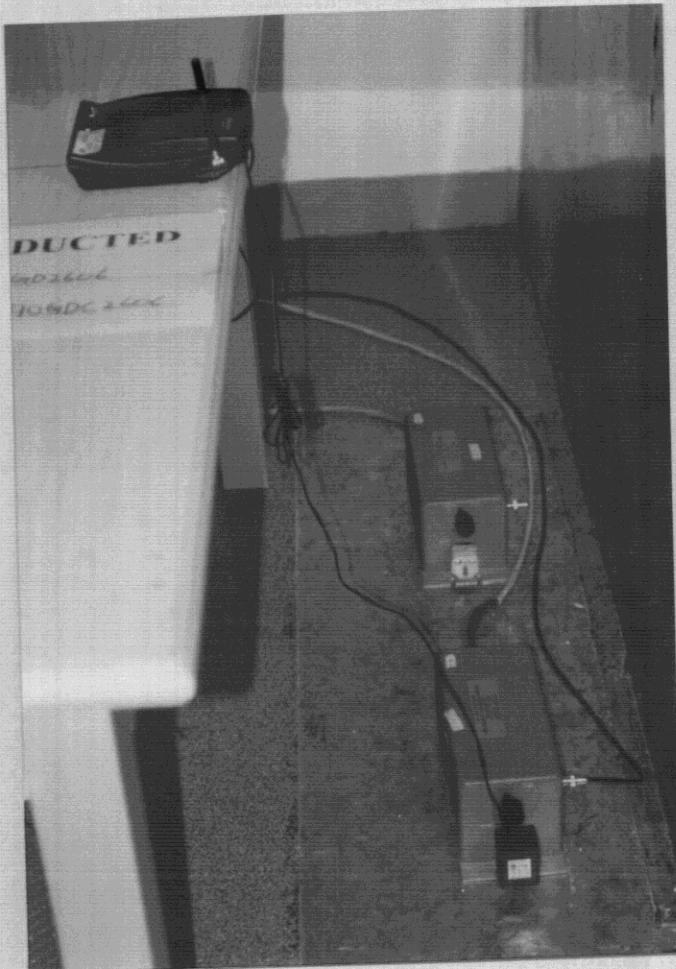
Worst Case Line-Conducted Configuration

Side View

at 16.515 MHz

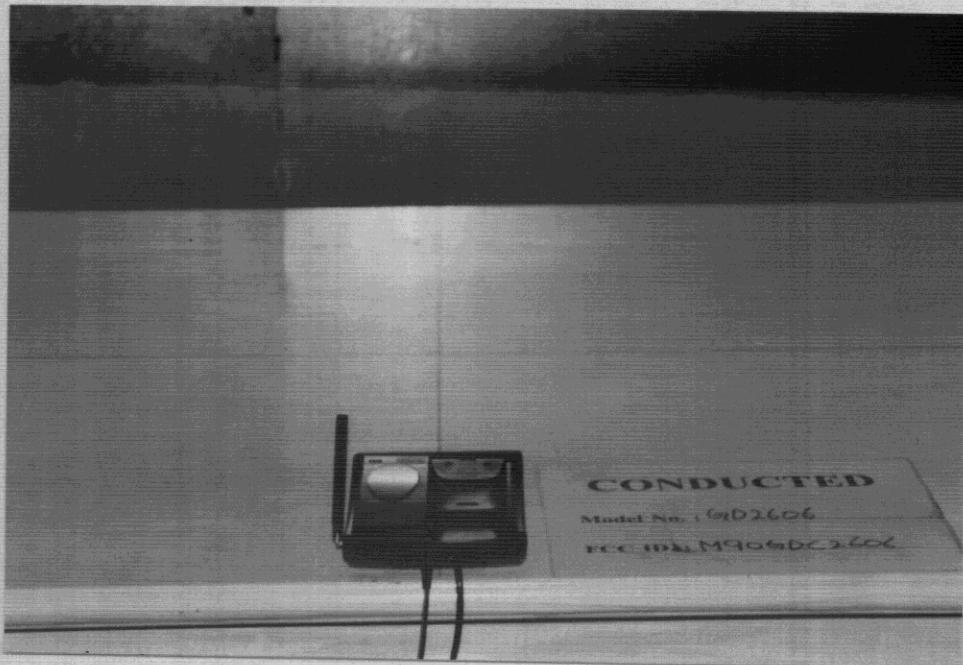
3.7 Line Conducted Configuration Photograph (cont.) - Base Unit

Worst Case Line-Conducted Configuration

Rear View

at 16.515 MHz

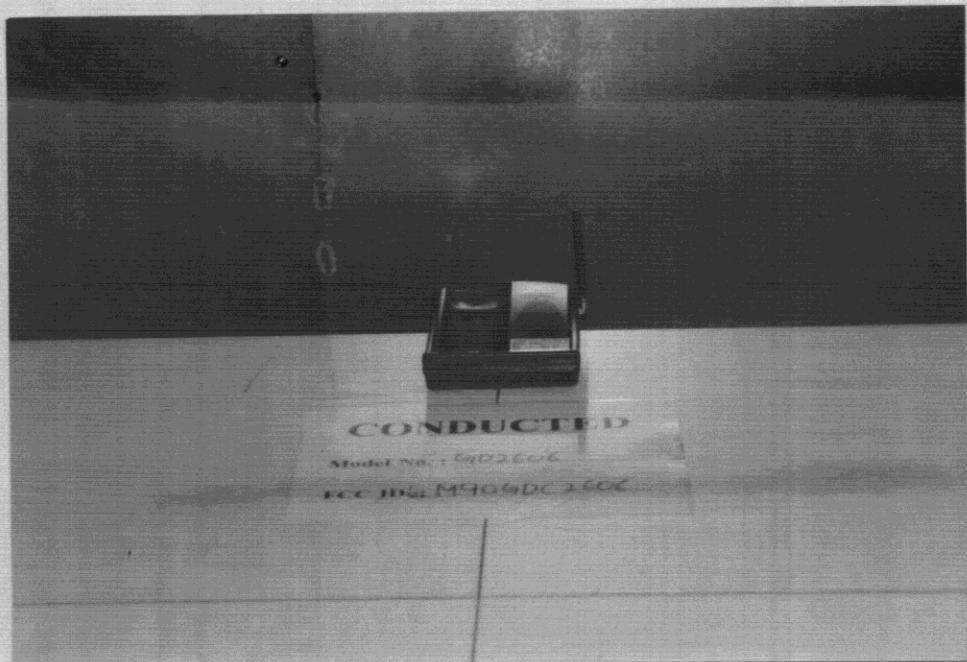
3.7 Line Conducted Configuration Photograph - Base Unit

Worst Case Line-Conducted Configuration

Front View

at 16.515 MHz

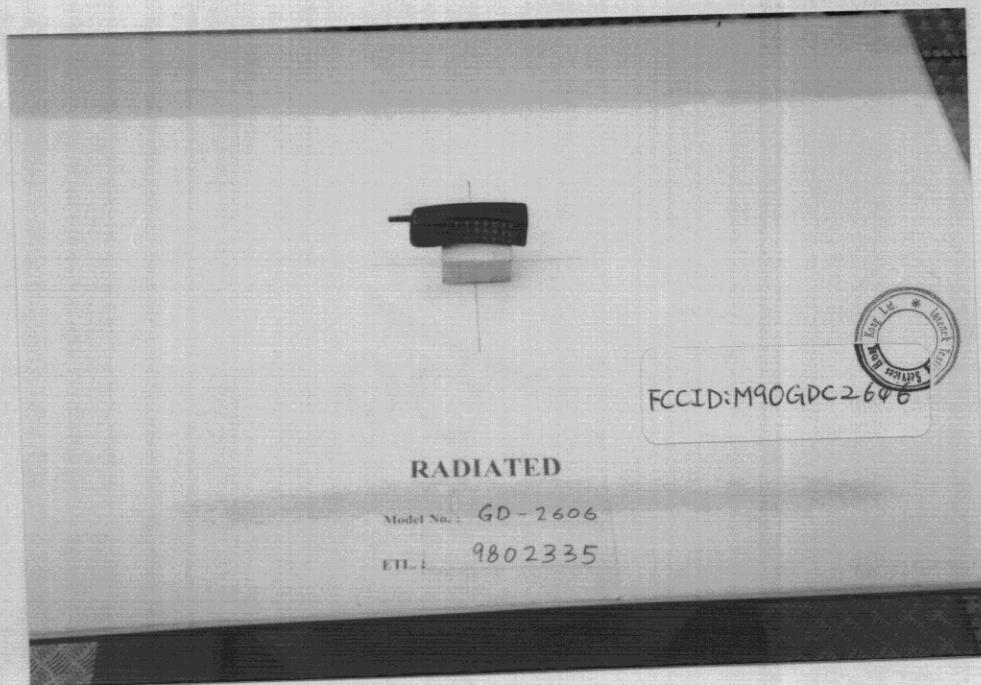
3.4 Radiated Emission Configuration Photograph - Handset

Worst Case Radiated Emission

Front View

at 3707.300 MHz

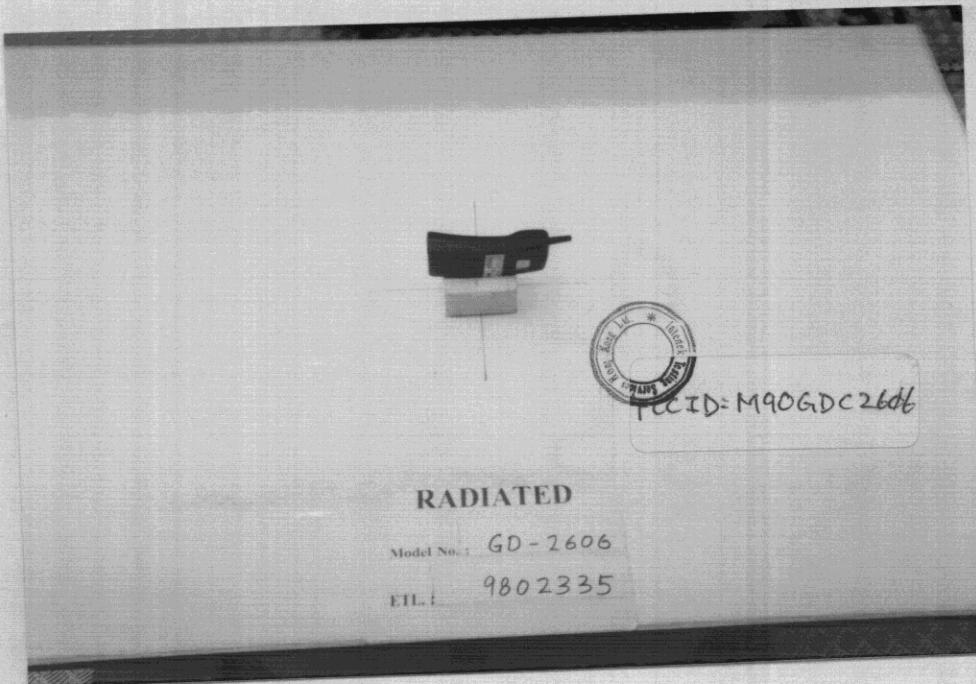
3.4 Radiated Emission Configuration Photograph (cont.) - Handset

Worst Case Radiated Emission

Rear View

at 3707.300 MHz

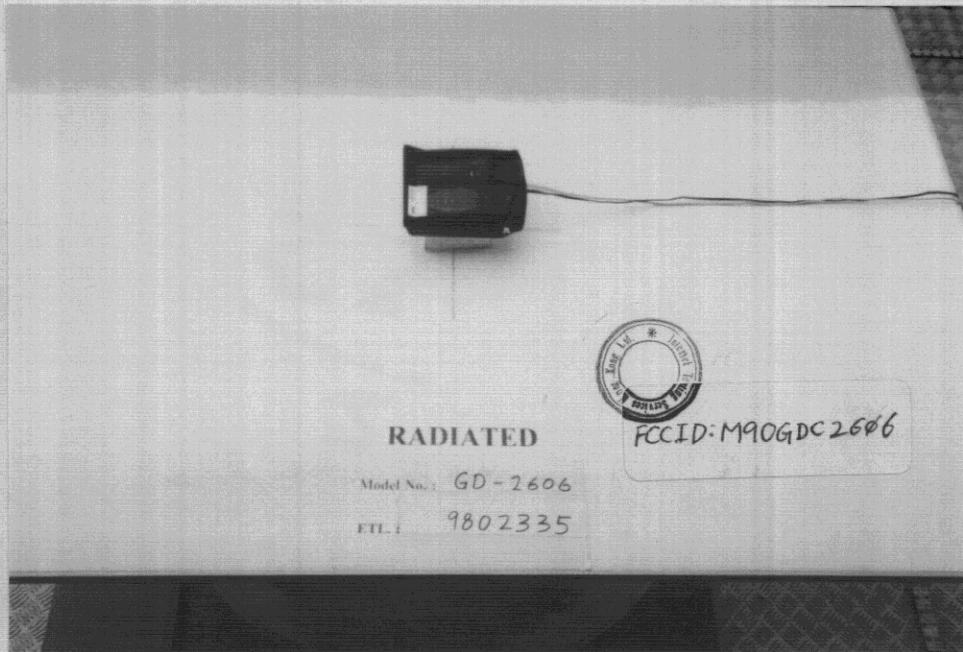
3.2 Radiated Emission Configuration Photograph - Base Unit

Worst Case Radiated Emission

Front View

at 3614.482 MHz

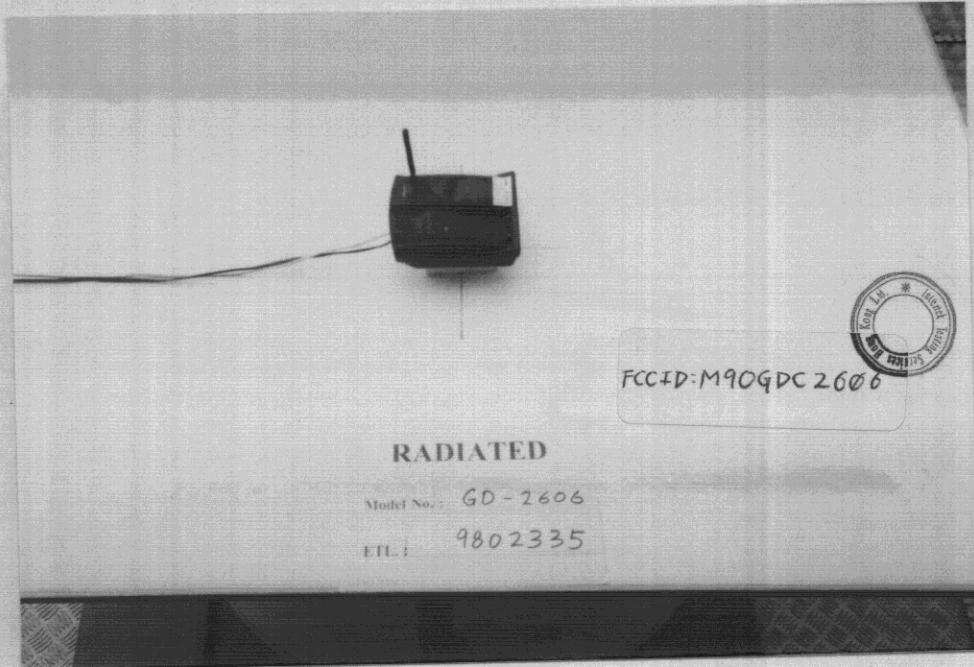
3.2 Radiated Emission Configuration Photograph (cont.) - Base Unit

Worst Case Radiated Emission

Rear View

at 3614.482 MHz
