11.12 Radiated Test Configuration

11.13 Conducted Test Configuration

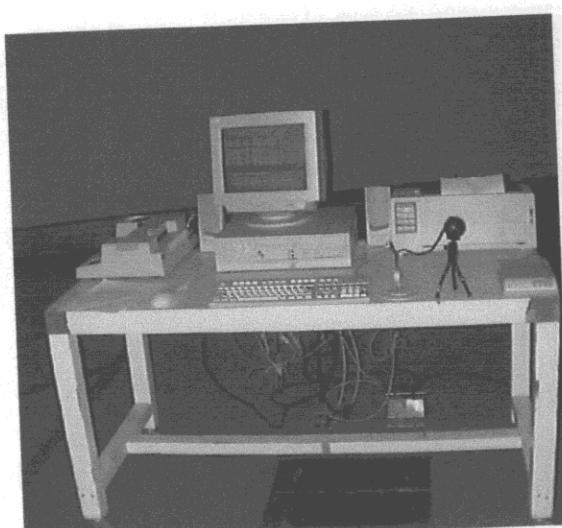
Free field front view

NOTE: these photographs were taken after the testing had completed and some of the bundling had come apart. During testing the cables were bundled in accordance with ANSI rules.

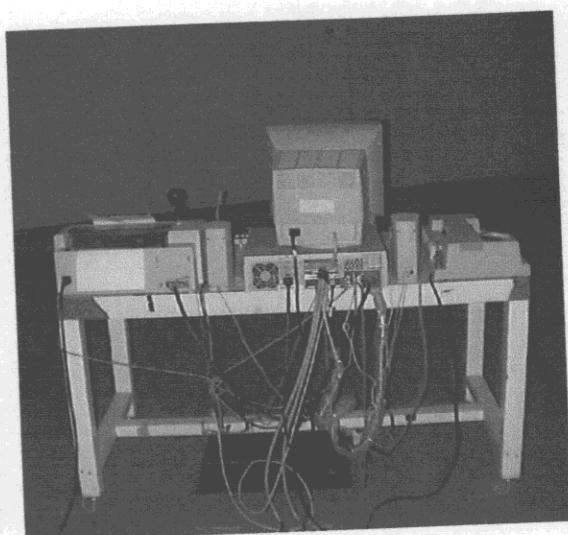
Free field rear view

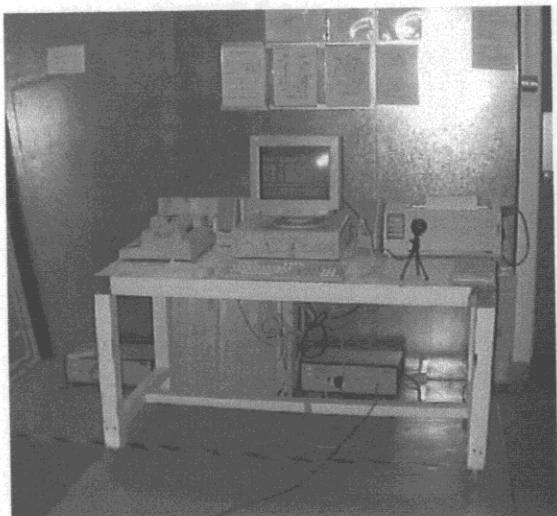
Conducted front view
