Report No.: 9806385

Channel A

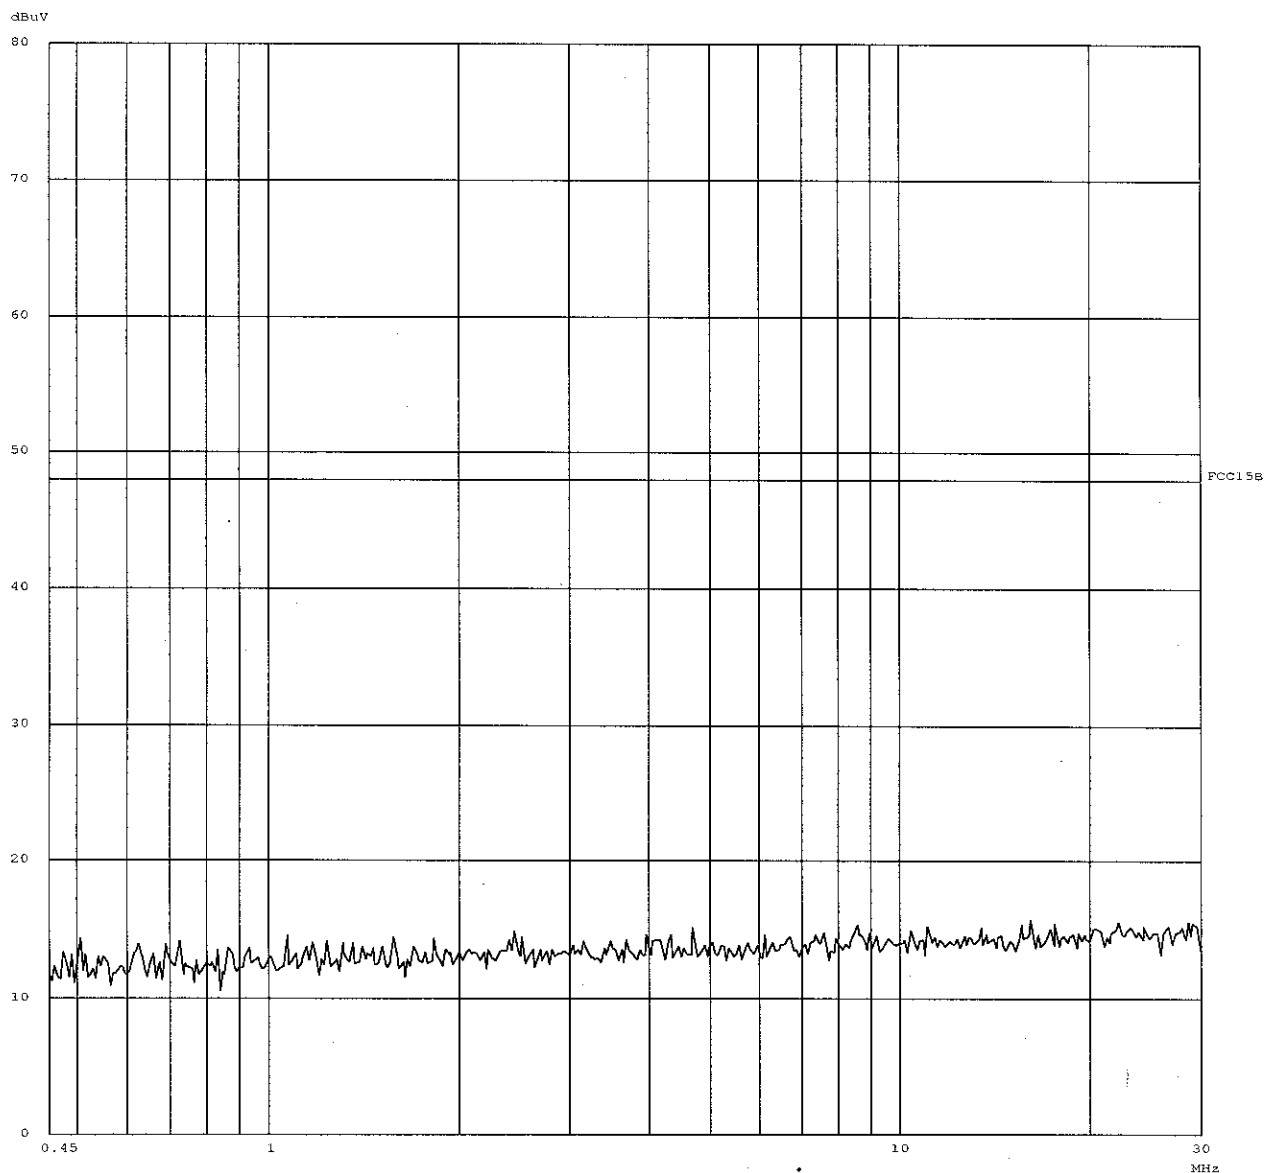
Scan Settings (1 Range)

| Frequencies | | | Receiver Settings | | | | | |
|---|---|---|---|---|---|---|---|---|
| 450k | 30M | 5k | 10k | PK | 20ms | AUTO | LN OFF | 60dB |

Final Measurement: x QP

Meas Time: 1 s  
Subranges: 16  
Acc Margin: 20dB

| Transducer No. | Start | Stop | Name |
|---|---|---|---|
| 3 | 9k | 30M | EI078 |

no Results

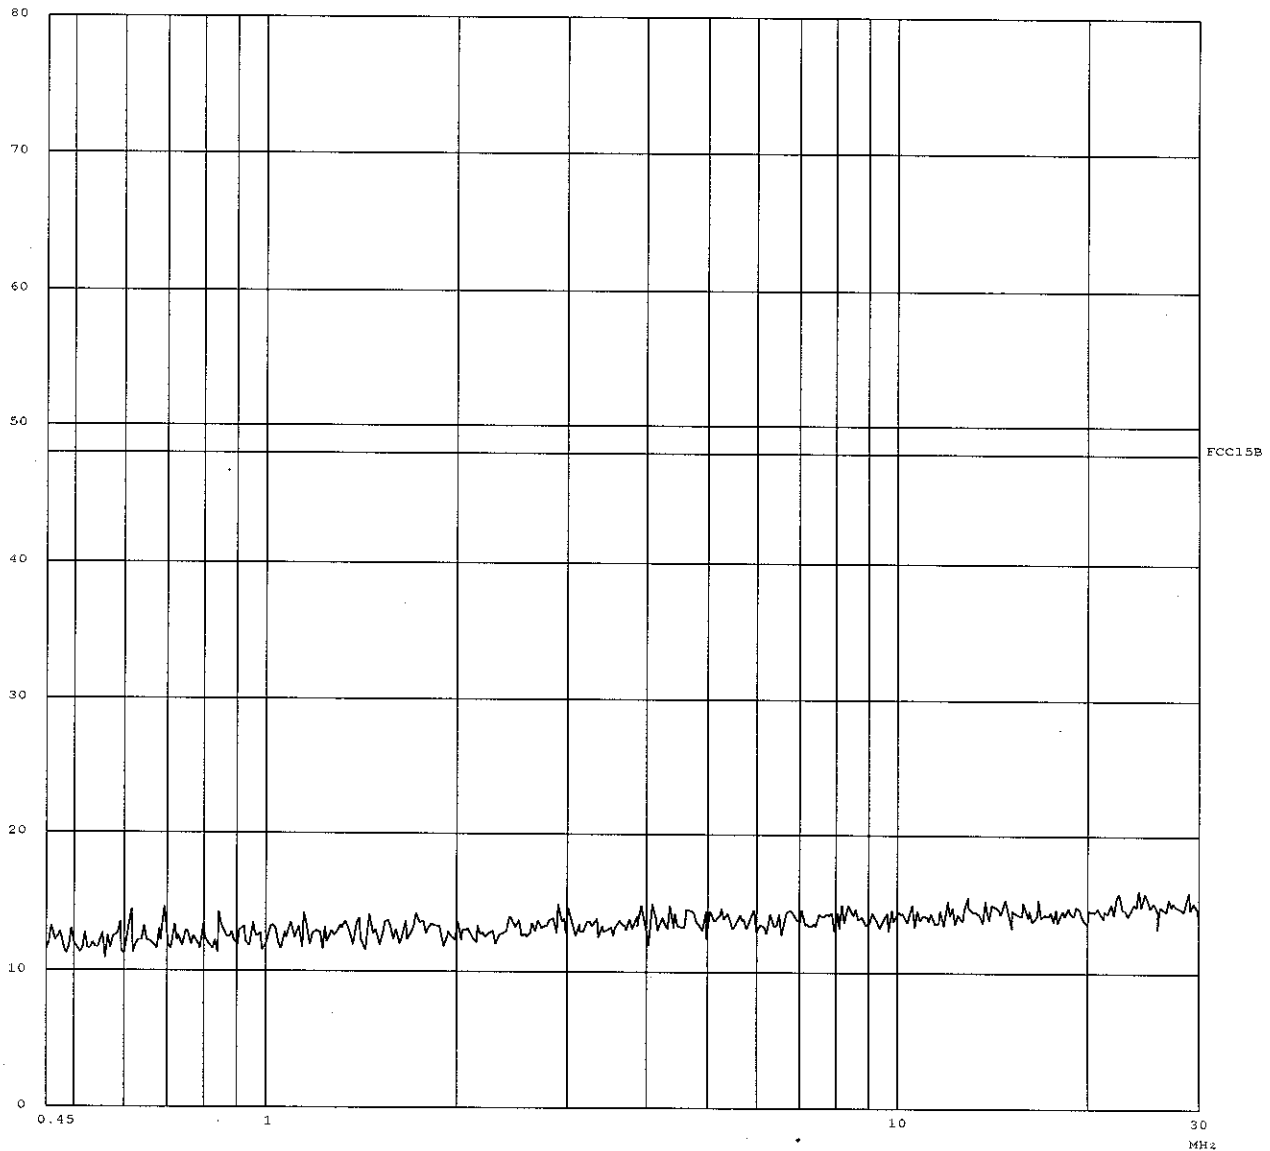
Channel B

Scan Settings (1 Range)

| Start | Stop | Step | IF BW | Detector | M-Time | Atten | Preamp | OpRge |
|---|---|---|---|---|---|---|---|---|
| 450k | 30M | 5k | 10k | PK | 20ms | AUTO | LN OFF | 60dB |

Final Measurement: x QP

| Transducer No. | Start | Stop | Name |
|---|---|---|---|
| 3 | 9k | 30M | EI078 |

Meas Time: 1 s

Subranges: 16

Acc Margin: 20dB

no Results
