### **APPENDIX 3: Photographs of test setup**

#### **Radiated Emission**

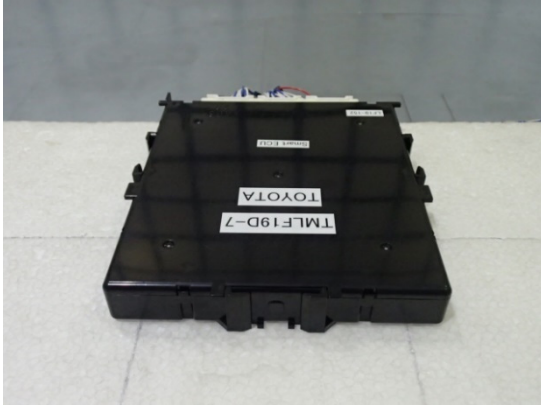
#### ECU

Below 30 MHz: X-axis  
Above 30 MHz: Horizontal: X-axis /  
Vertical: X-axis

#### **X-axis**

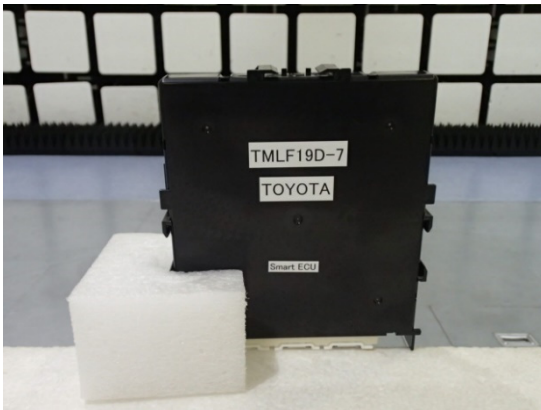
#### **Y-axis**

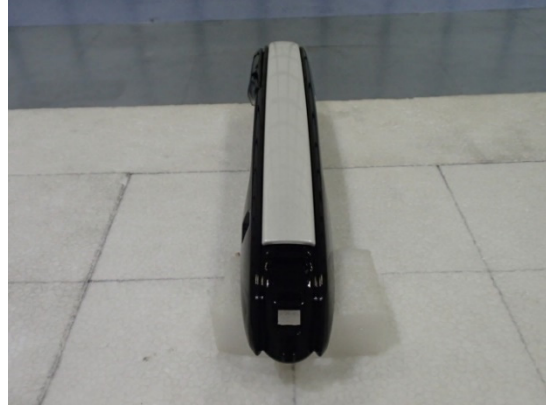
#### Outside Antenna

Below 30 MHz: X-axis  
Above 30 MHz: Horizontal: X-axis /  
Vertical: X-axis

#### **X-axis**

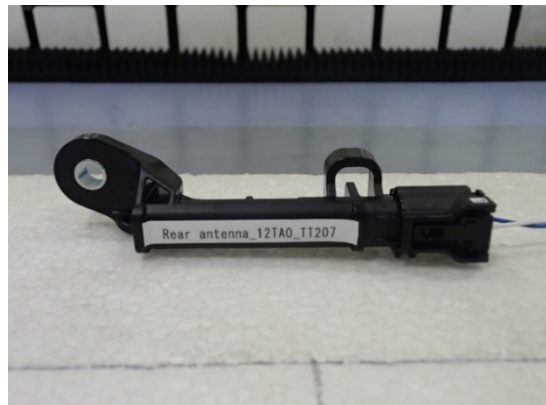
#### Rear Antenna

**Z-axis**

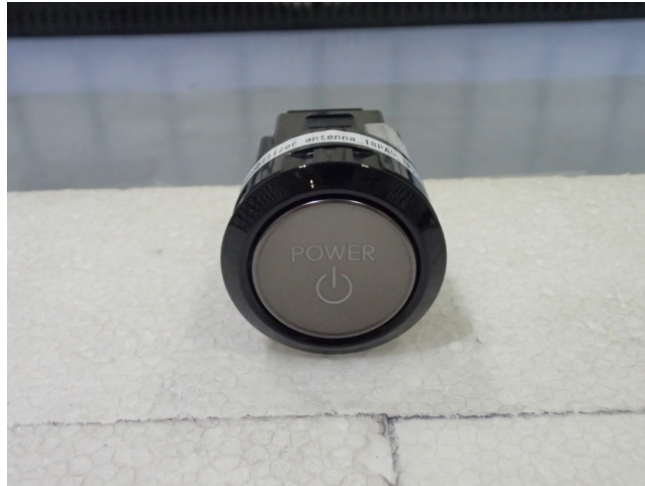
### **Immobilizer Antenna**

**Horizontal: X-axis / Vertical: X-axis**

**X-axis**

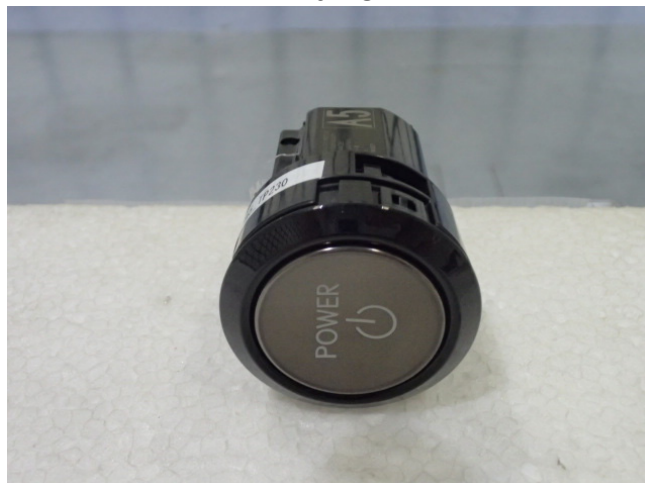
**Z-axis**

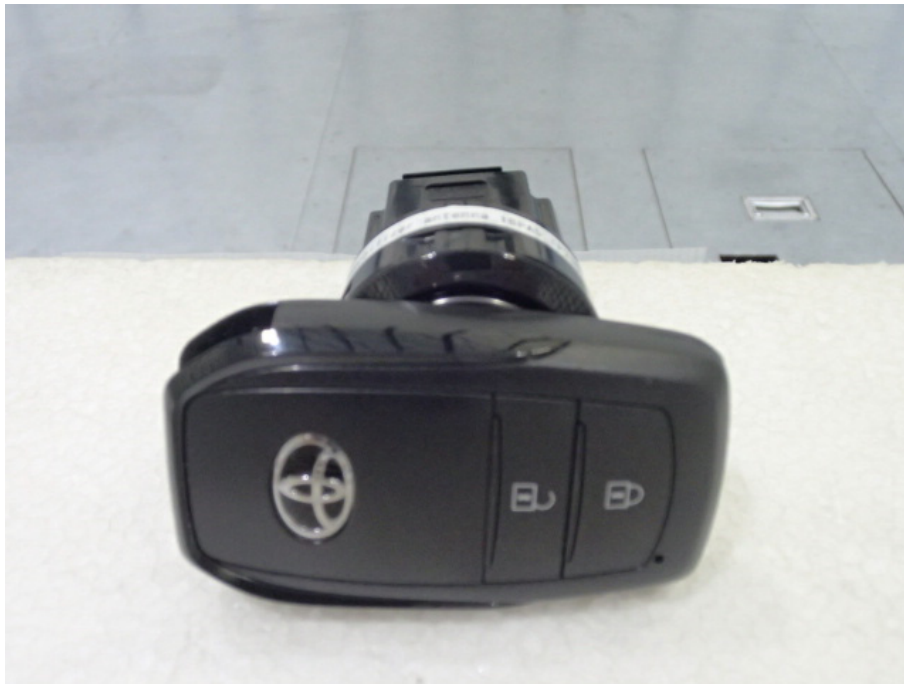
**With transponder key attached**

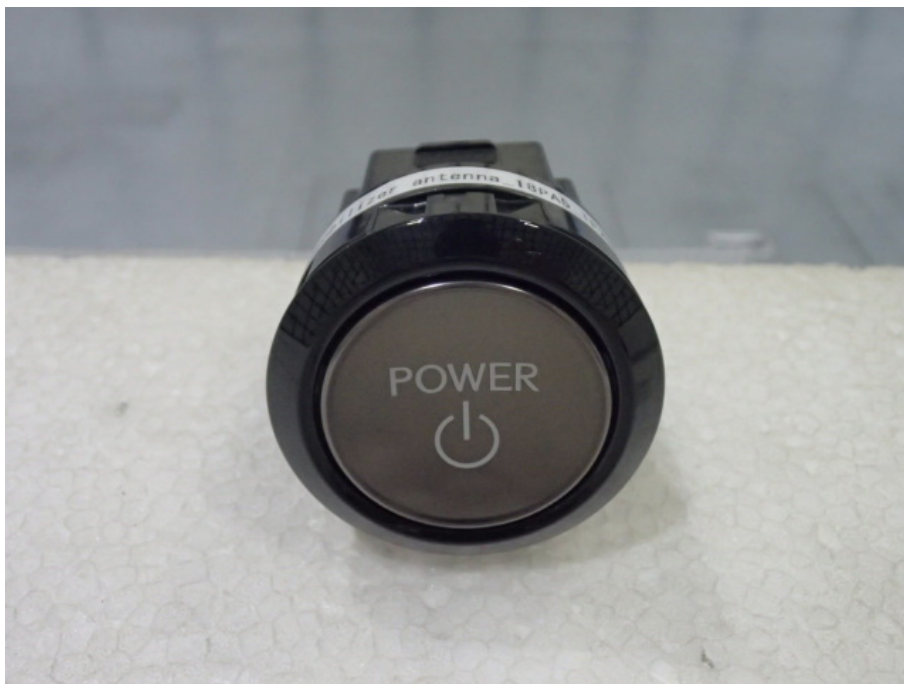
**Without transponder key attached (Worst)**
