| | <p style="text-align: center;">Exhibit 9 -- Internal Photos</p> <p style="text-align: center;">Bosch Telecom Node Transmitter</p> <p style="text-align: center;">FCC ID: NNS3214823</p> <p style="text-align: center;">Part Number: 3214823-003 (Vertically Polarized) 3214823-004 (Horizontally Polarized)</p> |

Information Provided in this Exhibit

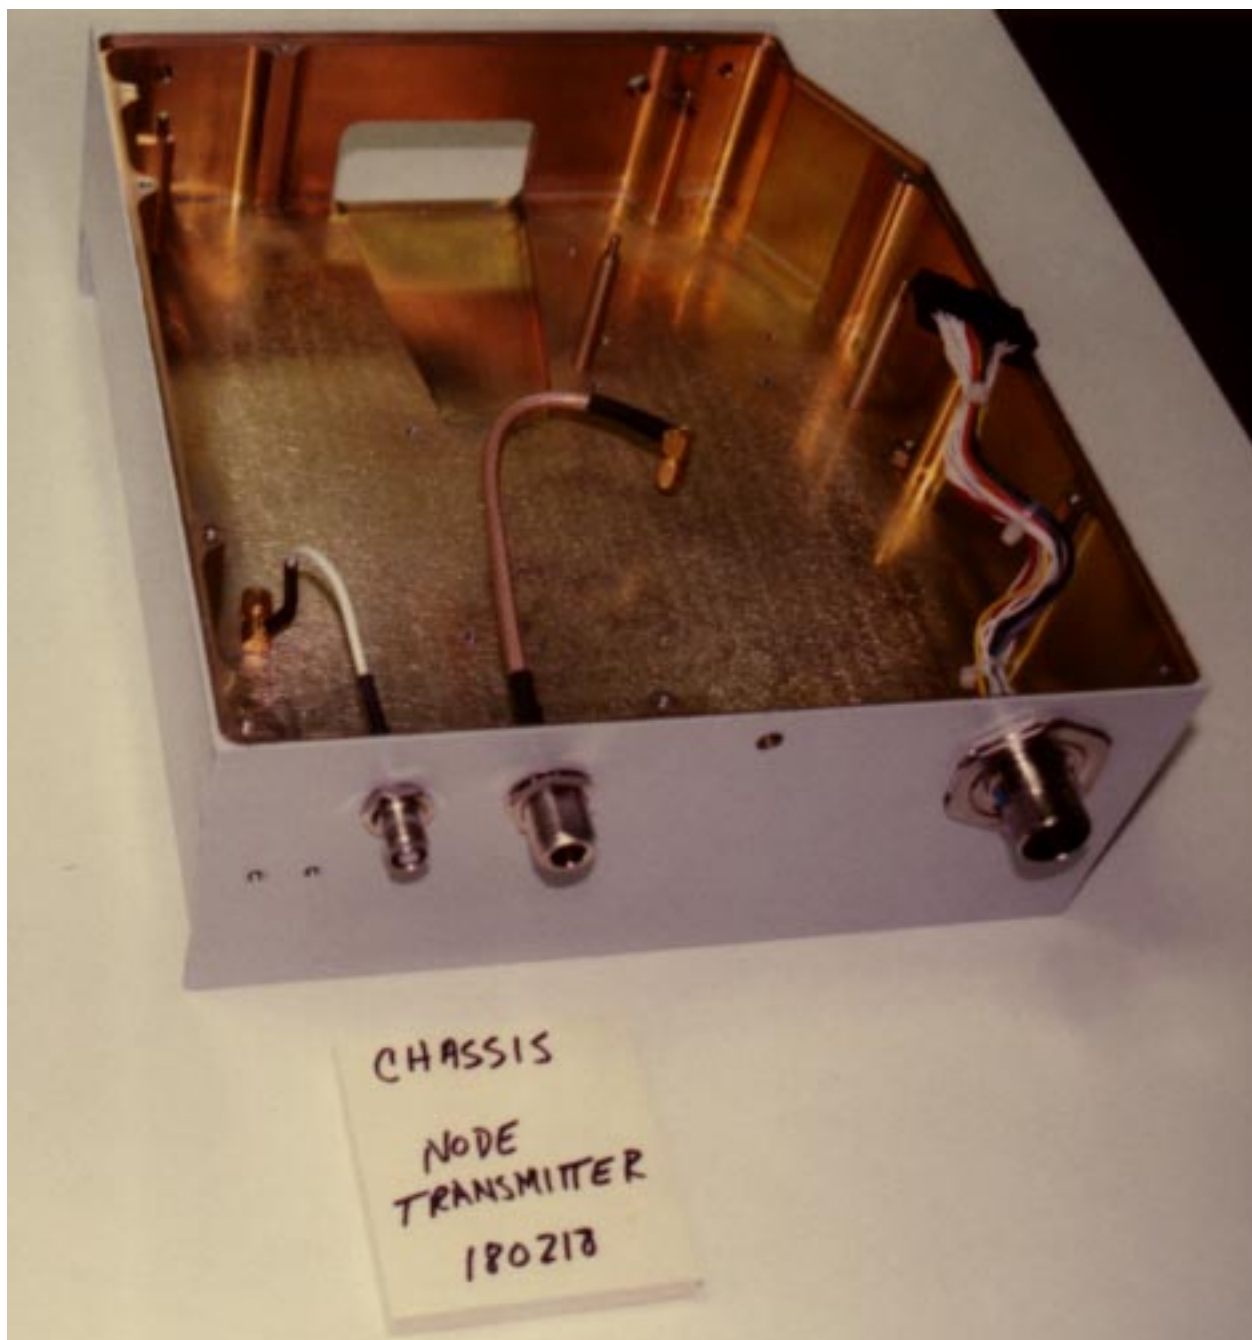
Figure 9-3 Original Transmitter Chassis with All Components Removed

The transmitter was originally housed in a machined aluminum chassis (-001 and -002 configurations). The chassis was redesigned in mid 1998 to remove accoustic resonances, increase the effectiveness of the RF seal at the chassis-cover interface, and to reduce manufacturing costs. Photographs of the Transmitter components mounted in the original chassis are shown on pages 2 and 3 of this exhibit. A photograph of the interior of the original transmitter chassis is shown on page 4. Photographs of the transmitter components alone are shown on pages 5 through 9 of this exhibit.

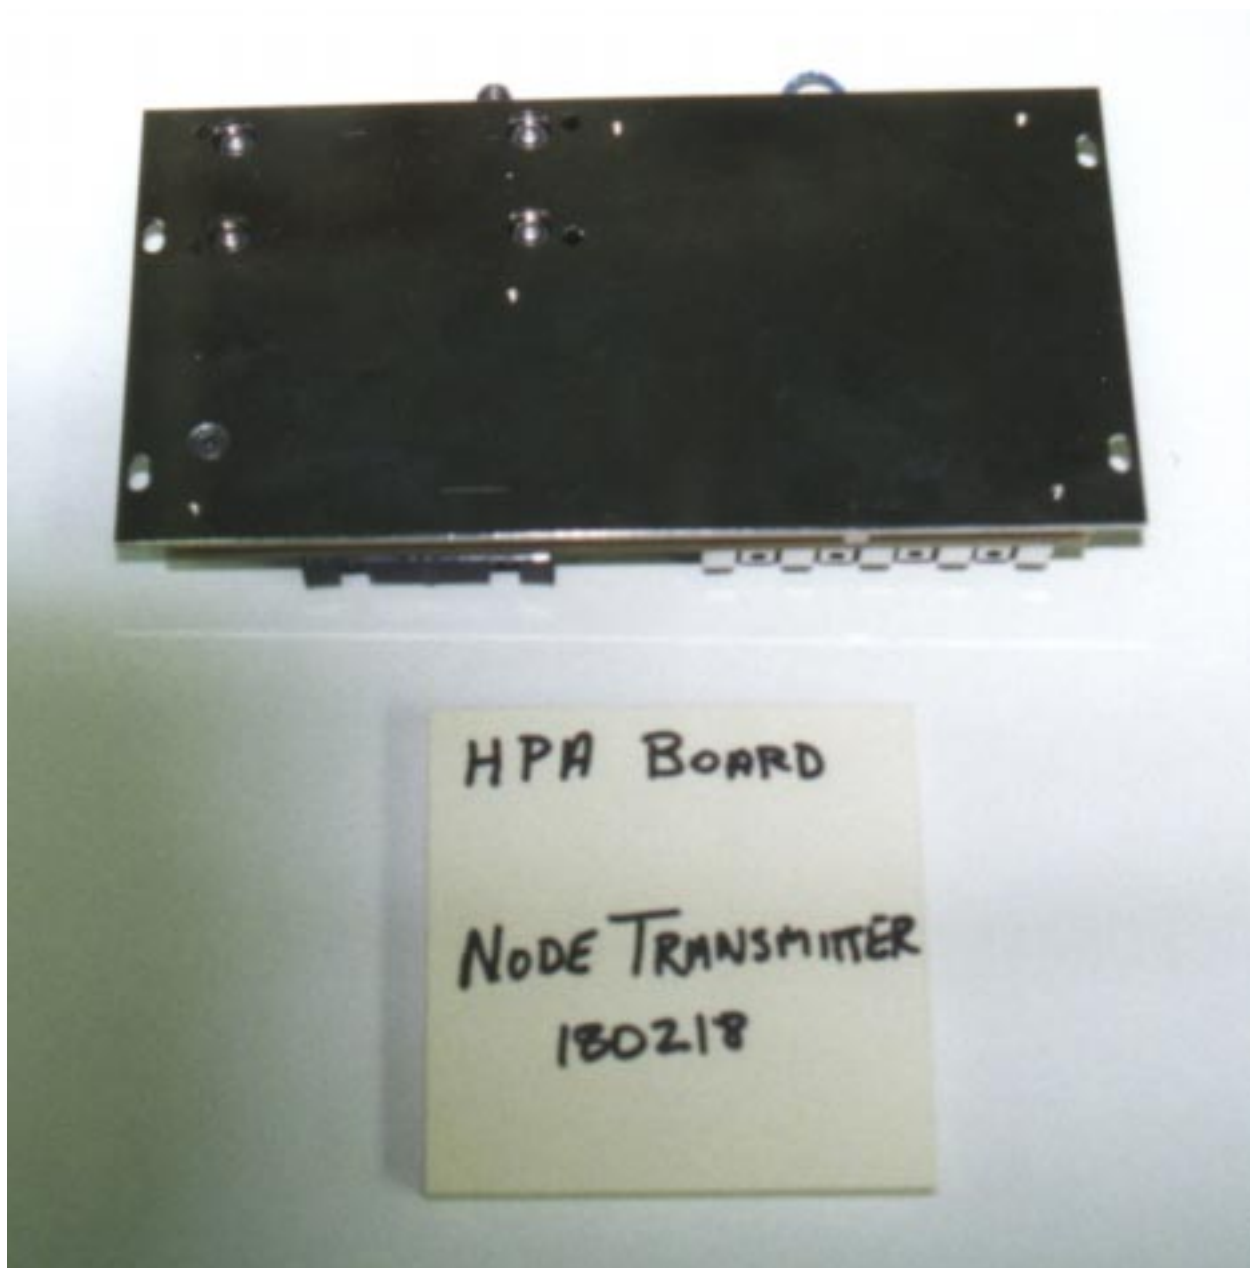
Figure 9-7 Transmitter High Power Amplifier (HPA) (Bottom View)

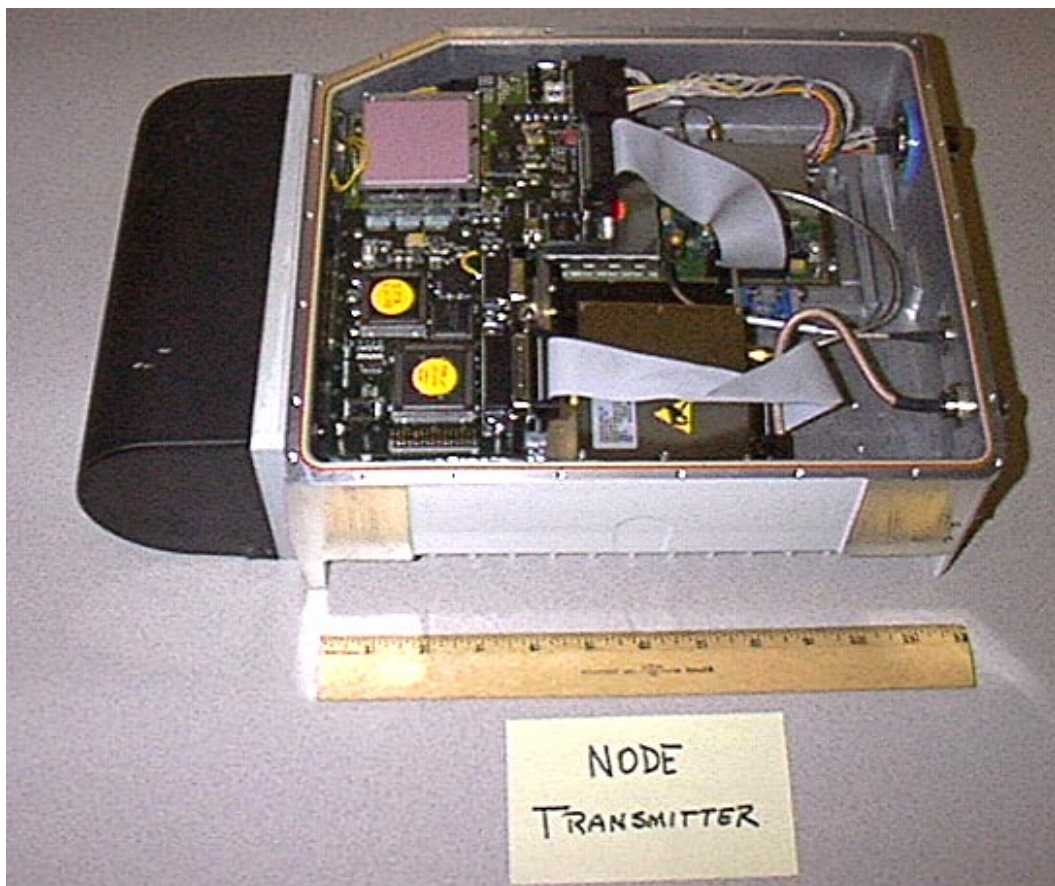
Figure 9-9 Transmitter in Redesigned Chassis with Chassis Cover Removed

The redesigned chassis will be used for all future production of the transmitter. A photograph of the transmitter components mounted in the redesigned chassis is shown on page 10 of this exhibit.
