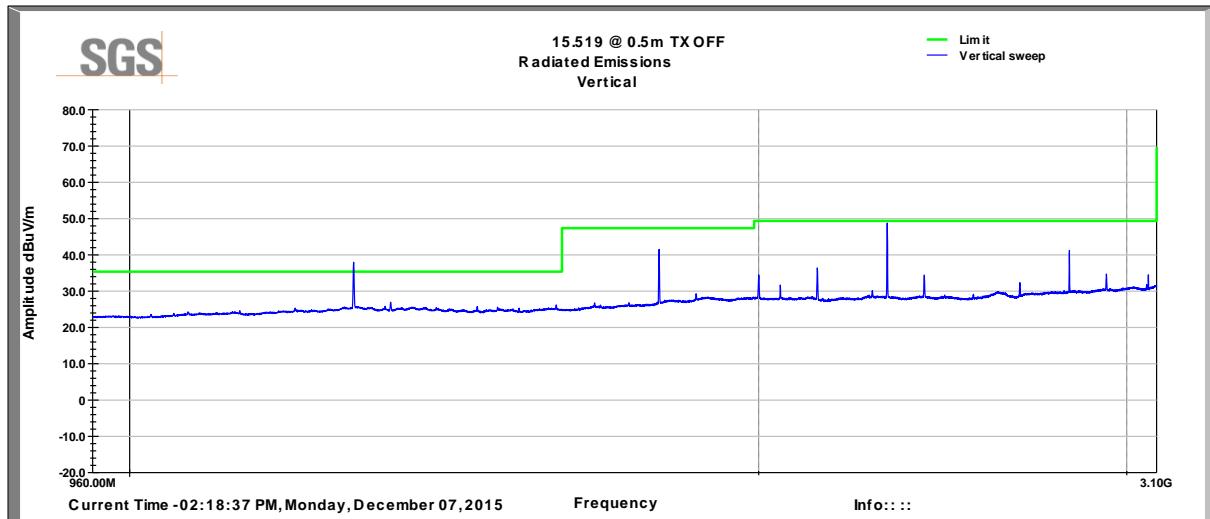
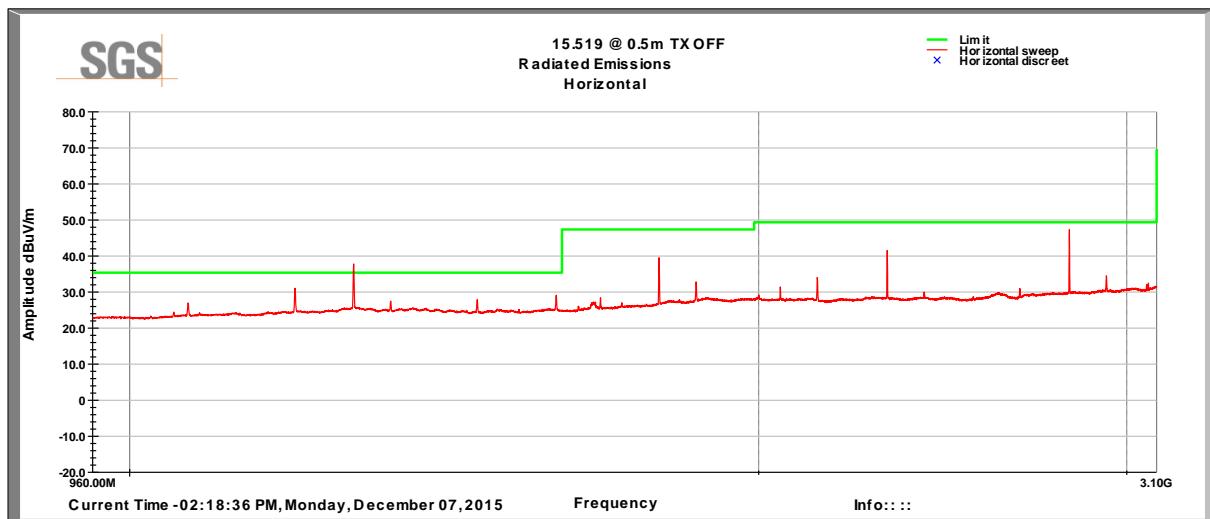
Ambient emissions scan  
EUT was removed from the chamber  
Noise spike are related to EMI receiver and Ethernet cable passing through the waveguide.

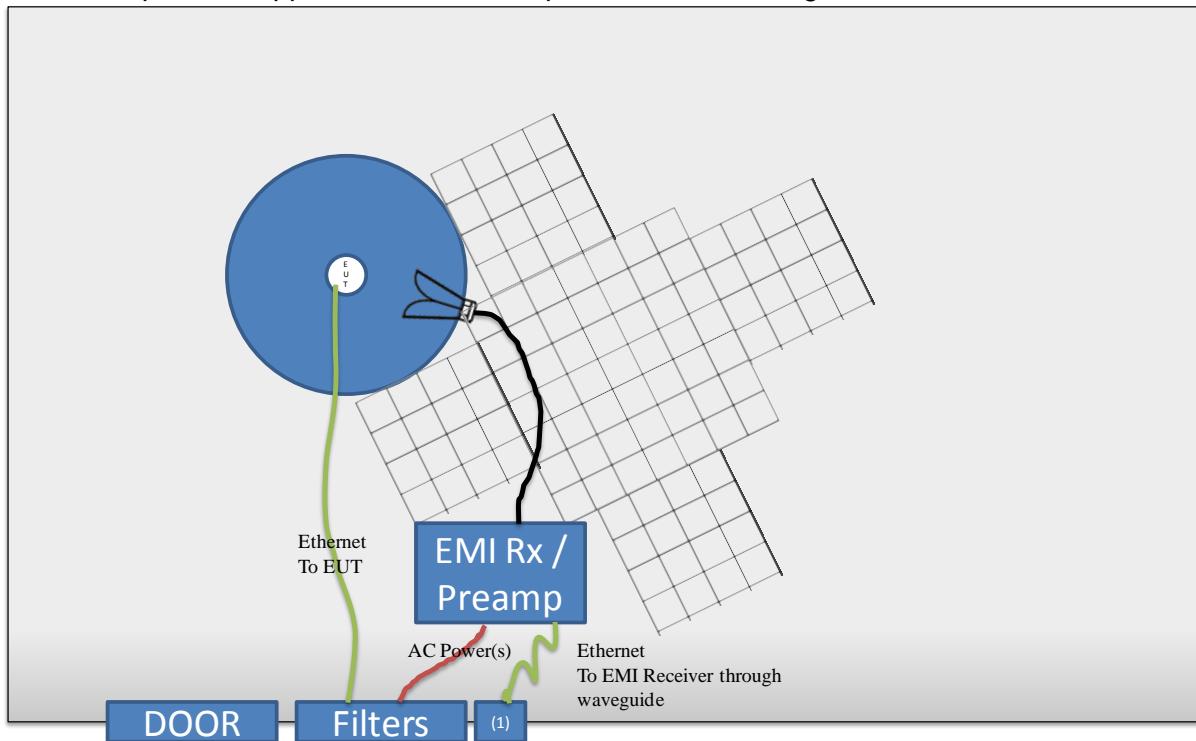
Layout of testing when cable lengths are critical for the measurement.  
Example here approximates the test position when testing at a 0.5 meter distance.
