TITLE: PLI Evaluation Report (RFI) **FCC ID: 0725346T (Pending)**
DRAWING: Q534615W.DWG
BY: Laura Bramschreiber and Phuong Nguyen

Page 19 of 41
Issued: 20 Feb 2005
Approved: Lee Pulver

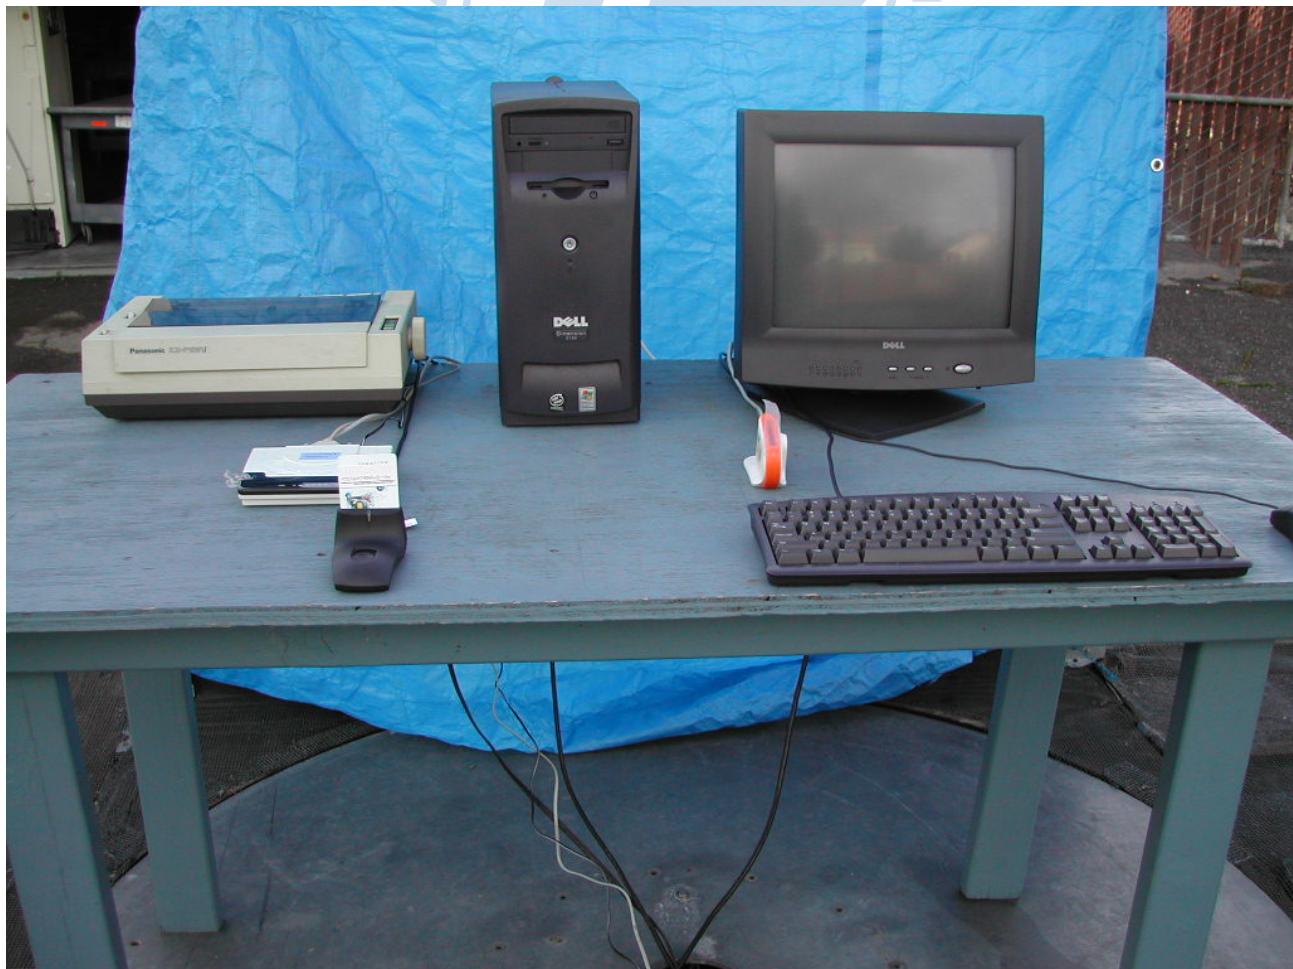
FIGURE 1: PLI Photograph Number 5346C2934SJ-07 illustrates the front view of the Equipment Under Test with all peripherals attached in **Test Configuration #1**. The "open field" radiated and the "screen room" conducted Radio Frequency Interference / Electromagnetic Interference test programs utilized this equipment and cable configuration.

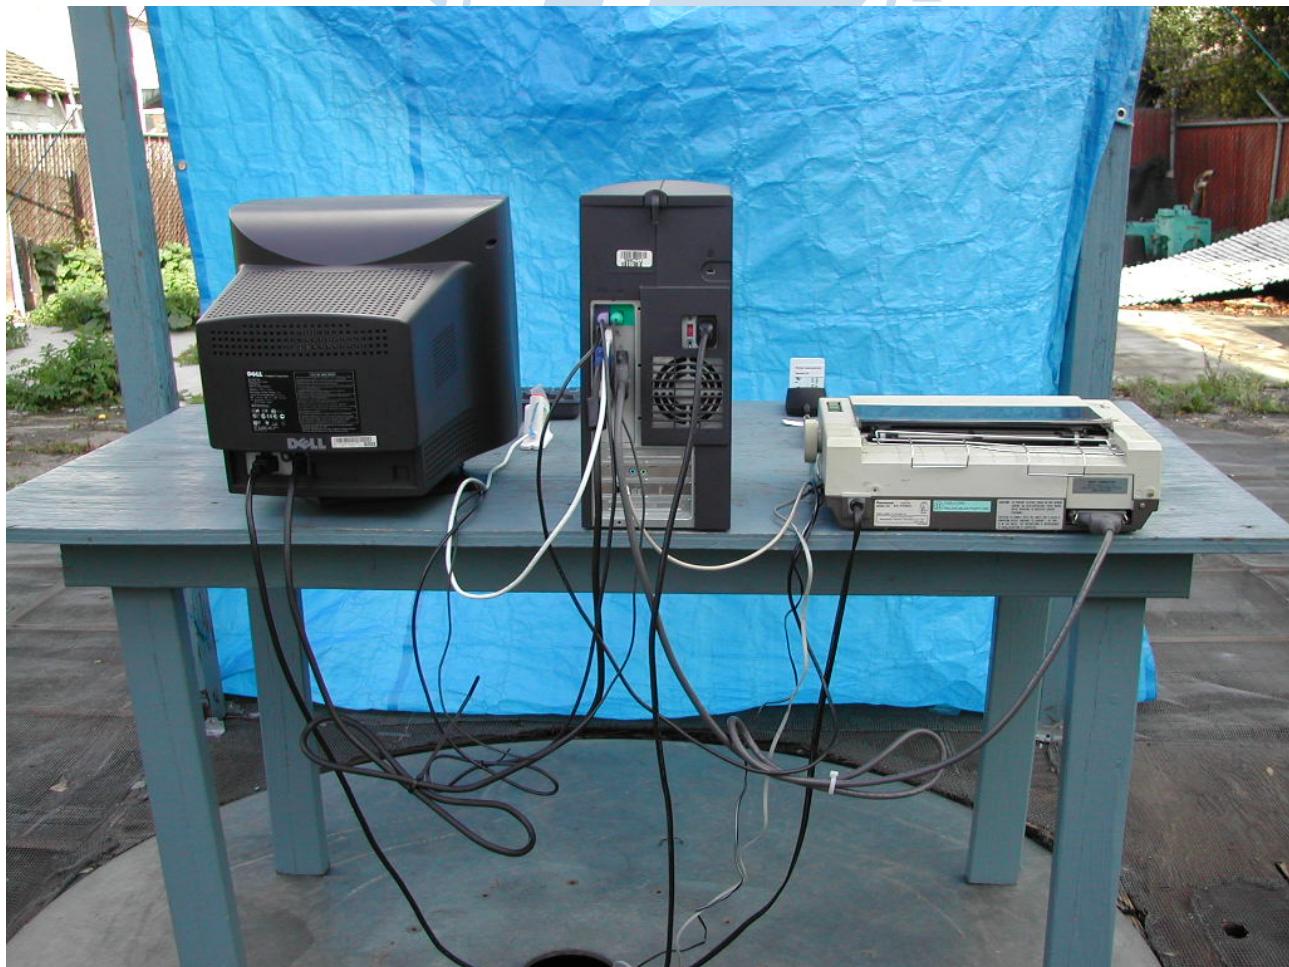
FIGURE 2: PLI Photograph Number 5346C2934SJ-06 illustrates the rear view of the Equipment Under Test with all peripherals attached in **Test Configuration #1**. The "open field" radiated and the "screen room" conducted Radio Frequency Interference / Electromagnetic Interference test programs utilized this equipment and cable configuration.

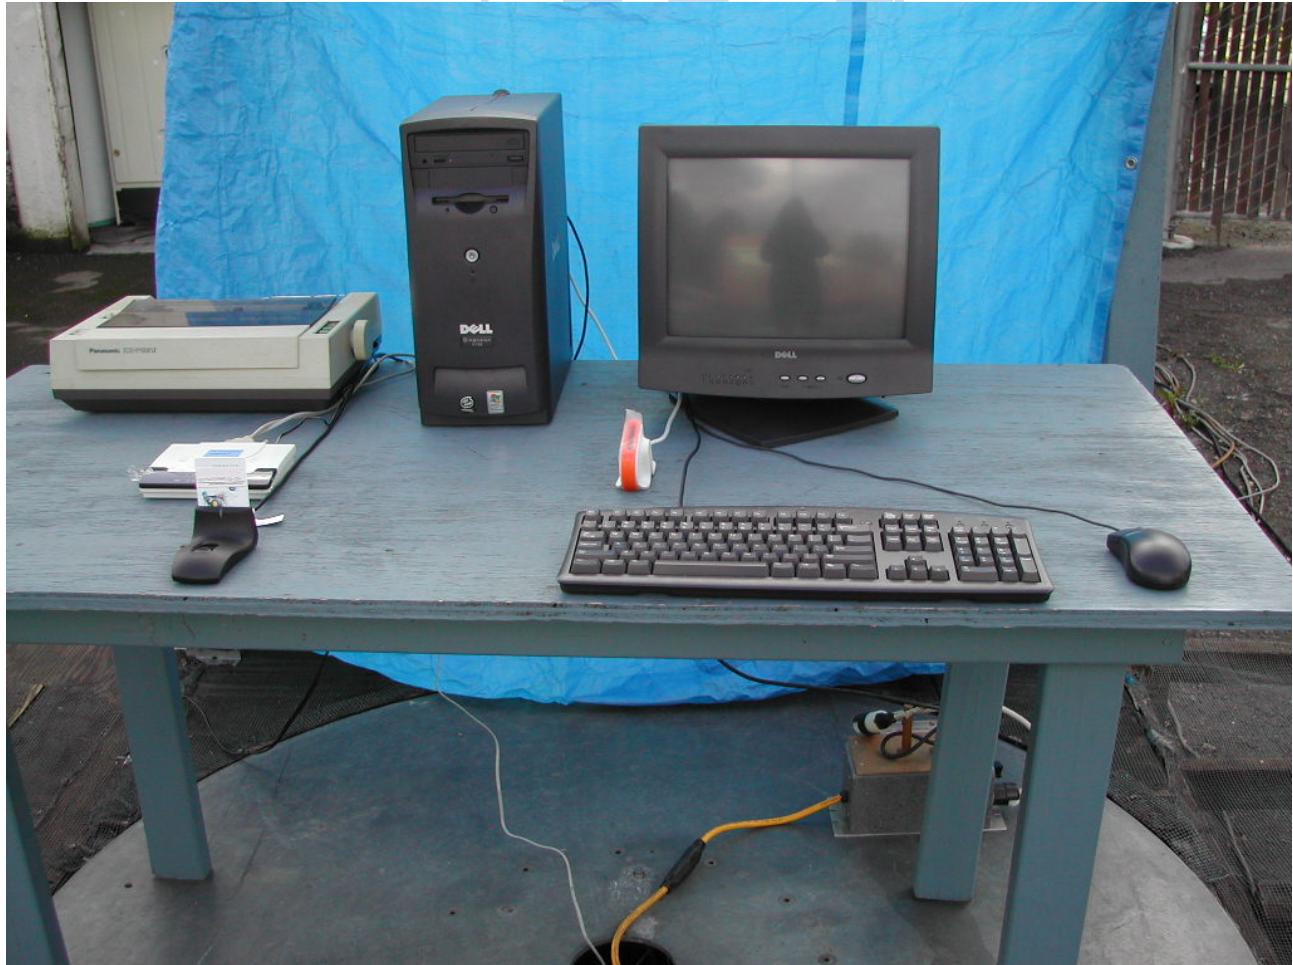
FIGURE 3: PLI Photograph Number 5346C2934SJ-08 illustrates the front view of the Equipment Under Test with all peripherals attached in conducted Electromagnetic Interference **Test Configuration #1**.

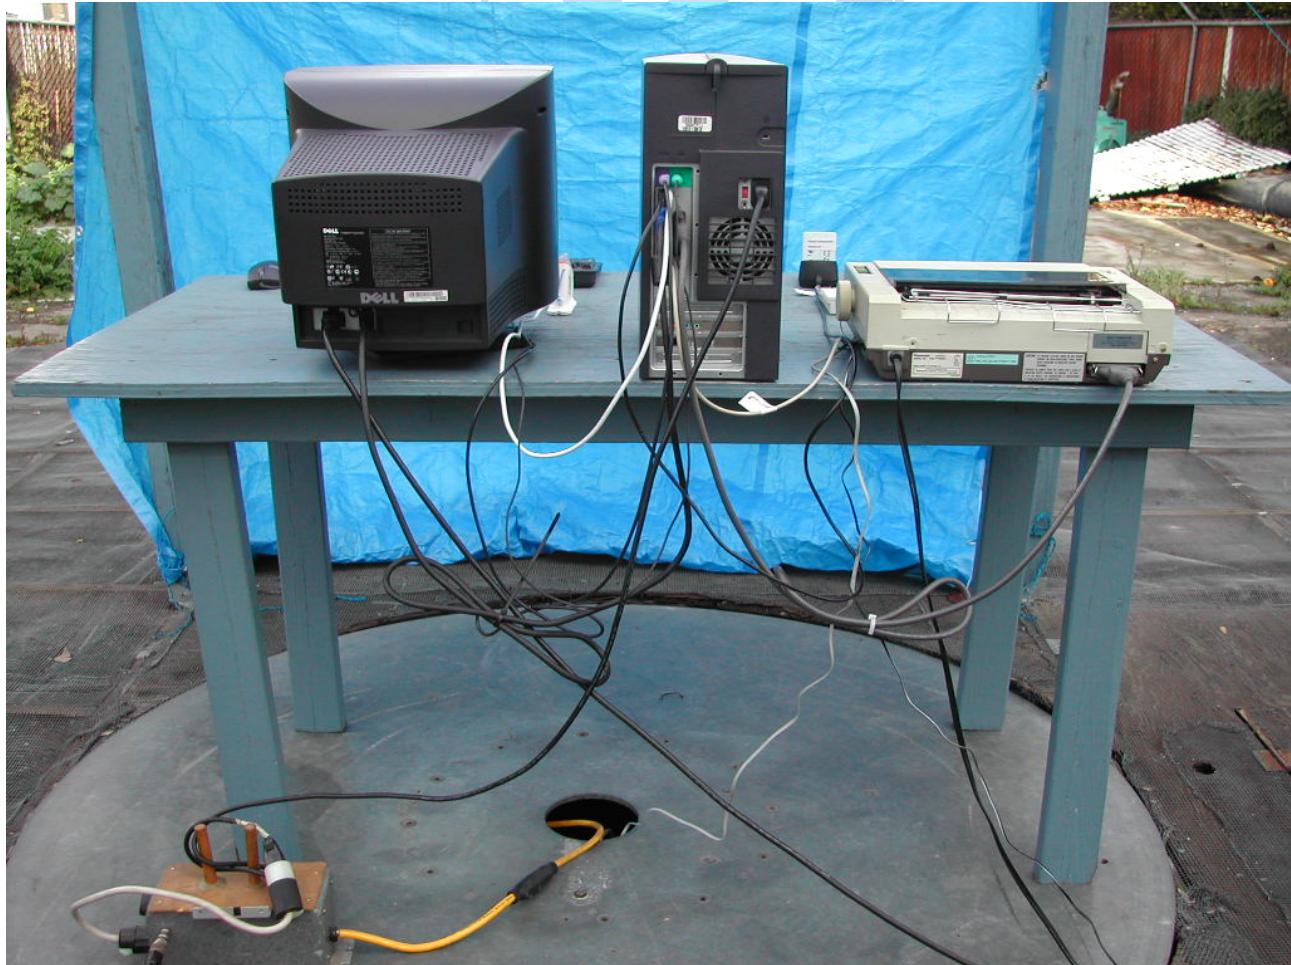
FIGURE 4: PLI Photograph Number 5346C2934SJ-09 illustrates the rear view of the Equipment Under Test with all peripherals attached in conducted Electromagnetic Interference **Test Configuration #1**.
