## Appendix B: photographs of test setup

## Appendix C: photographs of EUT

Reference to the test report no. BLA-EMC-202410-A5501

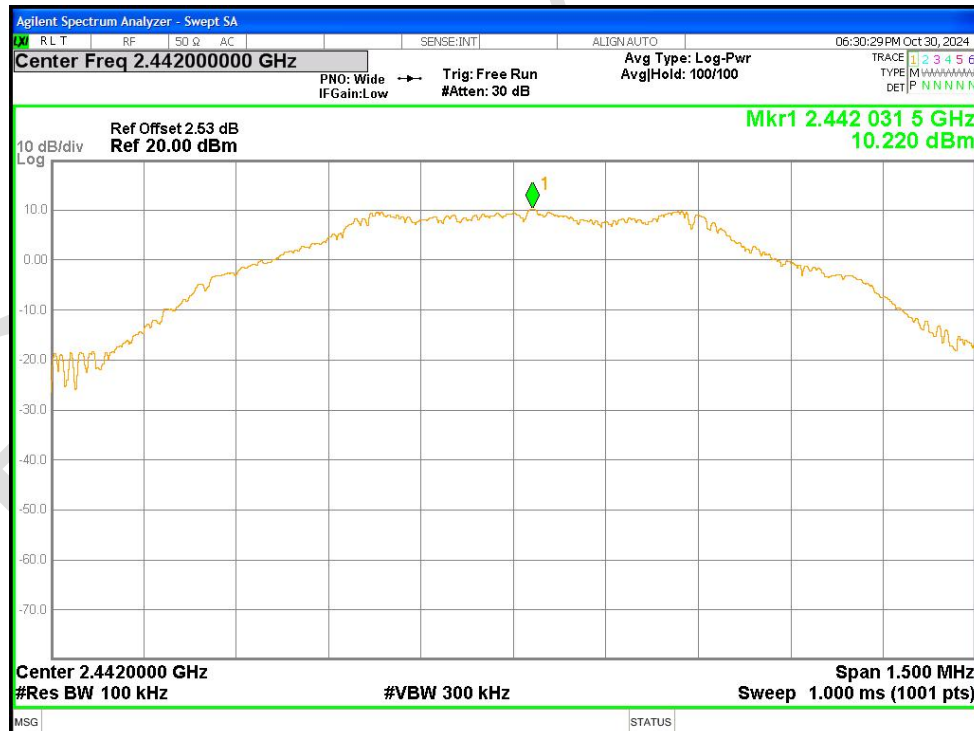
Tx. Spurious NVNT BLE 1M 2442MHz Ant1 Emission

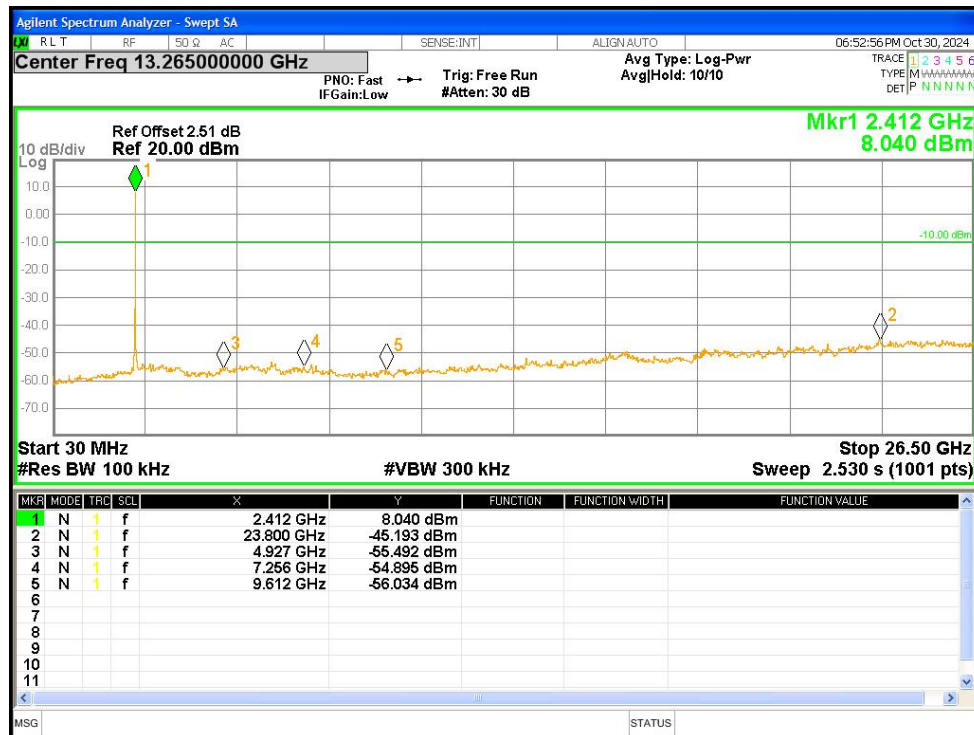
Tx. Spurious NVNT BLE 2M 2442MHz Ant1 Ref

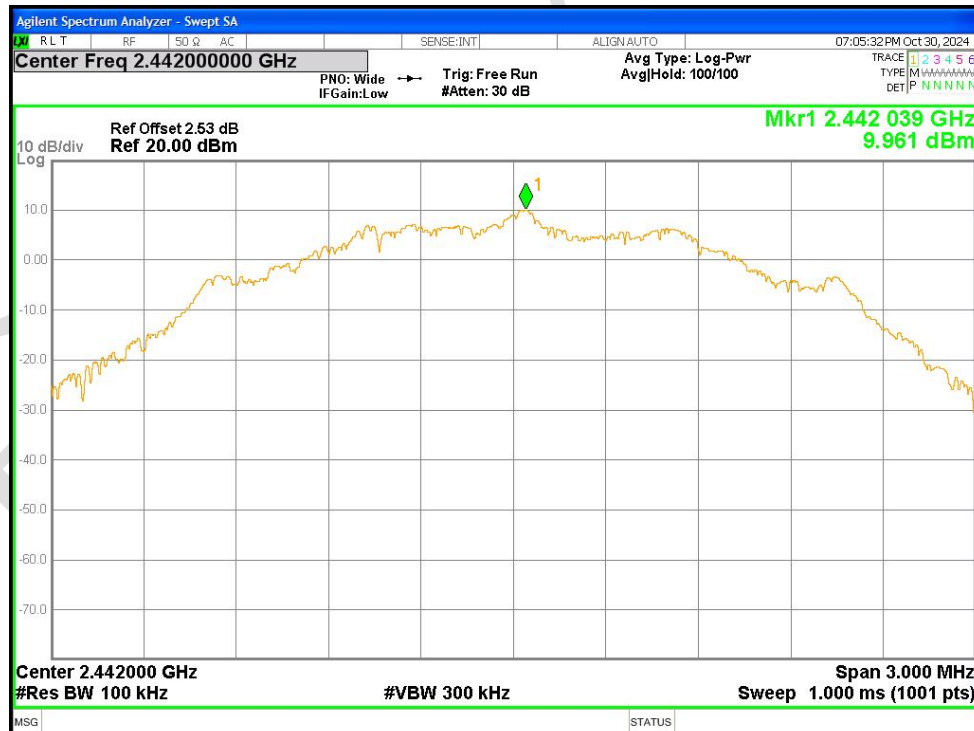
Tx. Spurious NVNT BLE 2M 2442MHz Ant1 Emission

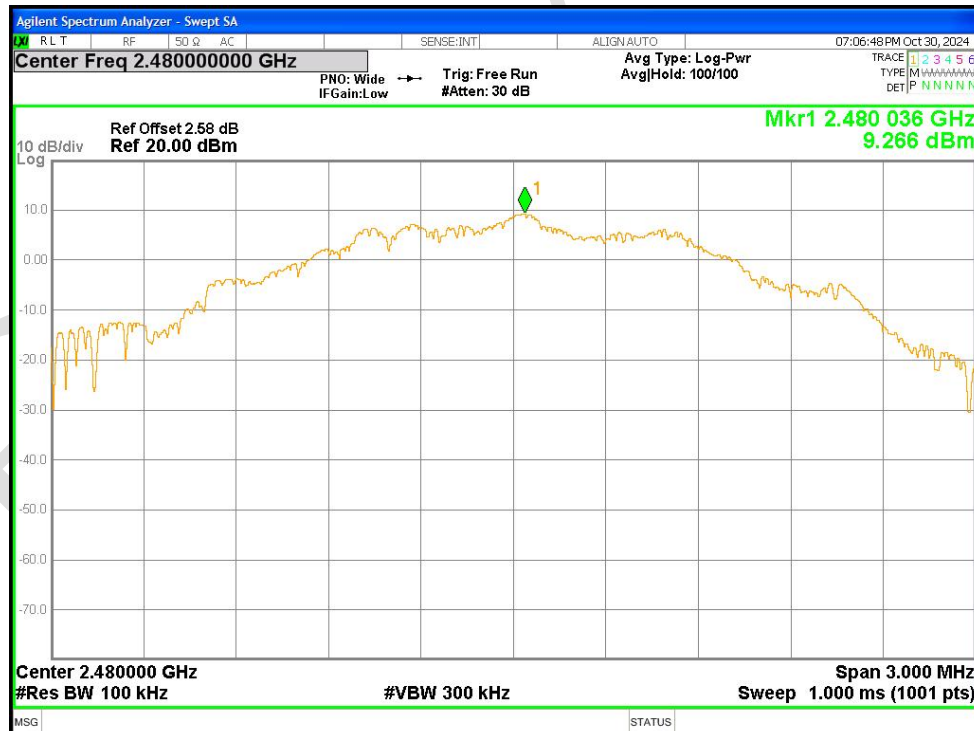
Tx. Spurious NVNT BLE 2M 2480MHz Ant1 Emission

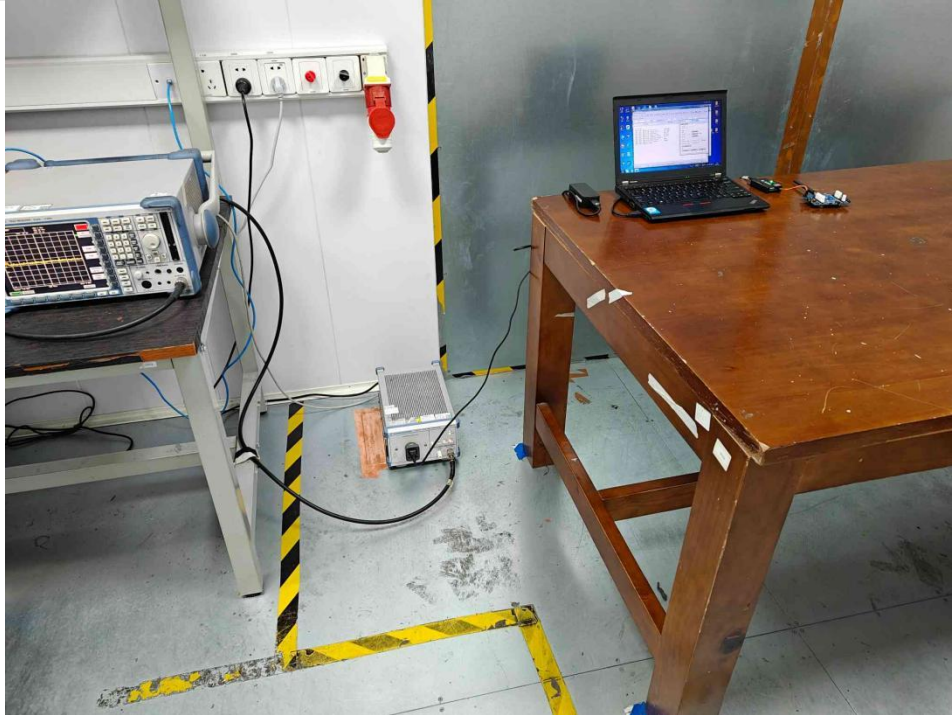
Conducted emissions at AC power line (150kHz-30MHz)

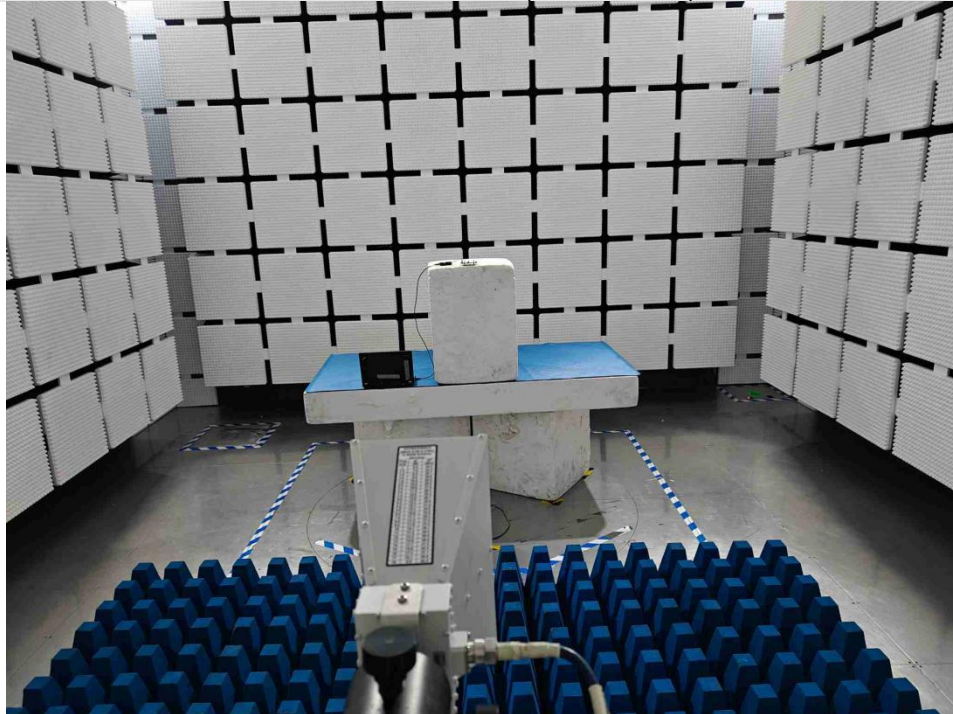
Radiated Emissions (above 1GHz)
