PEP Testing Laboratory

Condition: FCC CLASS-B 3m 3142B.H3 HORIZONTAL

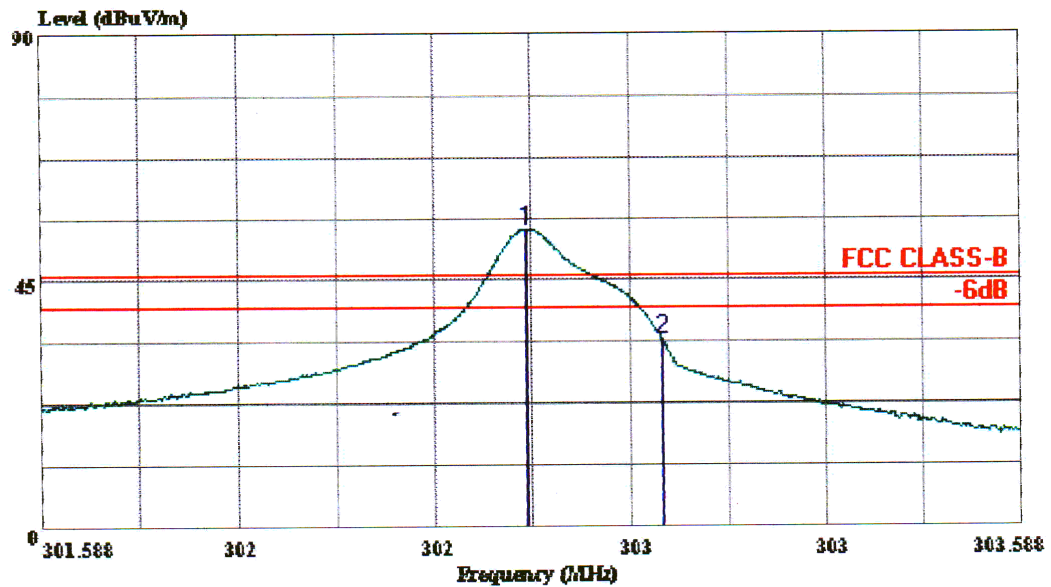
Figure 5.4 Occupied Bandwidth

cut : RC-01

power: DC12V

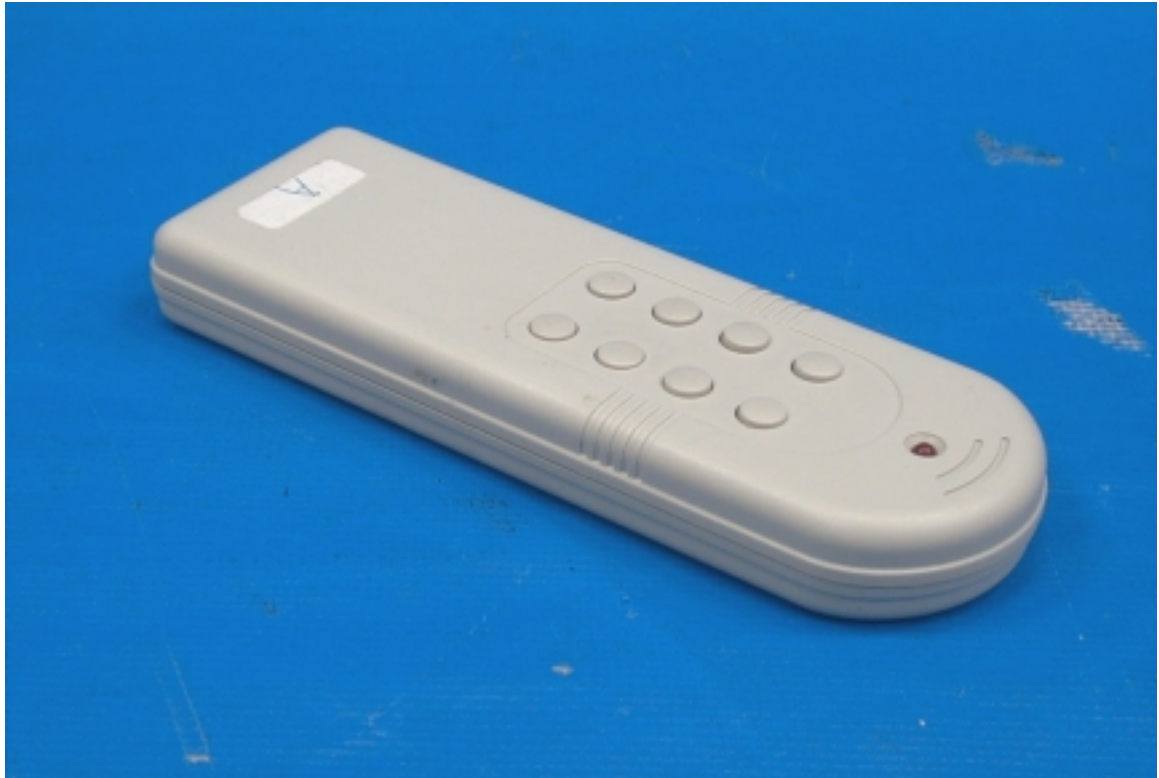
Figure 6.1 EUT Top View

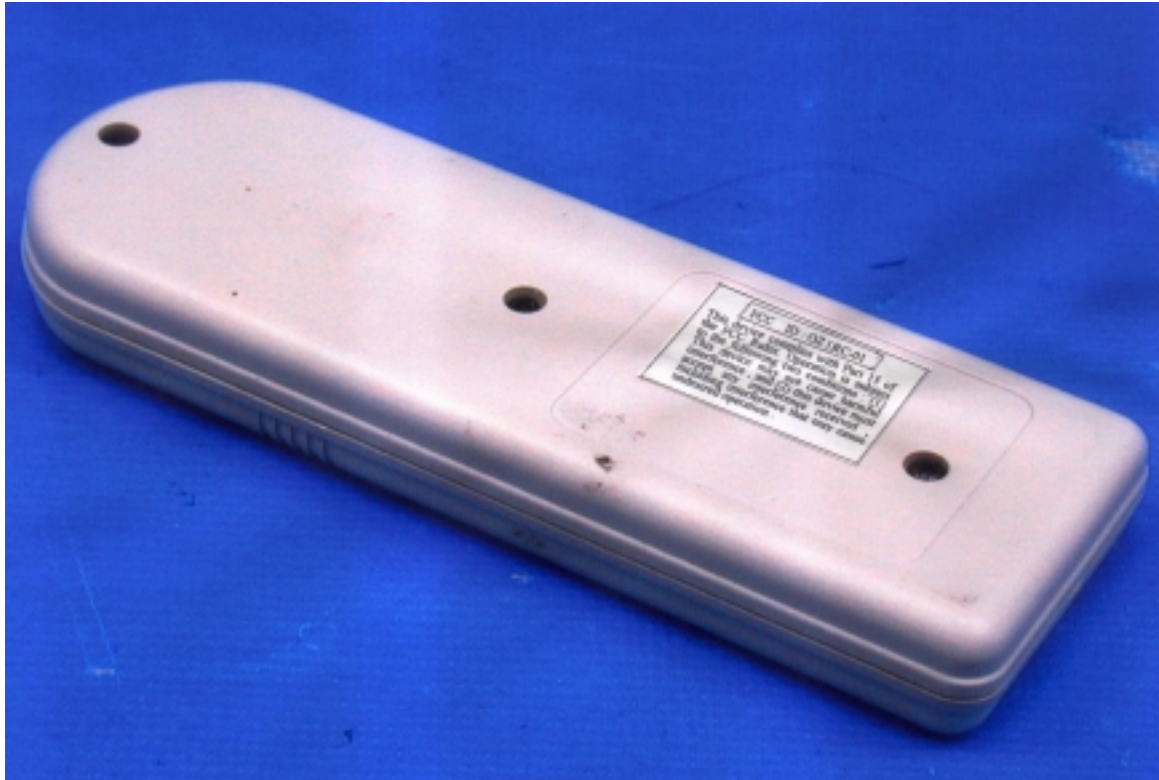
**Figure 6.2 EUT Bottom View**

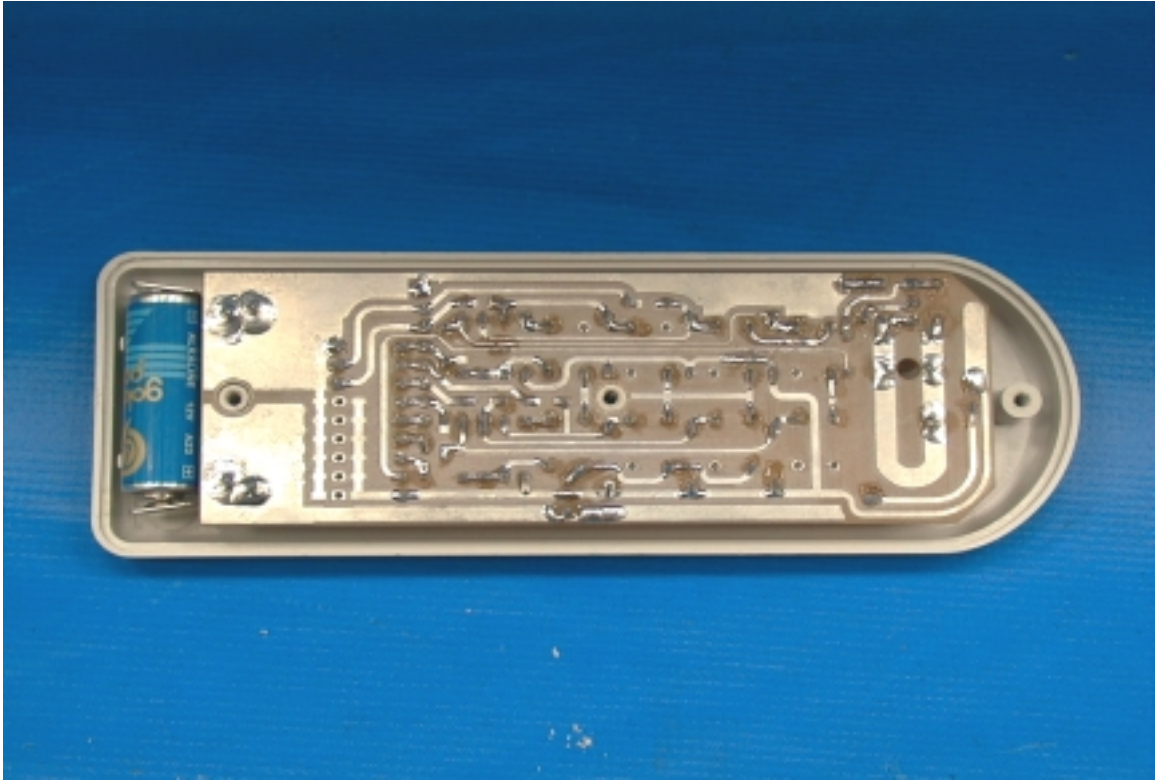
**Figure 6.3 EUT Inside View**

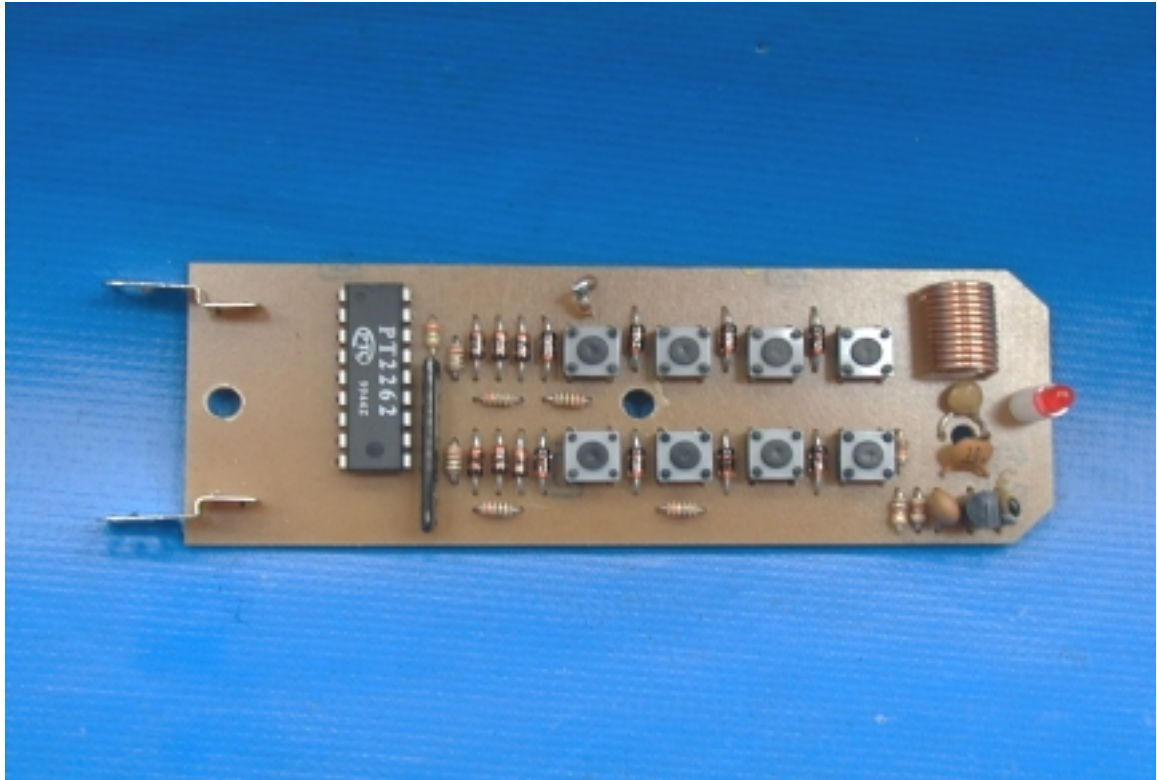
**Figure 6.4 EUT Component Side View**

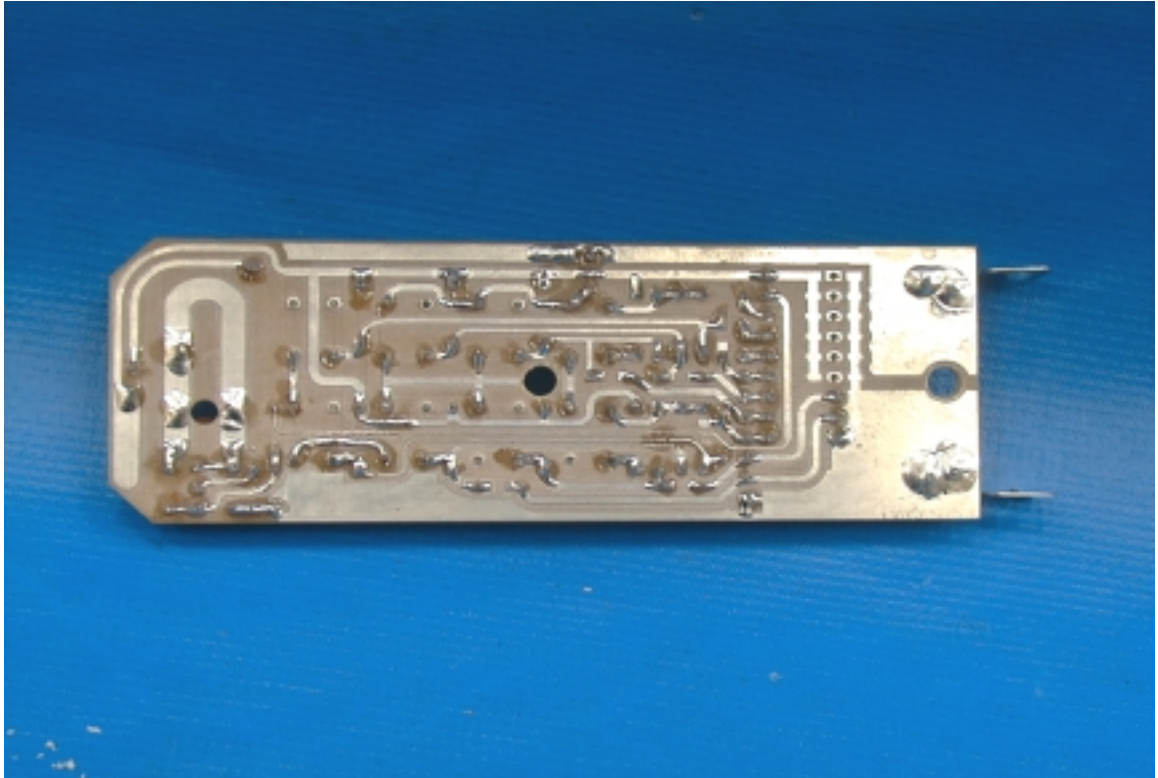
**Figure 6.5 EUT Soldering Side View**
