**Prufbericht-Nr: P00230684.f01**  
*Test report No: P00230684.f01*

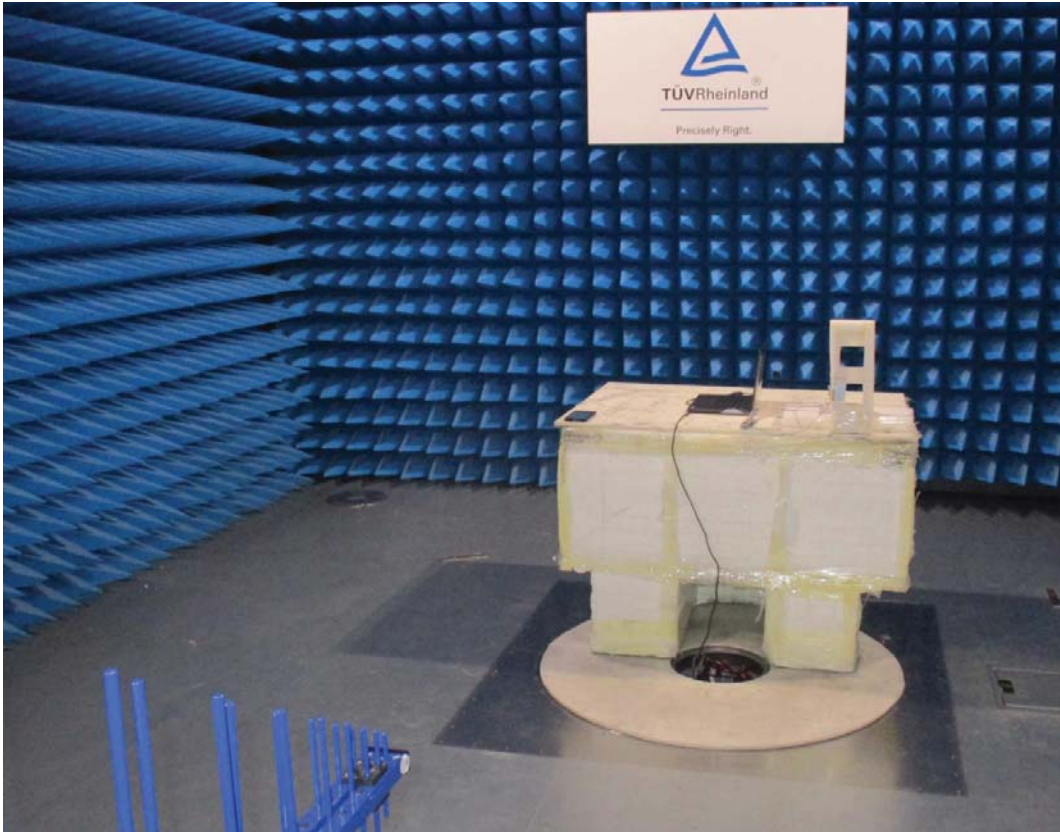
*Photo 1 Photograph test setup radiated emissions 30-1000 MHz*

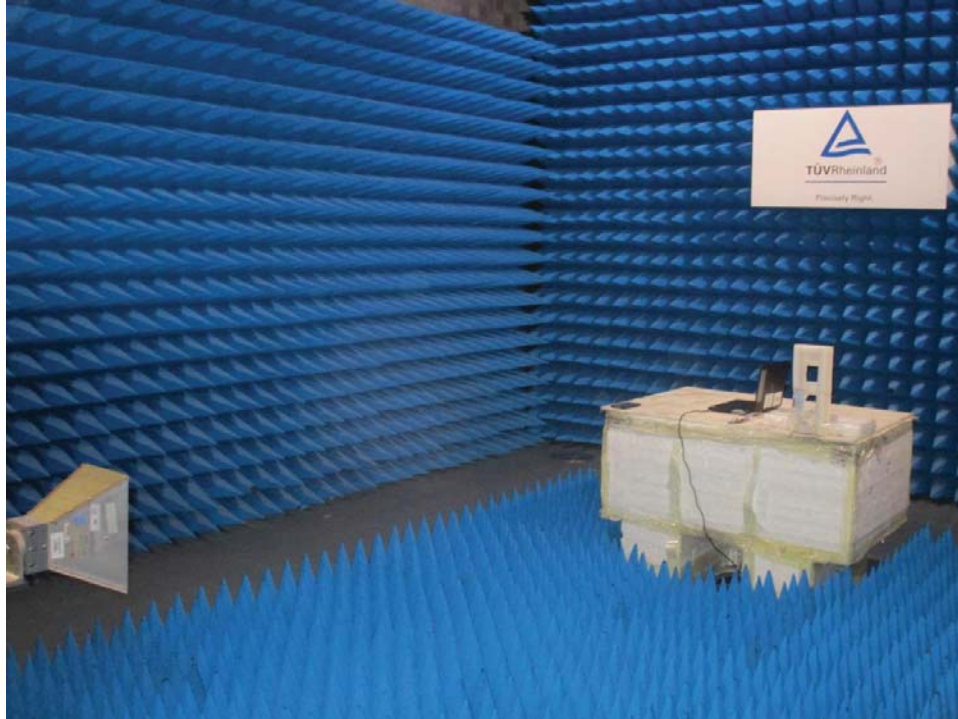
*Photo 2: Photograph radiated emissions 1 – 18 GHz*

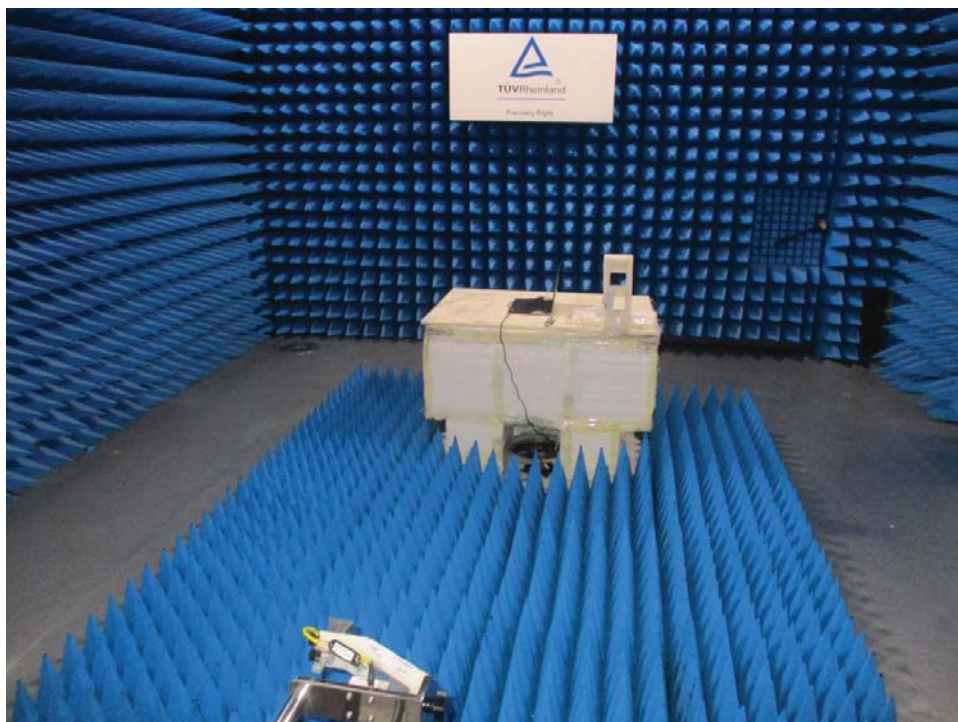
*Photo 3: Photograph radiated emissions 18 – 26.5 GHz*

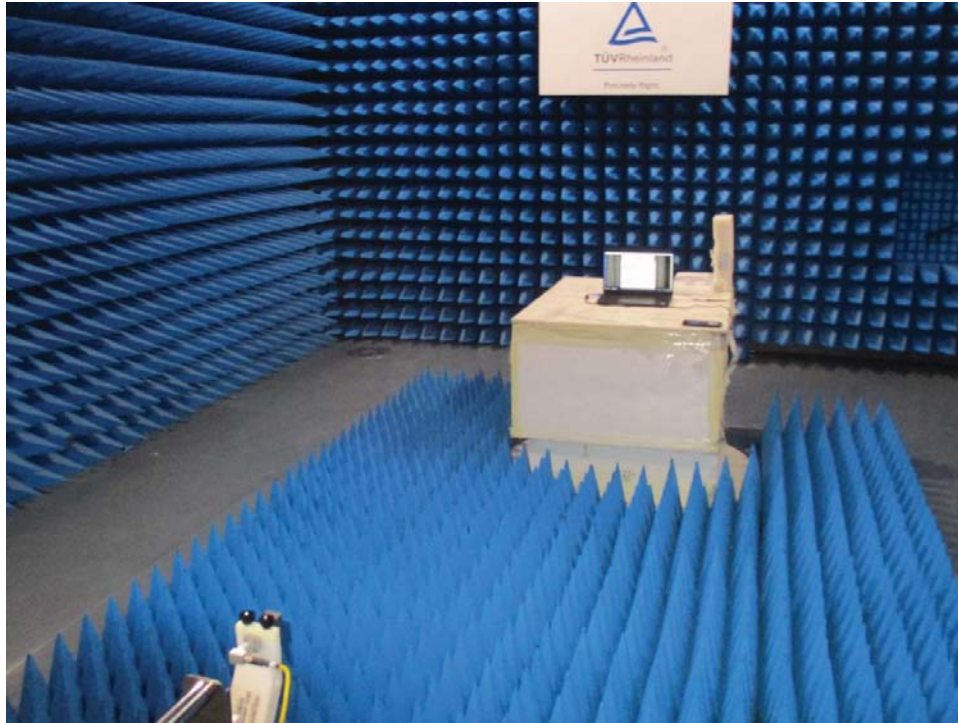
*Photo 4: Photograph radiated emissions 26.5 – 36 GHz*

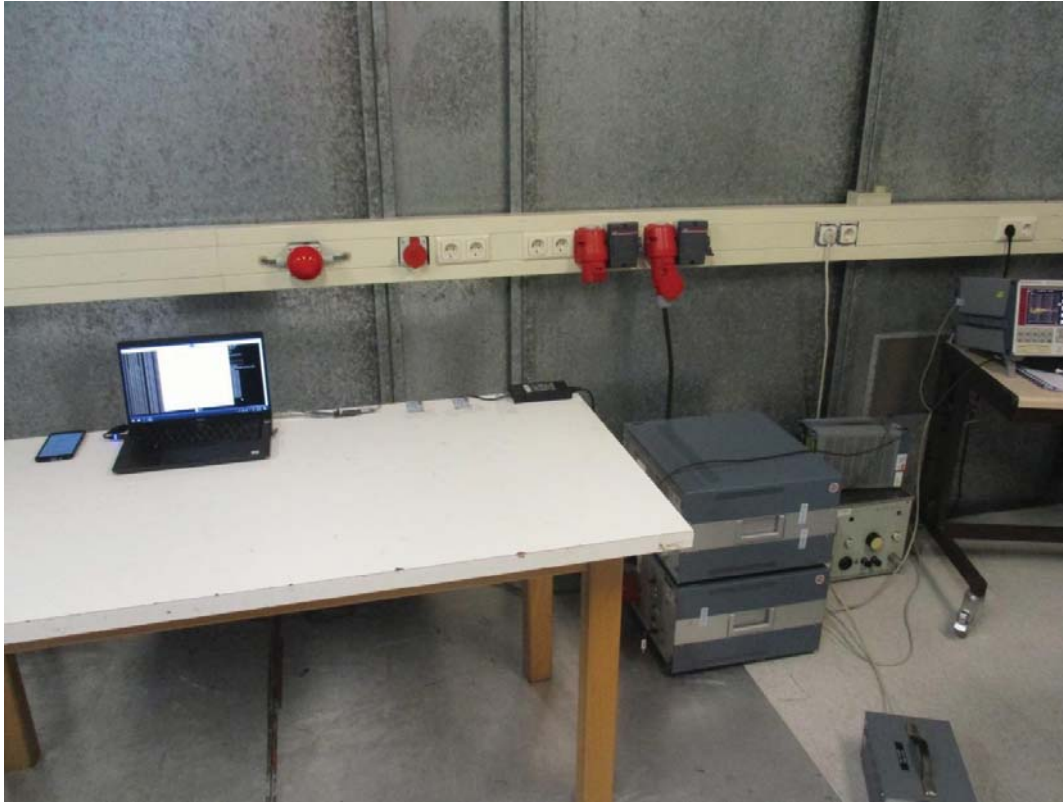
*Photo 5: Photograph conducted emissions 0.15-30 MHz*
