## Setup photos for HAC RF Emissions and T-Coil Test Report

| Test report no.: | HAC_Photo_RM-974_03 | Date of report: | 2014-04-20 |
| Tested devices: | RM-974 | | |
| Testing has been carried out in accordance with: | <b>ANSI C63.19-2011</b><br>American National Standard for Methods of Measurement of Compatibility between Wireless Communications Devices and Hearing Aids | | |

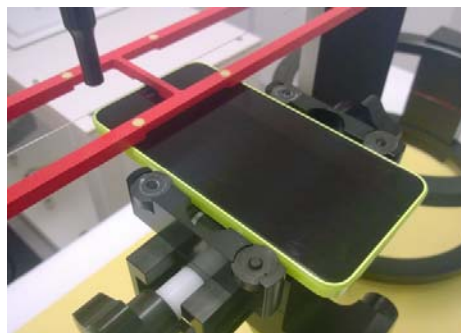
The device was positioned such that Device Reference plane was touching the bottom of the Test Arch. The scan is centered at the acoustic output by aligning the acoustic output with the intersection of the Test Arch's middle bar and dielectric wire.

Photo of the device positioned under Test Arch
