Sensortronics Industries, Inc.
Strike Sensor
FCC ID#: PSW-SS2001

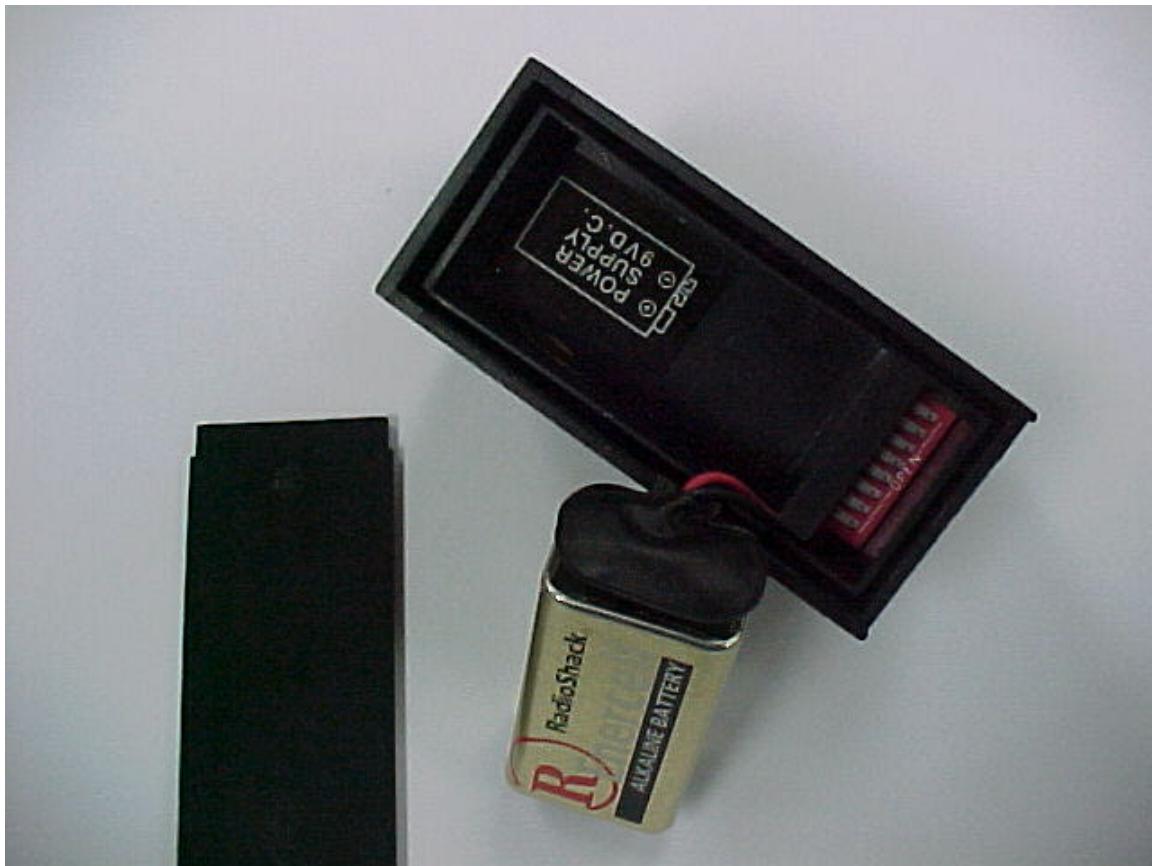
Photo Four
Battery Case Open with Battery removed – Programming Switches Accessable

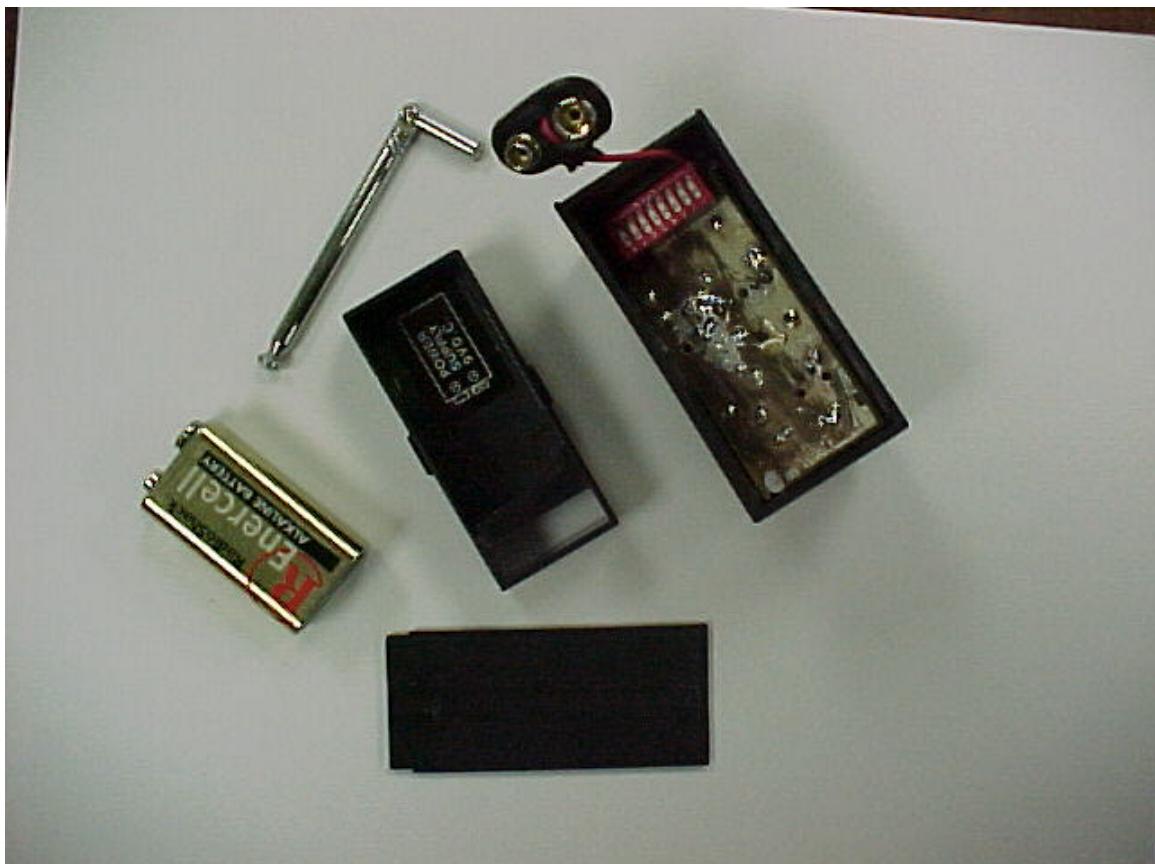
Photo Five
Battery Compartment Removed exposing the PCB – Open for Inspection

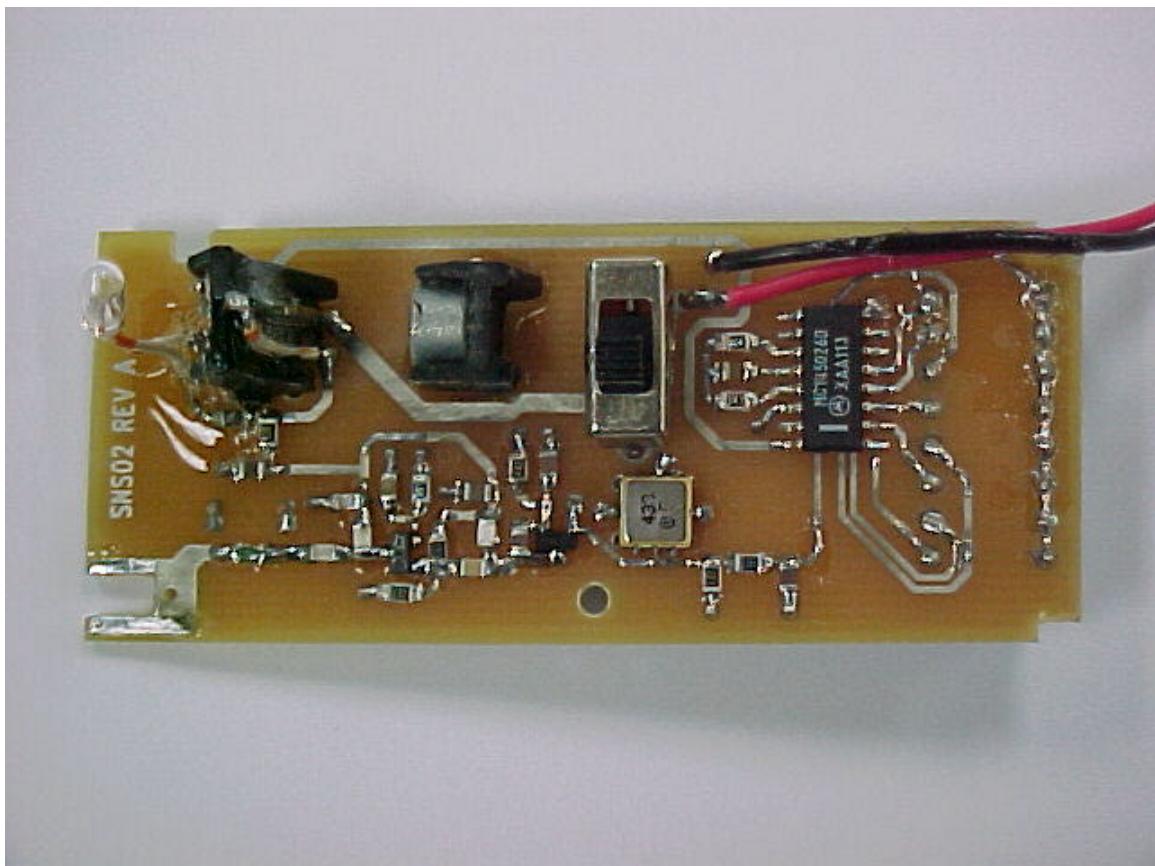
Photo Six
PCB removed – Component Side

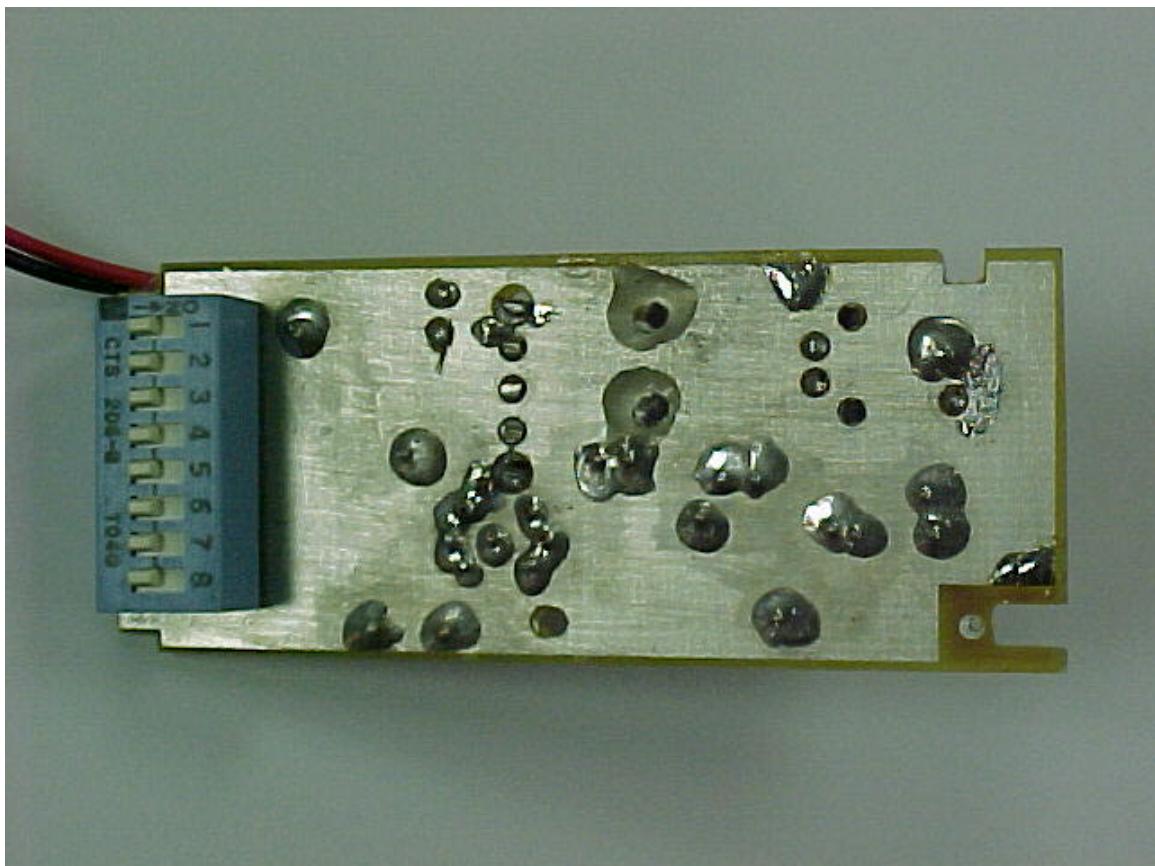
Photo Seven
PCB removed – Trace Side

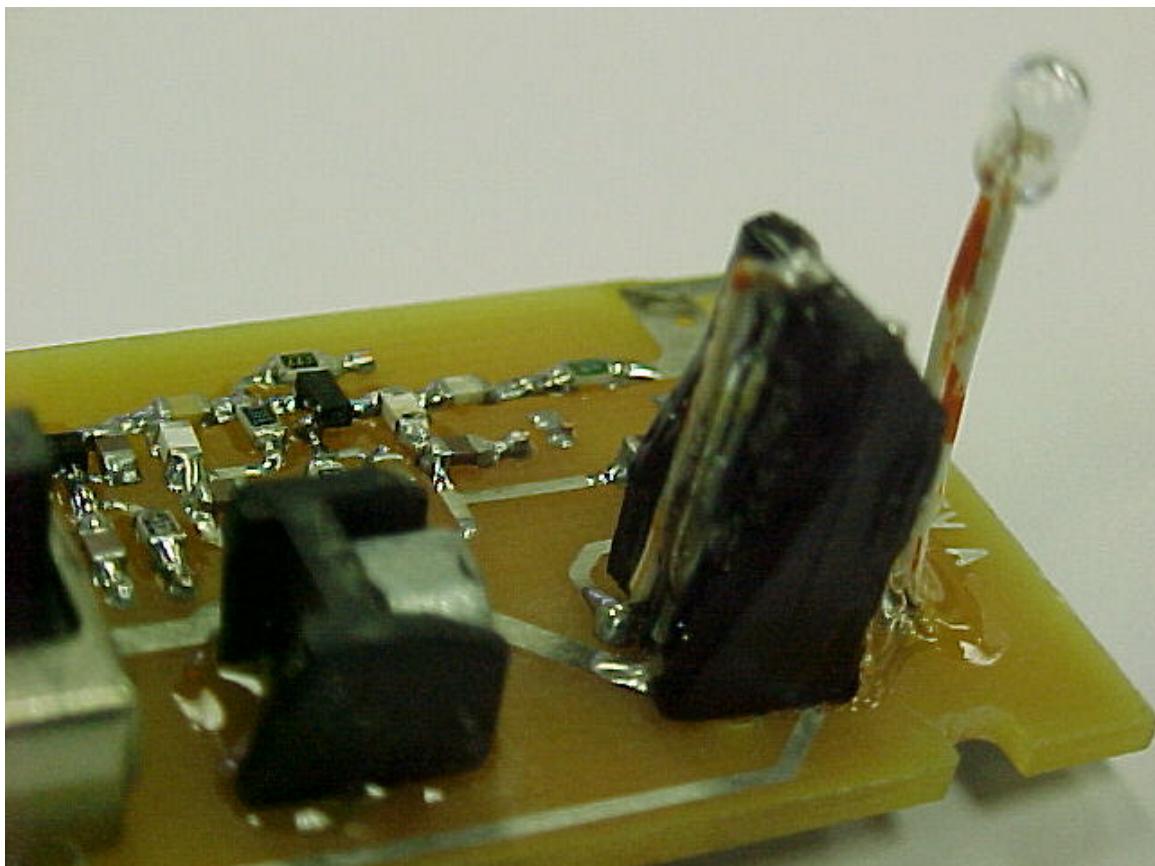
Photo Eight
PCB close-up of Mercury Switch to engage RF Transmitter

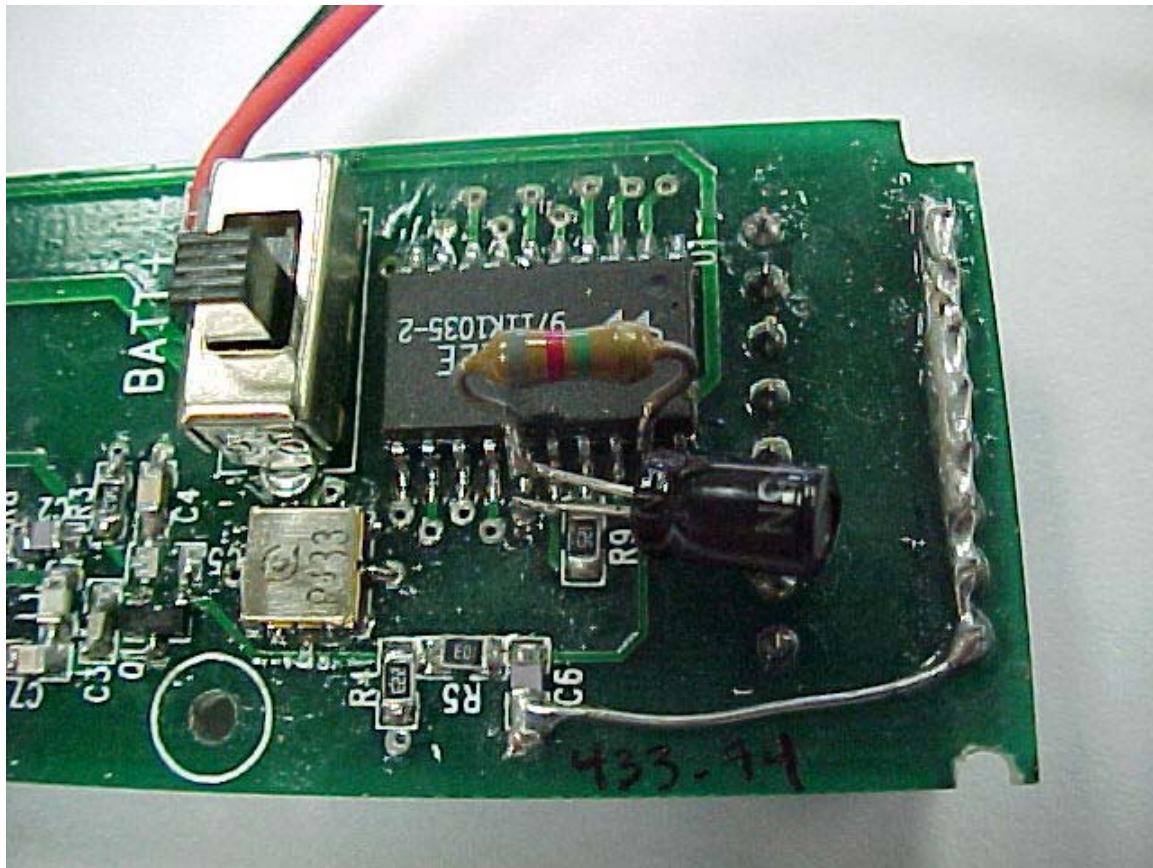
Photo Nine

**RC modification to provide 4 sec. Time Out on the transmitter
Updated schematic supports this modification.**
