## CONDUCTED SPURS AND HARMONICS

### CONDUCTED SPURIOUS OUTPUT

## CONDUCTED HARMONIC OUTPUTS

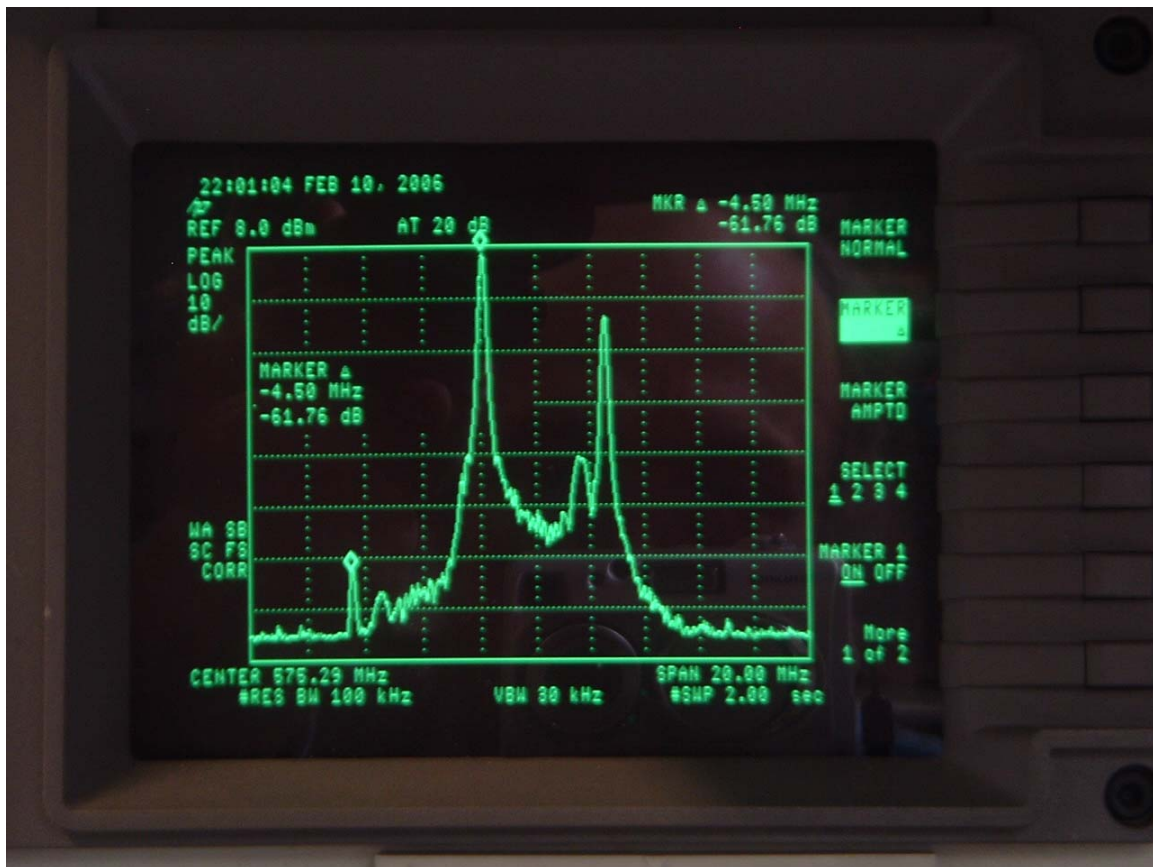
POWER OUTPUT 2.0KW

The following photograph indicates the spurious performance ( $\pm 3$  MHz) from the designated TV channel. As can be seen from the photos taken at a power level of 2.0kW, the spurious levels are  $>60$  dB below the peak of sync of the visual carrier. The diamond in the top center of the screen indicates the true peak of sync of the visual carrier and the waveform indicates that the  $-4.5$  MHz intermodulation (IM) product is 61.75 dB down from peak of sync. The  $+9$  MHz IM product visible in the photo is at  $-72$  dB below the visual carrier. This photo indicates the desired 13dB aural to visual power level. The SPAN is 20MHz and the vertical scale is 10dB/div.

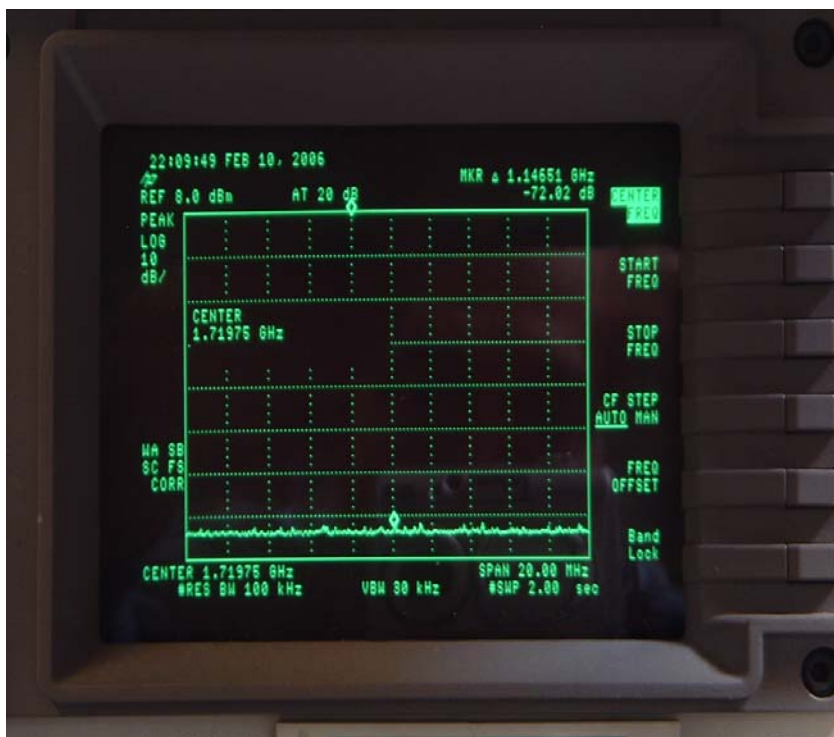
Third harmonic spectrum

The following data indicates the harmonic performance of the UTX2KW ULTRA. The setup of Figure 1 was used to measure the harmonics. In this case the spectrum analyzer replaced the HP435 Power meter. Only the second and third harmonics were visible above the -75 dB noise floor of the spectrum analyzer. The following table displays the actual value of the harmonic that takes into account of the high power attenuators and cable used for the measurements. The value of <-75dB in the table indicates that the harmonic level was below the noise floor of the spectrum analyzer. Photographs of the spectrum containing the second and third harmonics are shown below. The pictures indicate that the harmonic levels are below 60 dB compared to the diamond at the top of the screen.

Photographs of 2<sup>nd</sup> and 3<sup>rd</sup> harmonics are on the following page.
