# Setup photos for HAC RF Emissions and T-Coil Test Report

| <b>Test report no.:</b> | HAC_Photo_RM-1063_03 | <b>Date of report:</b> | 2015-01-13 |
| <b>Tested devices:</b> | RM-1063 | | |
| <b>Testing has been carried out in accordance with:</b> | <p><b>ANSI C63.19-2011</b><br/>American National Standard for Methods of Measurement of Compatibility between Wireless Communications Devices and Hearing Aids</p> <p><b>CTIA Test Plan for Hearing Aid Compatibility, Revision 3.0, November 2013</b></p> | | |

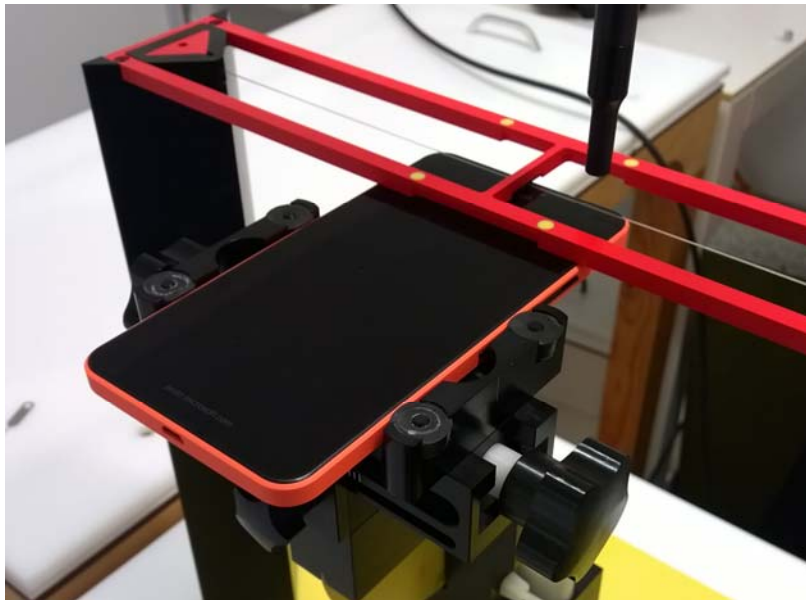
The device was positioned such that Device Reference plane was touching the bottom of the Test Arch. The scan is centered at the acoustic output by aligning the acoustic output with the intersection of the Test Arch's middle bar and dielectric wire.

Photo of the device positioned under Test Arch
