### **APPENDIX 3: Photographs of test setup**

#### **Radiated Spurious Emission**

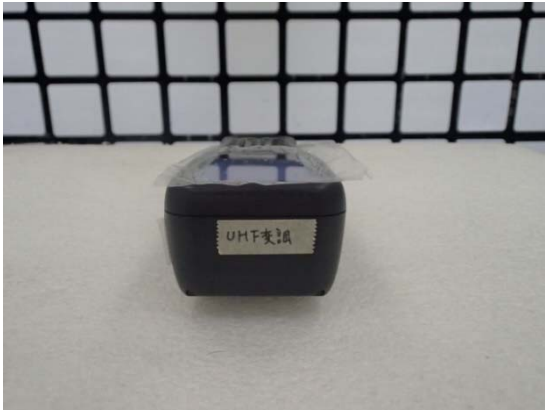
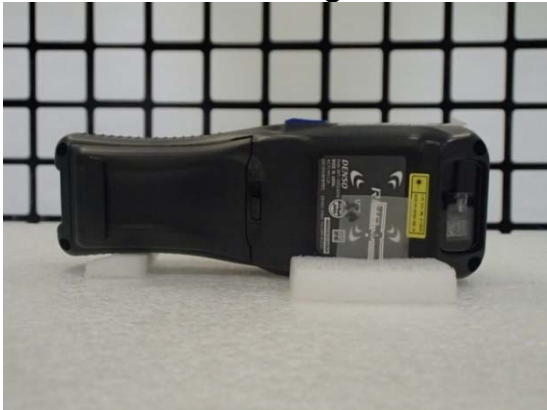
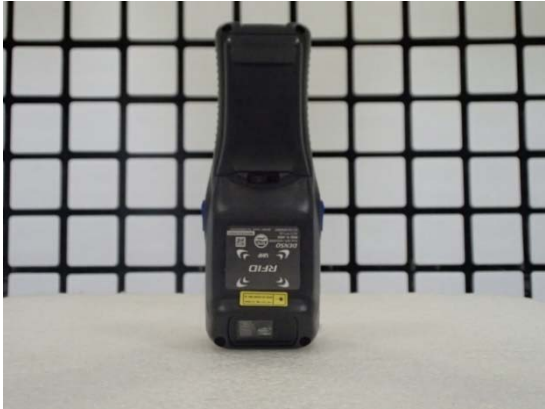
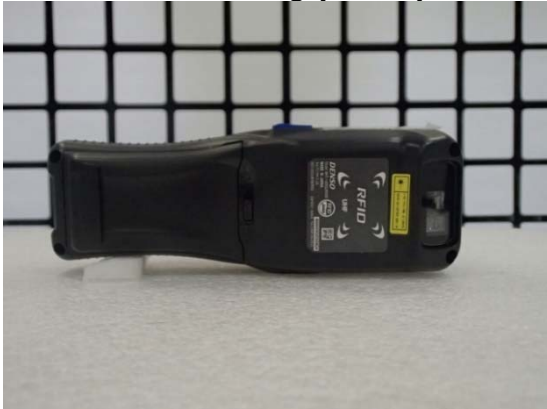
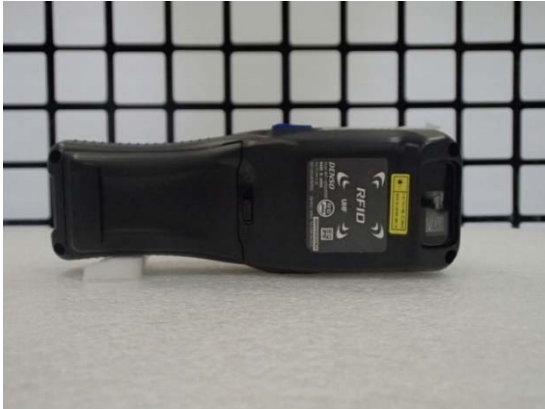
**Worst Case Position**

| Test Range | Horizontal | Vertical |
| Below 1 GHz | Z-axis | Y-axis |
| Above 1 GHz | Y-axis | Y-axis |

**X-axis**

**With Tag**

**Y-axis**

**Without Tag (Worst)**

**Z-axis**

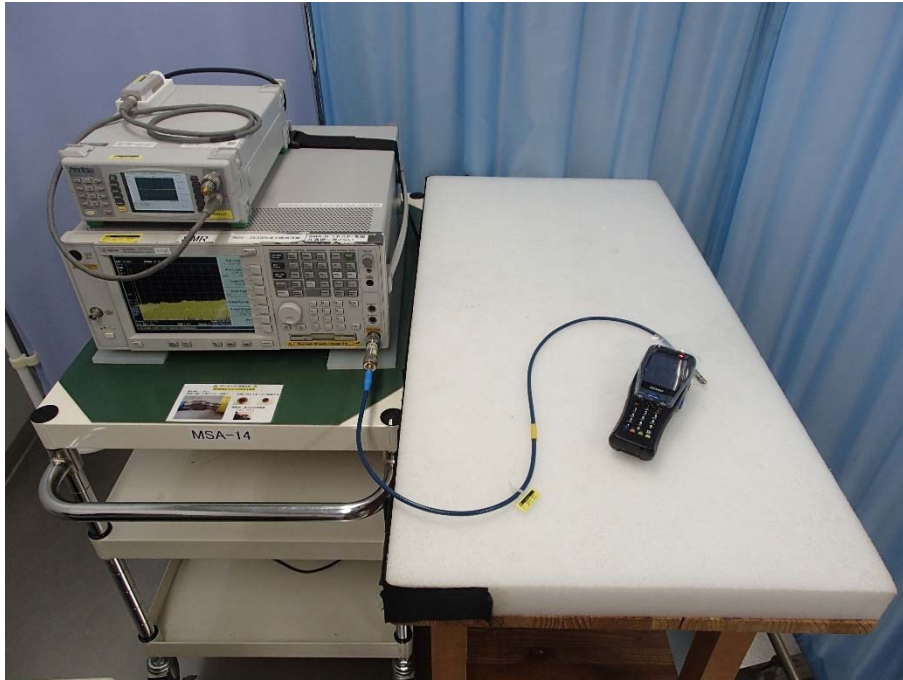
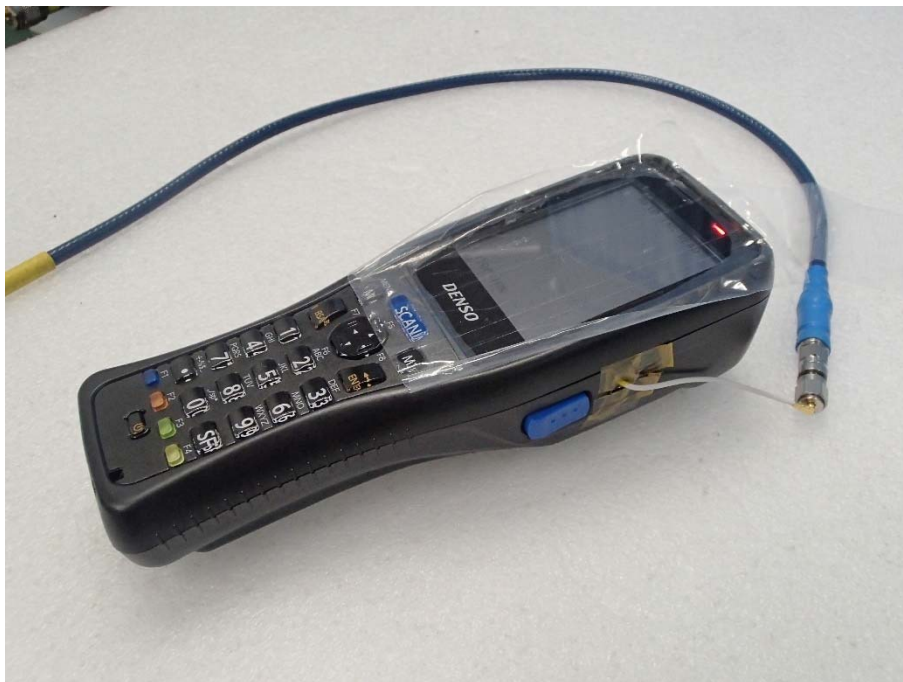
Photo 1

### Antenna Terminal Conducted Tests
