Overall View of  
Transmitter module

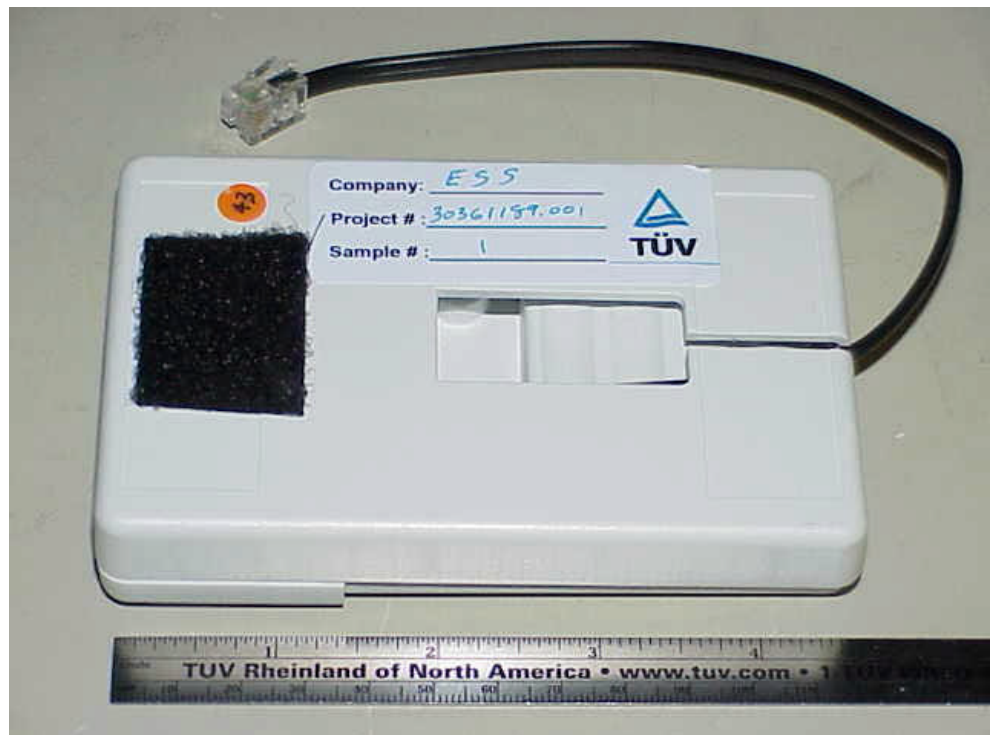
Bottom view of  
transmitter
