### **APPENDIX 3: Photographs of test setup**

#### **Conducted Emission**

### Radiated Spurious Emission

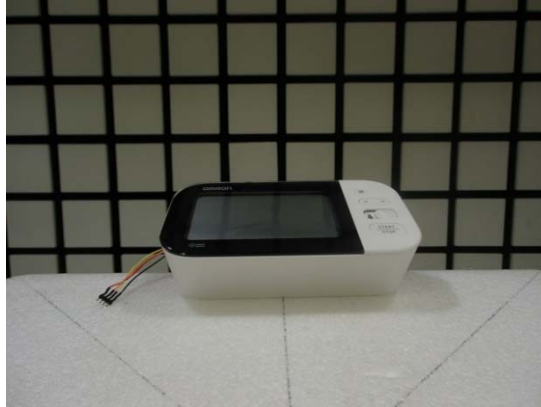
**X-axis**

**Worst Case Position**

**Below 1GHz (Horizontal: X-axis/ Vertical:Y-axis)**

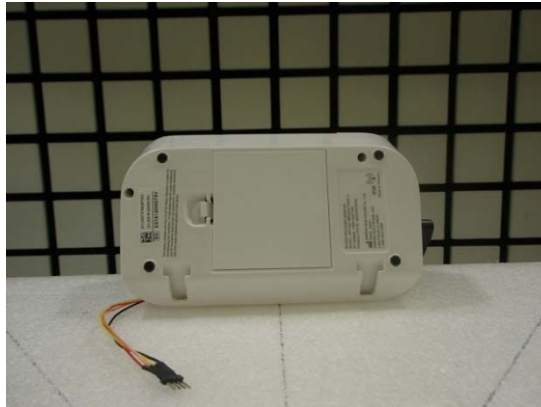
**Y-axis**

**Above 1GHz (Horizontal: Y-axis/ Vertical:Z-axis)**
