**ZTE CORPORATION**

# Product Change Description

[Model Name: V55, FCC ID: Q78-V55]  
[ZTE Corporation]

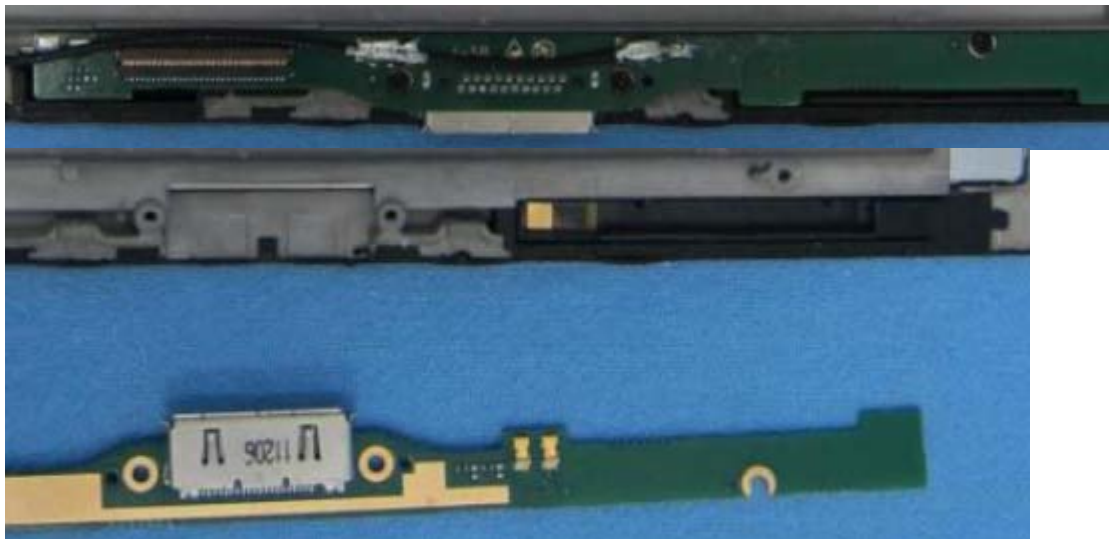
Before:

Antenna connects to RF module through RF cable which fix on pcb by welding.

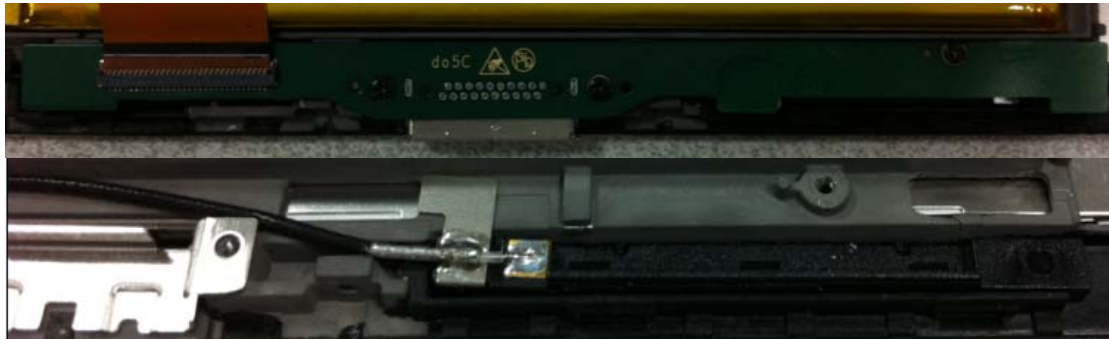
After:

Antenna connects to RF module through RF cable which soldered on antenna. The centre core of RF cable is soldered on antenna and the metallic shield is soldered on metal stamping which connects to the ground.

Reason for changes: Get more wider bandwidth, improve antenna performance.

WIFI band include BT band , and they use common antenna, so the changes of WIFI antenna makes no bad influence on BT performance.

The antenna gain is same as original.

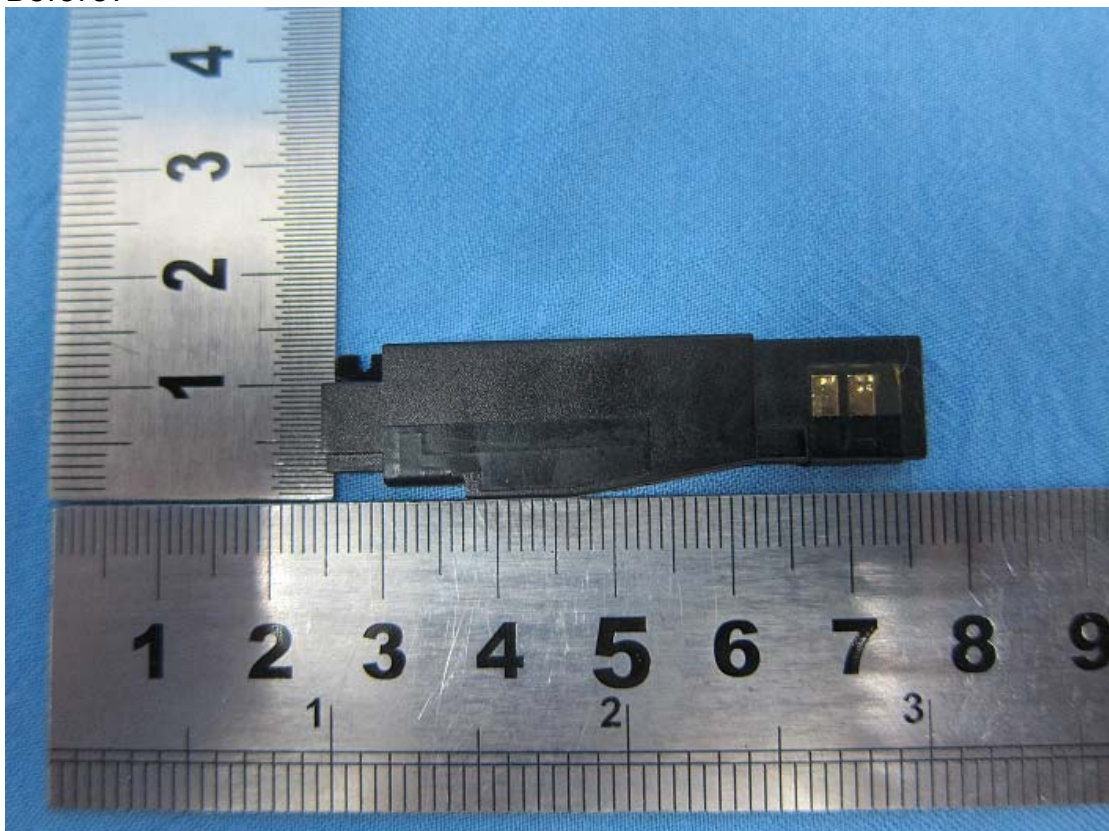
Before:

#### **WWAN Main antenna change:**

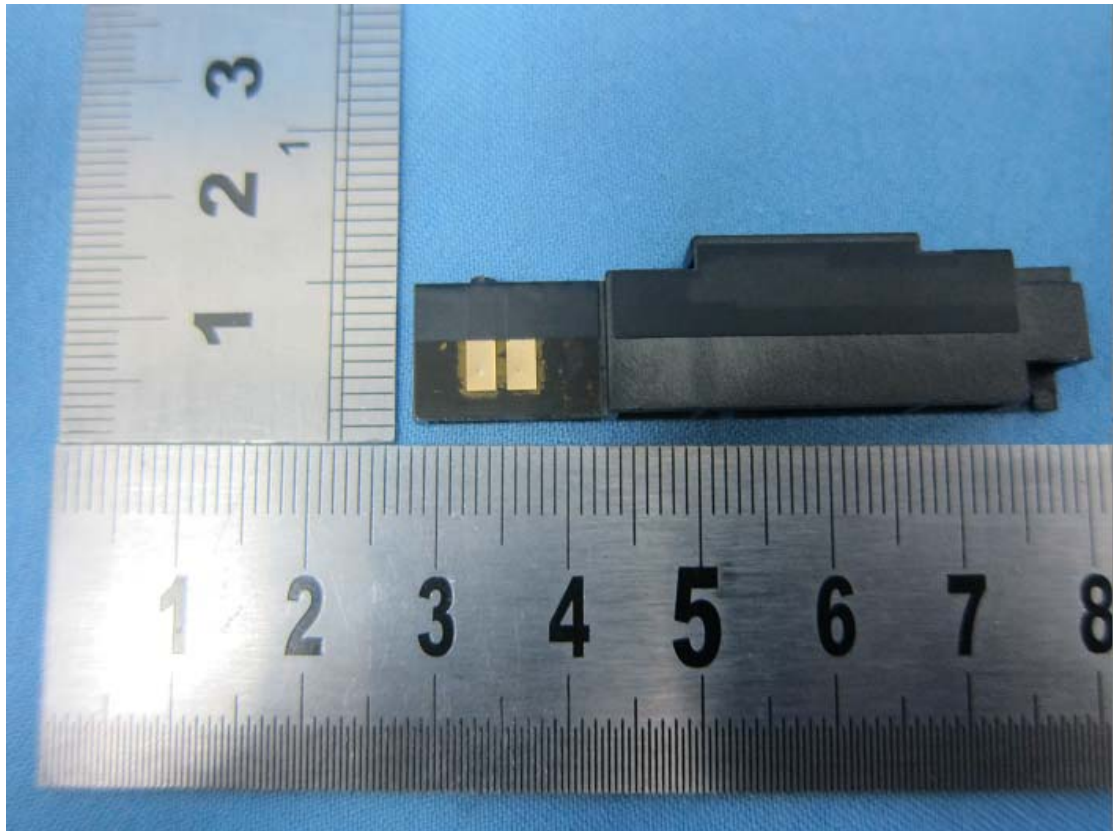
After:

Reason for changes: first, make the main antenna fixing to the cover more steady; second, improve performance of the main antenna.

The antenna gain is same as original.

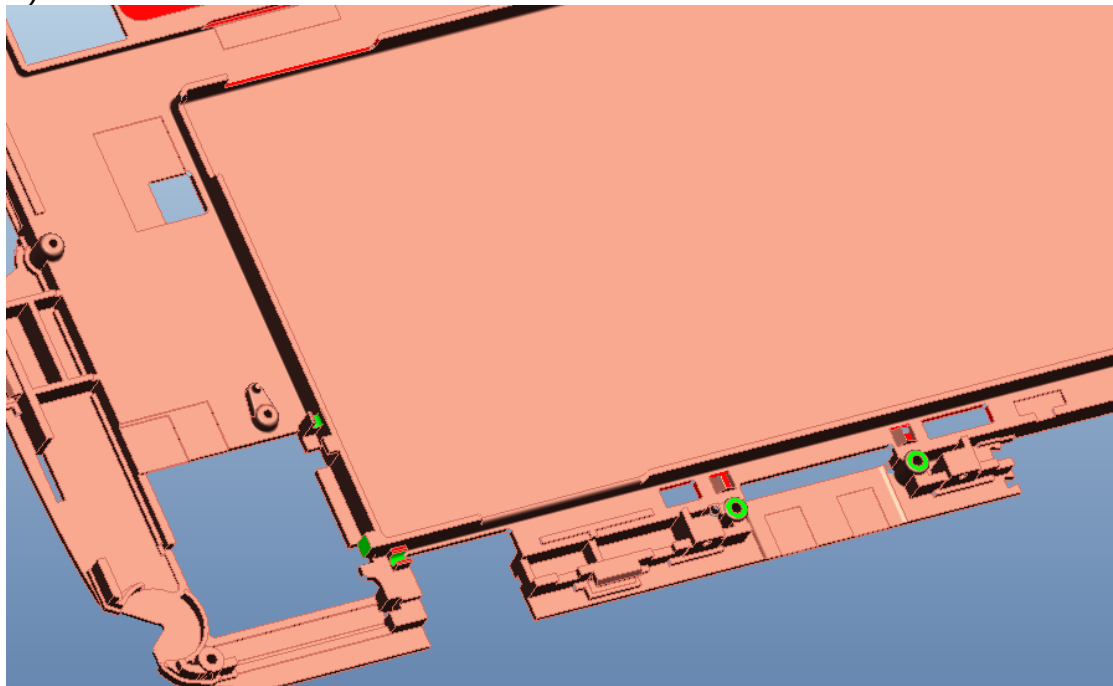
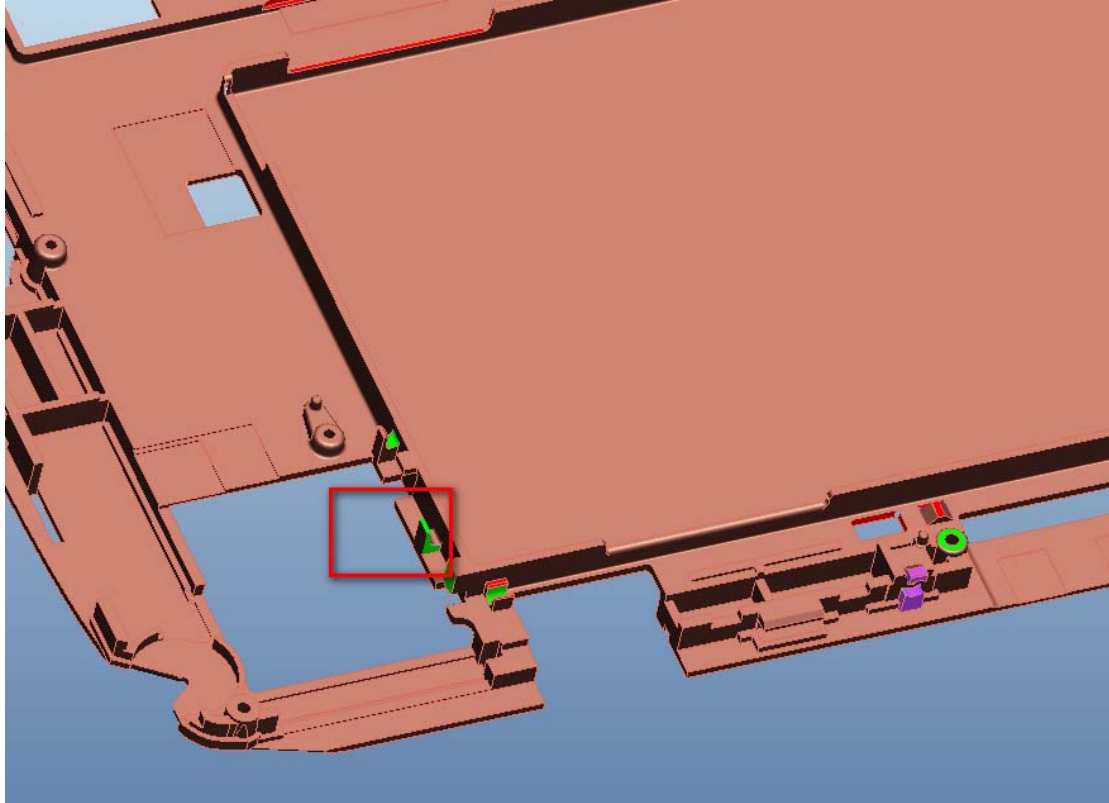
1) Before:

Reason for changes: Fix RF cable to avoid the cable to be pressed

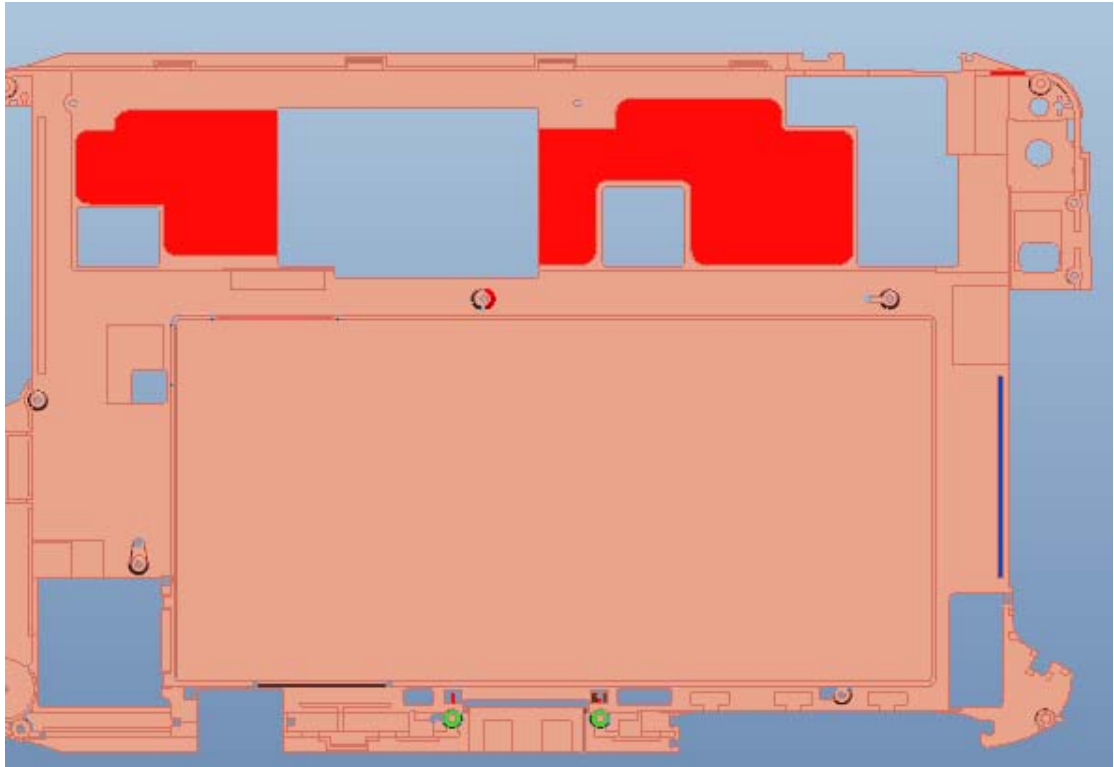
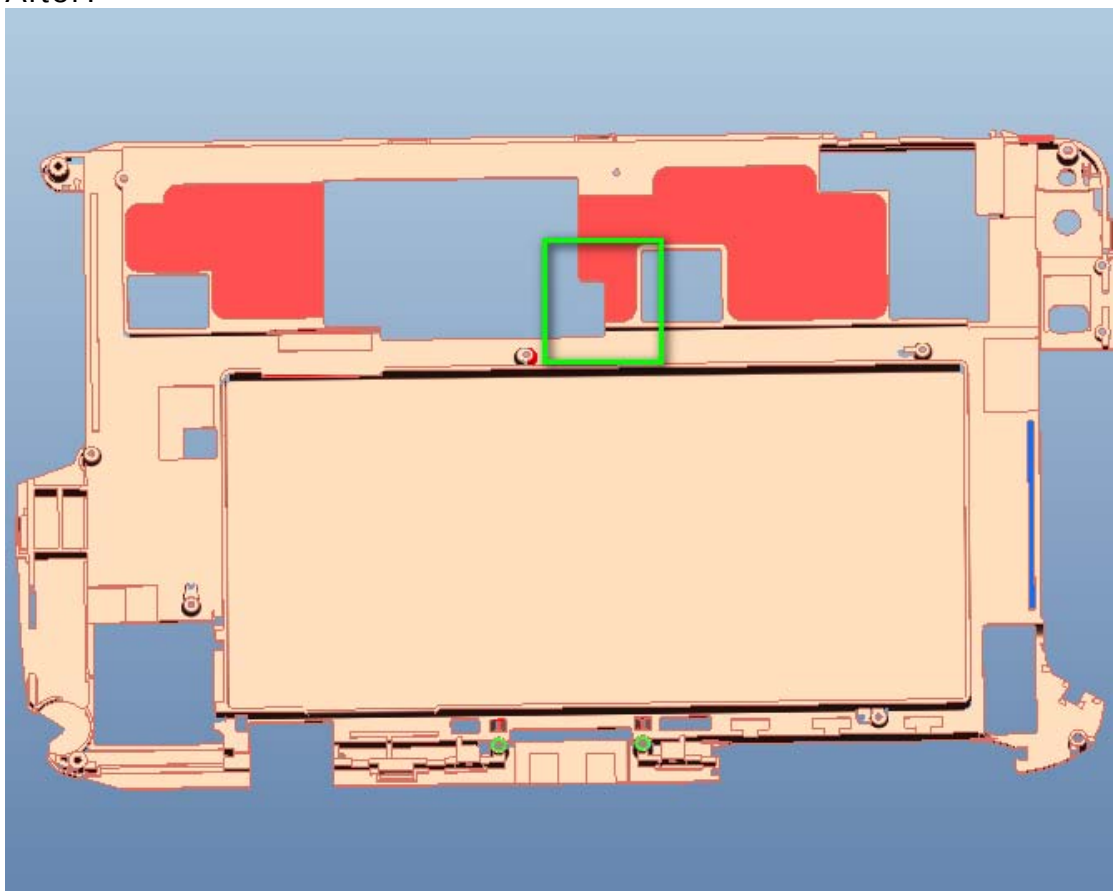
2)Before:

Reasons for changes:keep away from the LCD fpc

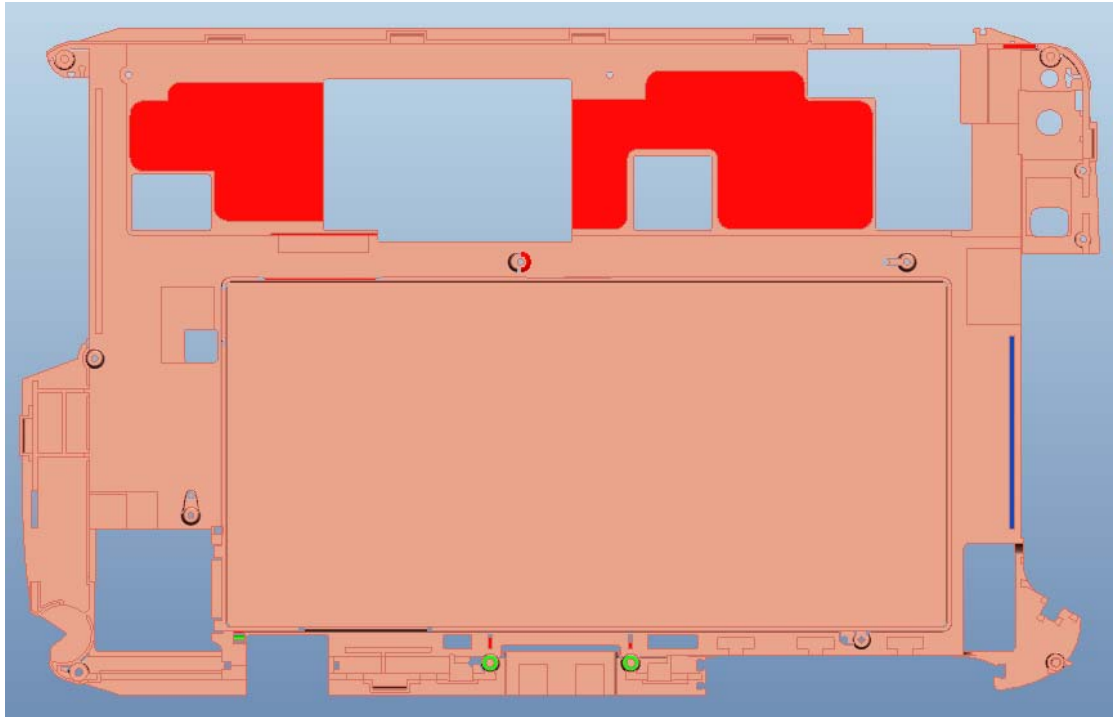
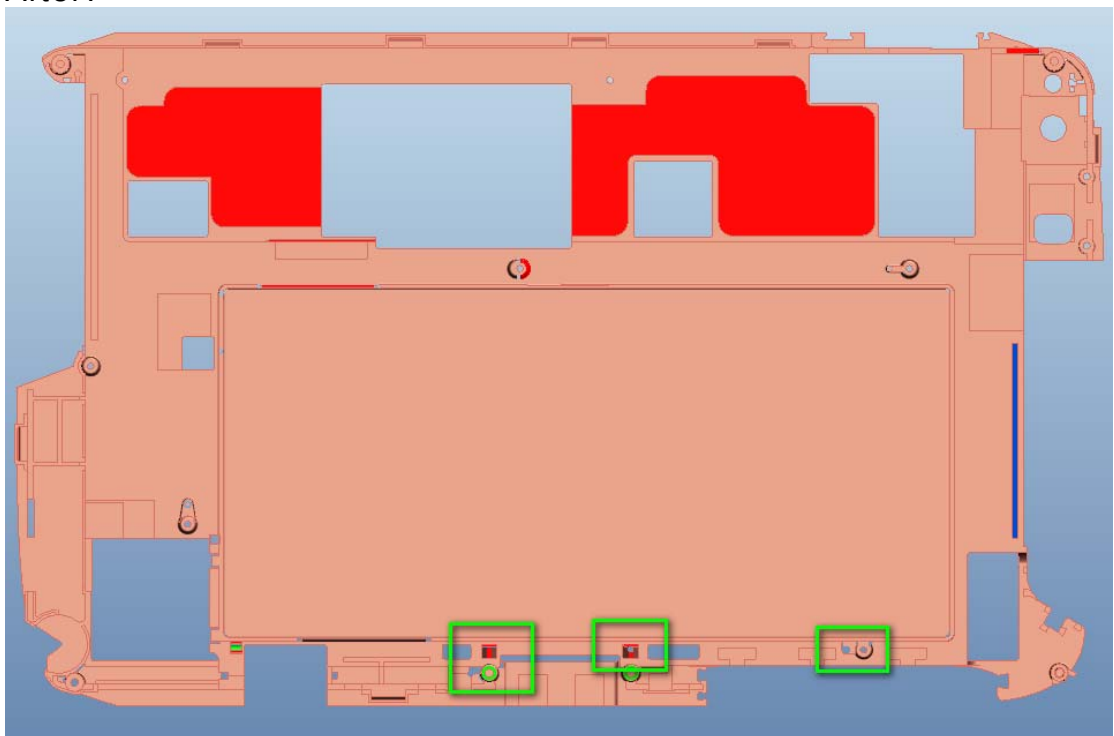
3)Before:

Reason for changes: enhance the front-frame

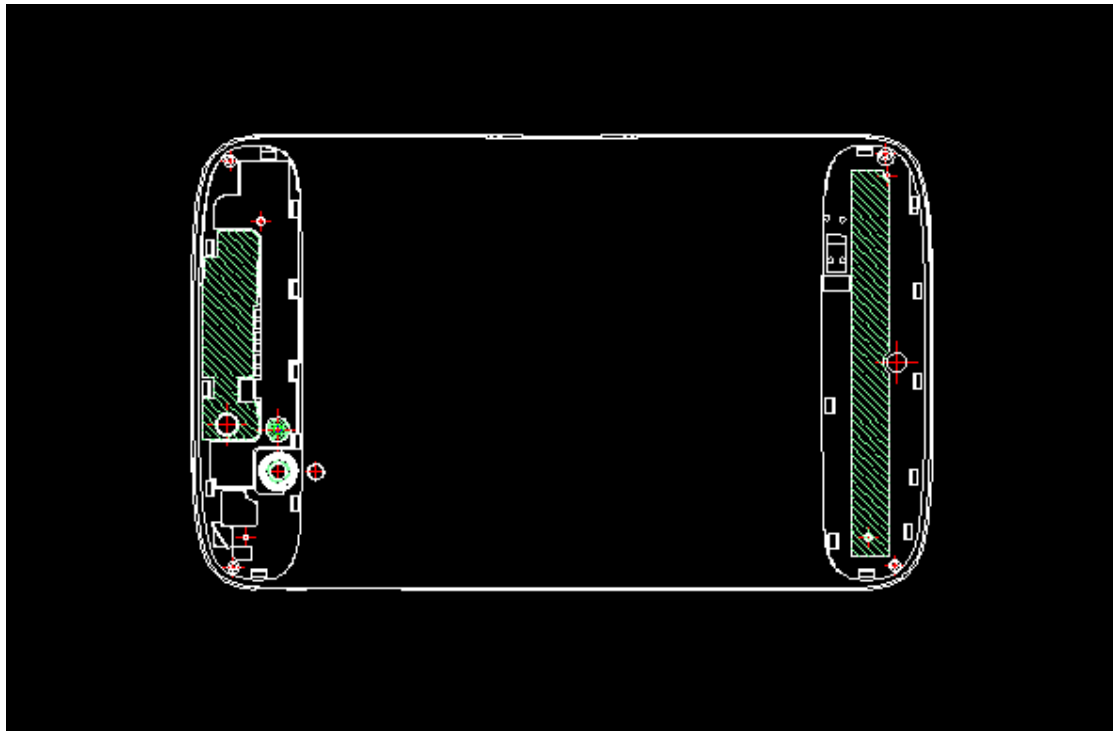
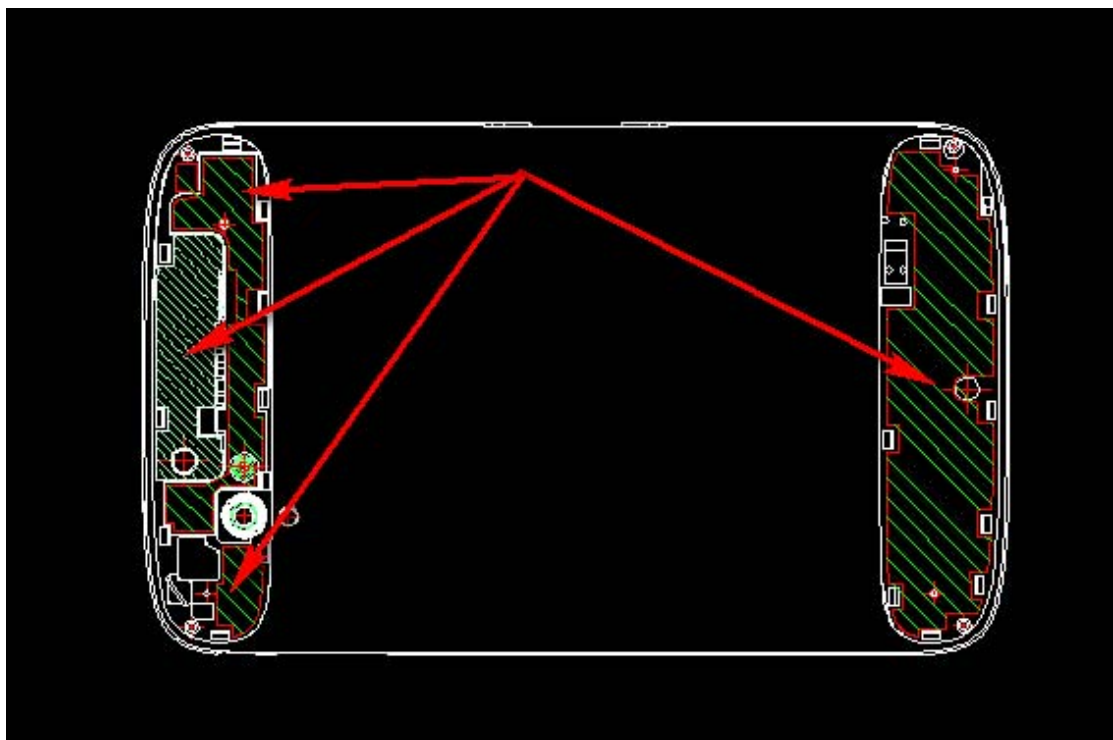
**Back cover change:**

Reason for changes: Increase and modify the glue to stick decorative- piece firmly

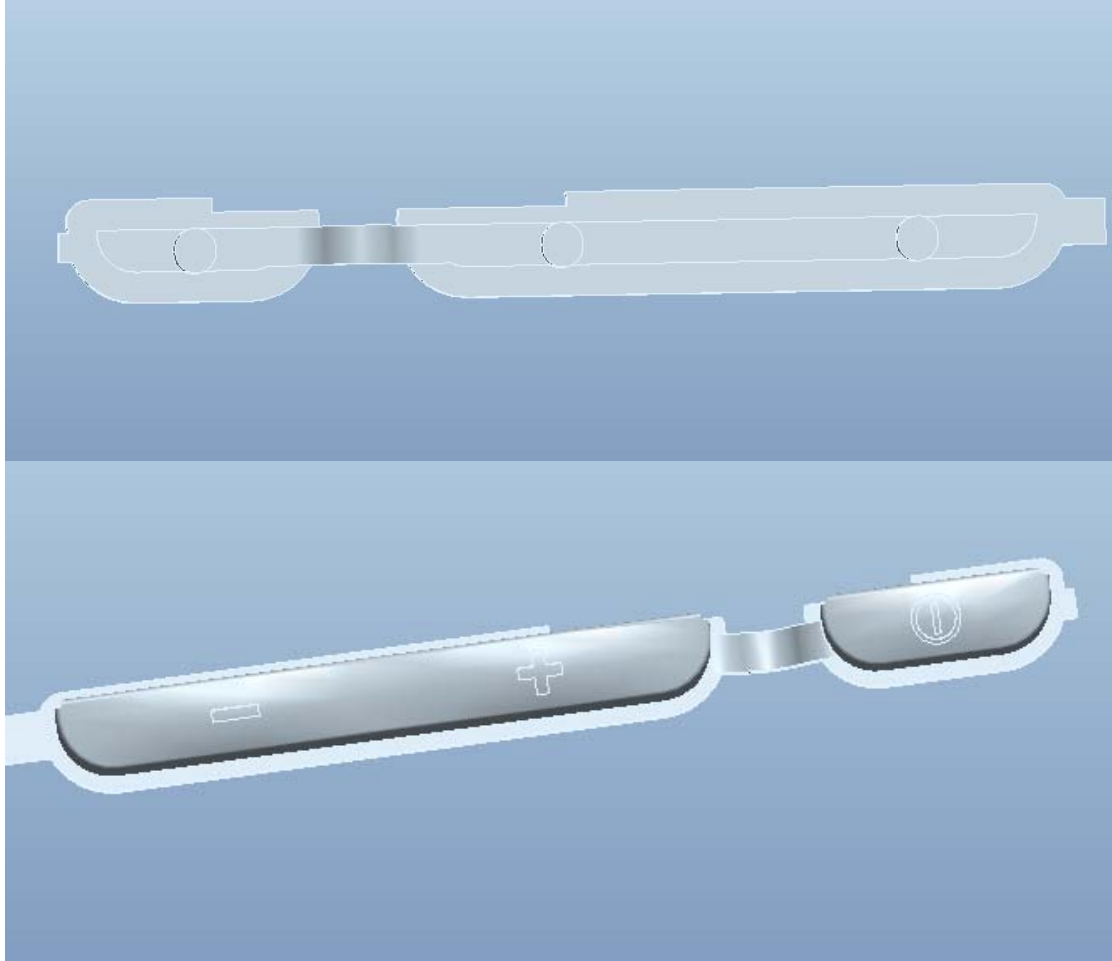
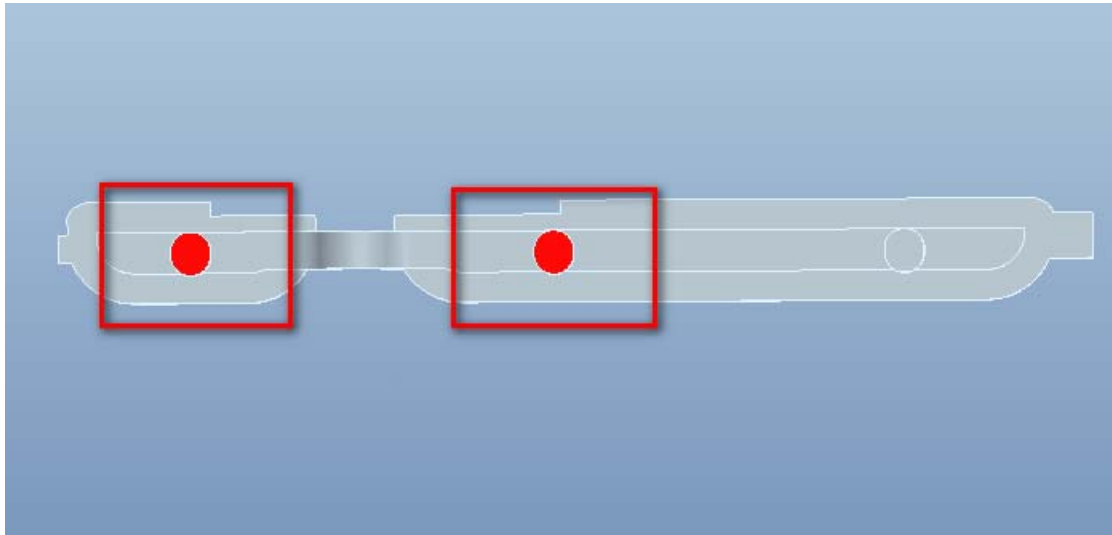
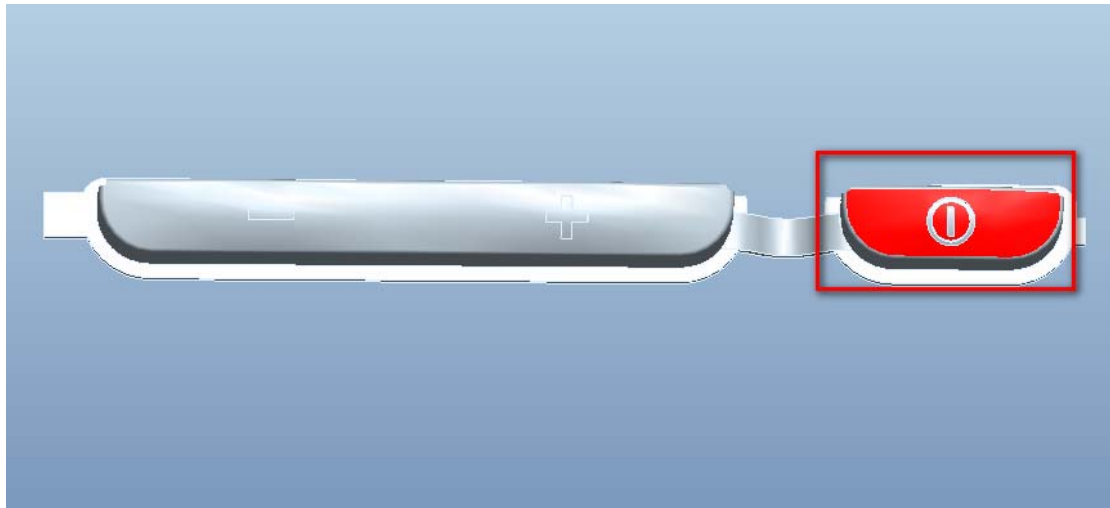
**Side-key changes:**

Reason for changes: It's to improve the handle of side-key that the TPU and PC are heightened

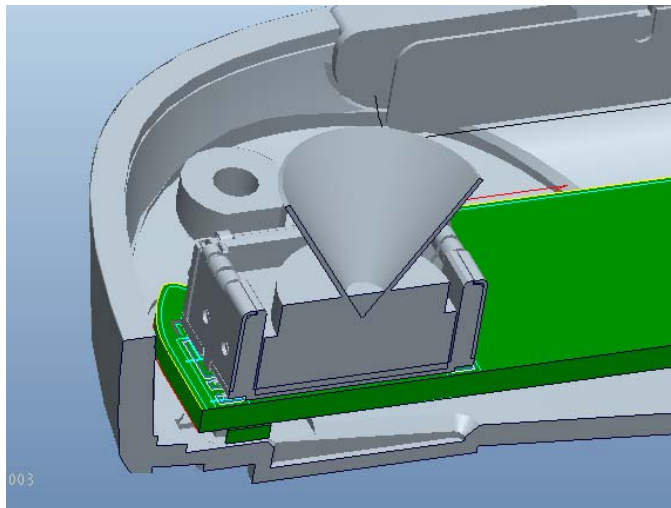
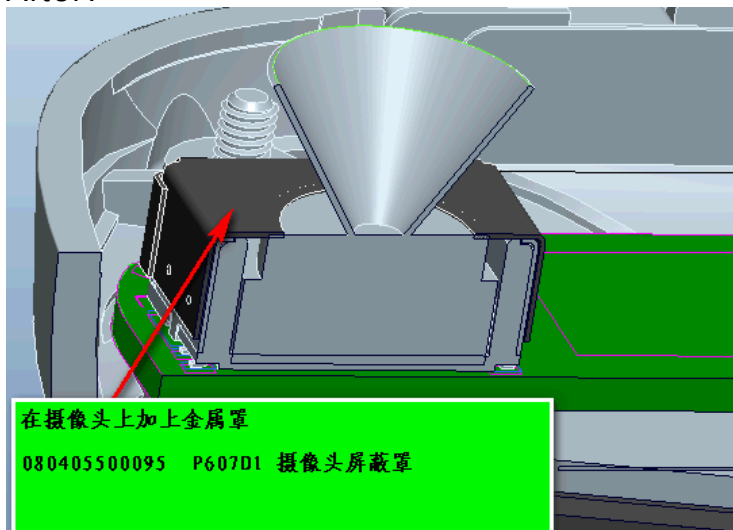
### Front camera changes:

Reason for changes: Add a shield cover over the front camera to cover the gaps, avoid the dust enter.

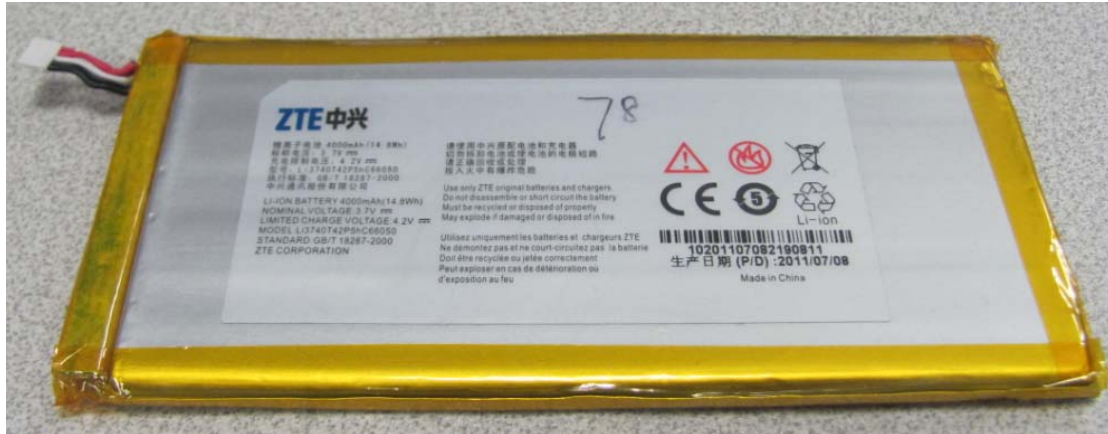
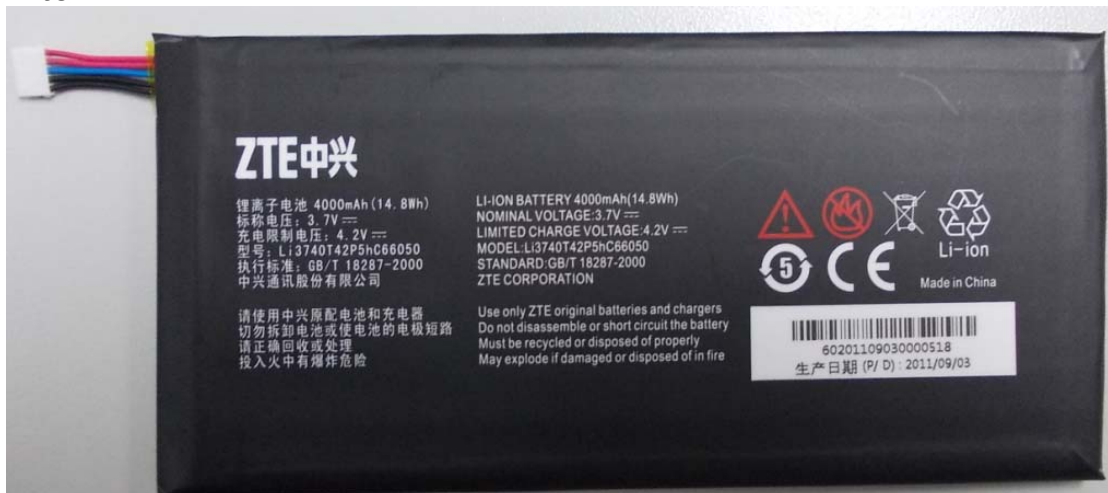
### Battery changes:

Reason for changes: make battery more reliable.
