Setup photos for HAC RF Emissions and T-Coil Test Report

Test report no.:	HAC_Photo_RM-927_03		Date of report:	2013-08-22		
Template version:	3.0		Number of pages:	3		
Testing laboratory:	TCC Nokia Salo Laboratory P.O.Box 86 Joensuunkatu 7H / Kiila 1B FIN-24101 SALO, FINLAND Tel. +358 (0) 7180 08000 Fax. +358 (0) 7180 45220		Client:	Nokia Corporation 16620 West Bernardo Drive SAN DIEGO CA. 92127 USA Tel. +1 858 831 5000 Fax. +1 858 831 6500		
Responsible test engineer:	Janne Hirsimäki	Product contact person:		Victoria Abadilla		
Measurements made by:	Janne Hirsimäki, Sami Savela					
Tested devices:	RM-927					
FCC ID:	QMND		IC: 661X-D			
Supplement reports:	RF_RM-927_01, T-Coil_RM-927_02					
Testing has been carried out in accordance with:	ANSI C63.19-2011 American National Standard for Methods of Measurement of Compatibility between Wireless Communications Devices and Hearing Aids					
Documentation:	The documentation of the testing performed on the tested devices is archived for 15 years at TCC Nokia.

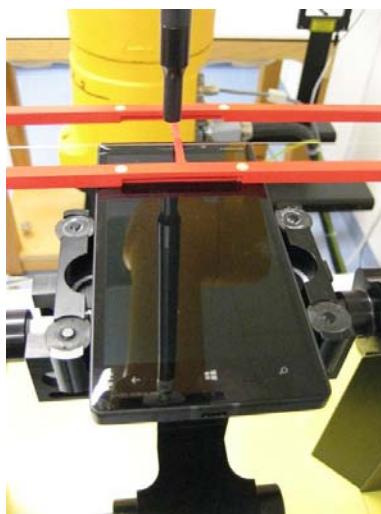
The device was positioned such that Device Reference plane was touching the bottom of the Test Arch. The scan is centered at the acoustic output by aligning the acoustic output with the intersection of the Test Arch's middle bar and dielectric wire.

Photo of the device positioned under Test Arch
