Test Set-up Photos for RM-155 SAR Compliance Test Report

Test report no.:	WR1124.303_V1	Date of report:	2006-06-15
Template version:	5	Number of pages:	4
Testing laboratory:	TCC, Dallas Nokia, Inc. 6021 Connection Drive Irving, TX 75039, USA Tel. +1 972 894 5000 Fax +1 972 894 4988	Client:	Nokia Mobile Phones, Inc. 12278 Scripps Summit Drive San Diego, CA 92131, USA Tel. +1 858 831 5000 Fax. +1858 831 6500
Responsible test engineer:	Anu Balijepalli	Product contact person:	Mario Murillo
Measurements made by:	B Alexander, A Balijepalli		
Tested device:	RM-155		
FCC ID:	QMNRM-155	IC:	NA
Supplement reports:	SAR Compliance Test Report, WR1124.301_V2		
Documentation:	The documentation of the testing performed on the tested devices is archived for 15 years at TCC Dallas.

1. SUMMARY OF SAR TEST REPORT

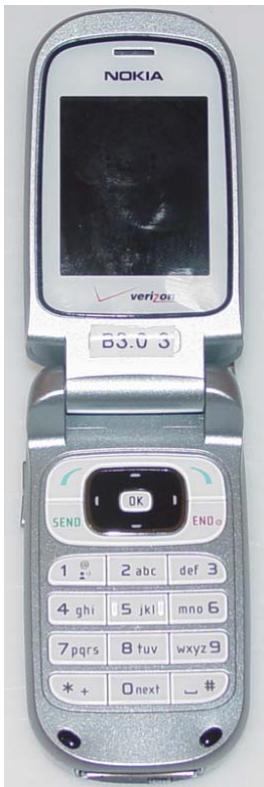
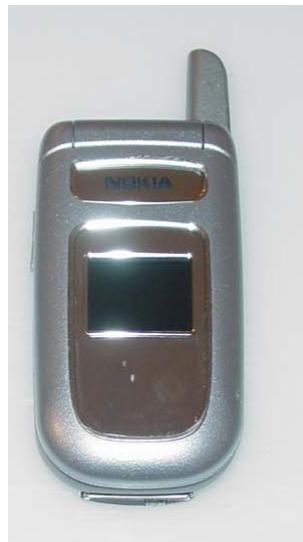
1.2 Picture of the Device

Period of test	2006-05-24 to 2006-06-02
SN, HW and SW numbers of tested device	026/01186372, 3001, V PR100_05w21_46.nbp
Batteries used in testing	BL-5B
Headsets used in testing	HS-9, HS-3
Other accessories used in testing	-
State of sample	Prototype unit
Notes	-

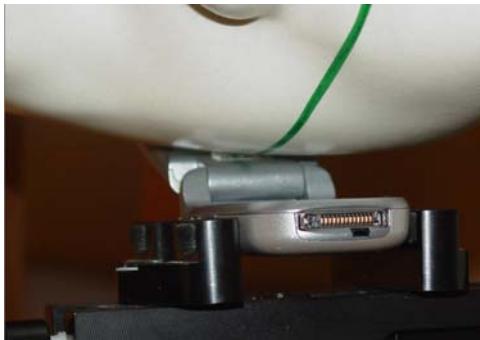
Photo of the device in "cheek" position

1.3.1 Against Phantom Head

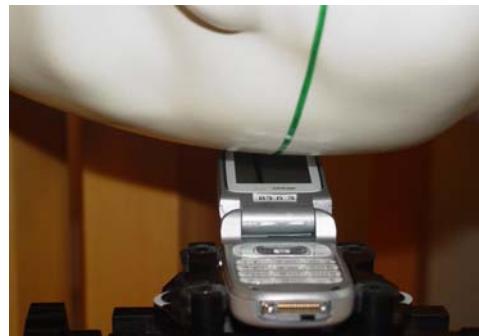
Photo of the device in "tilt" position

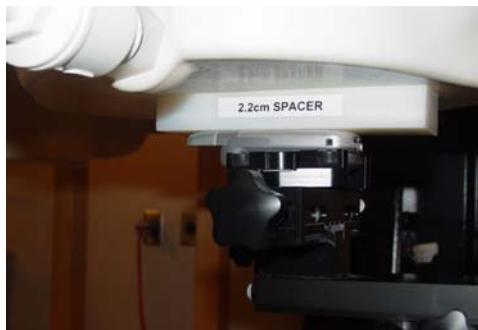
Photo of the device positioned for Body SAR measurement.
The spacer was removed for the tests.

1.3.2 Body Worn Configuration
