## Setup photos for HAC RF Emissions and T-Coil Test Report

| Test report no.: | HAC_Photo_RM-808_03 | Date of report: | 2011-11-10 |
| Tested devices: | RM-808 | | |
| Testing has been carried out in accordance with: | <b>ANSI C63.19-2007</b><br>American National Standard for Methods of Measurement of Compatibility between Wireless Communications Devices and Hearing Aids | | |

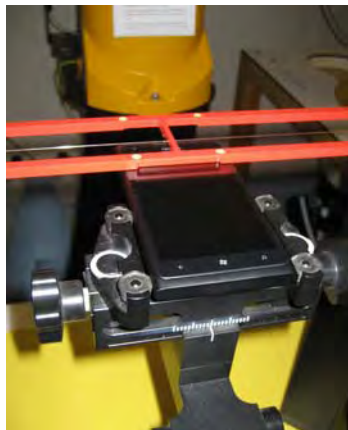
The device was positioned such that Device Reference plane was touching the bottom of the Test Arch. The scan is centered at the acoustic output by aligning the acoustic output with the intersection of the Test Arch's middle bar and dielectric wire.

Photo of the device positioned under Test Arch
