Setup photos for HAC RF Emissions and T-Coil Test Report

Test report no.:	HAC_Photo_RM-809_03	Date of report:	2011-10-10
Template version:	3.0	Number of pages:	3
Testing laboratory:	TCC Nokia Salo Laboratory P.O.Box 86 Joensuunkatu 7H / Kiila 1B FIN-24101 SALO, FINLAND Tel. +358 (0) 7180 08000 Fax. +358 (0) 7180 45220	Client:	Nokia Corporation 12278 Scripps Summit Drive SAN DIEGO CA. 92131 USA Tel. +1 858 831 5000 Fax. +1 858 831 6500
Responsible test engineer:	Janne Hirsimäki	Product contact person:	Victoria Abadilla
Measurements made by:	Janne Hirsimäki		
Tested devices:	RM-809		
FCC ID:	QMNRM-809	IC:	661X-RM809
Supplement reports:	T-Coil_RM-809_01, RF_RM-809_02		
Testing has been carried out in accordance with:	<p>ANSI C63.19-2007 American National Standard for Methods of Measurement of Compatibility between Wireless Communications Devices and Hearing Aids</p>		
Documentation:	The documentation of the testing performed on the tested devices is archived for 15 years at TCC Nokia.

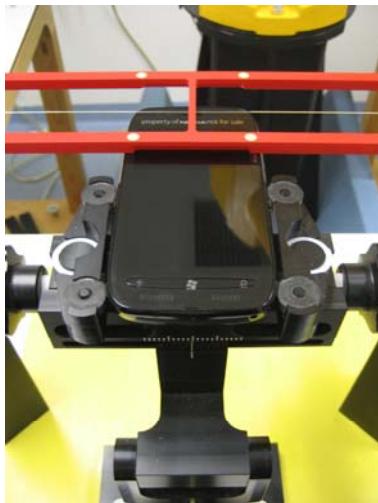
1.2.1 Scan area centered at the acoustic output

The device was positioned such that Device Reference plane was touching the bottom of the Test Arch. The scan is centered at the acoustic output by aligning the acoustic output with the intersection of the Test Arch's middle bar and dielectric wire.

Photo of the device positioned under Test Arch
